Final Conservation Report for Churchyard Memorials

St John the Baptist Church - Bishops Castle - Shropshire

The Diocese of Hereford

Elliott Ryder Conservation

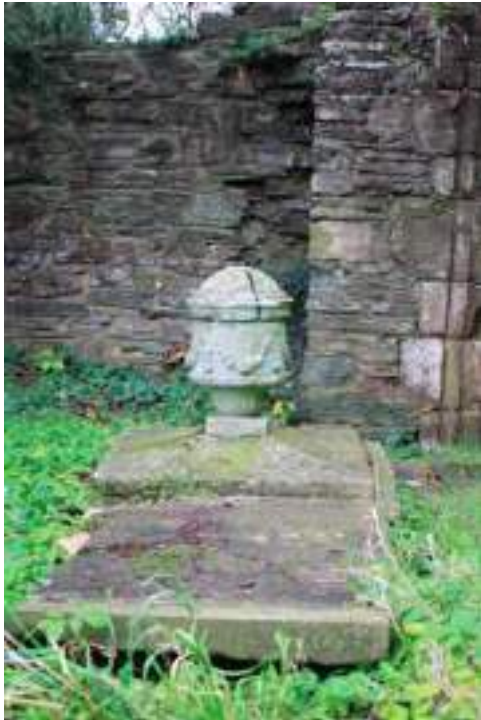
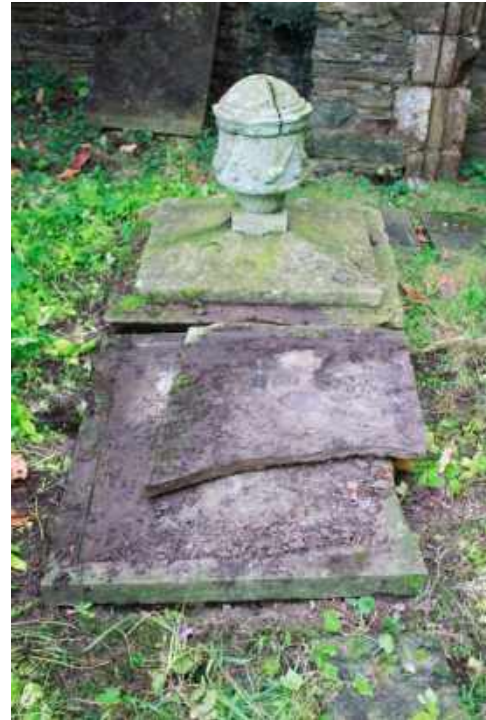
The box-tomb elements stacked haphazardly on top of each other with several of the side panels having fractured as a result of point-loading from uneven weight distribution. Note the extent of soil and debris on the upper surfaces and fractures through the urn-lid clearly visible.

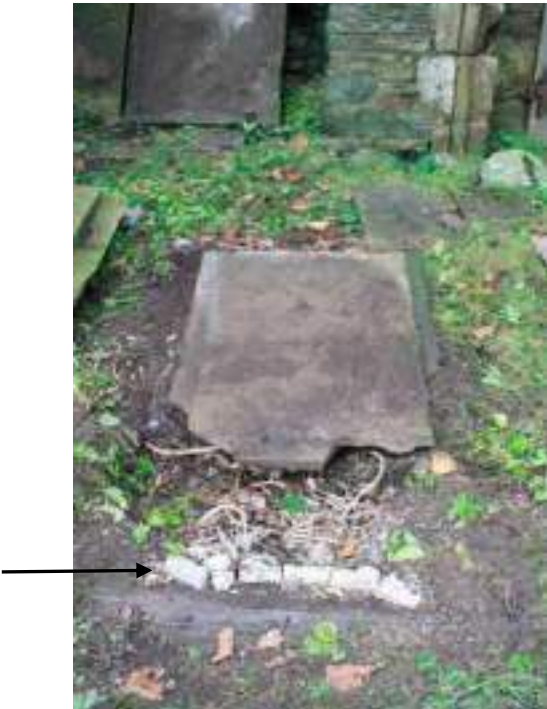
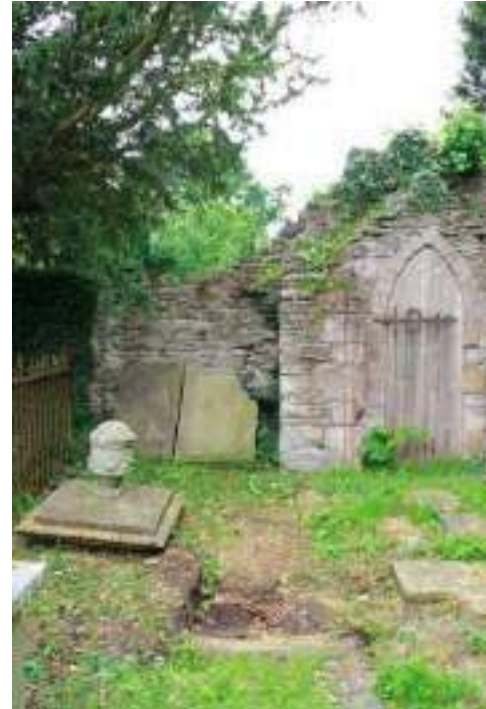
The bottom side panel with fractured elements safely removed. Note the remains of very thick white mortar (indicated) which formed a joint between the bottom bed of the inscription panel and top bed of the plinth which you can just see beneath ground level. This indicates an overly wide joint, due to structural instability. The right-hand image shows some of the elements leaning against a nearby wall, to be rain-washed over the winter and the capstone and urn moved away to one side, to enable erection of a lifting scaffold.

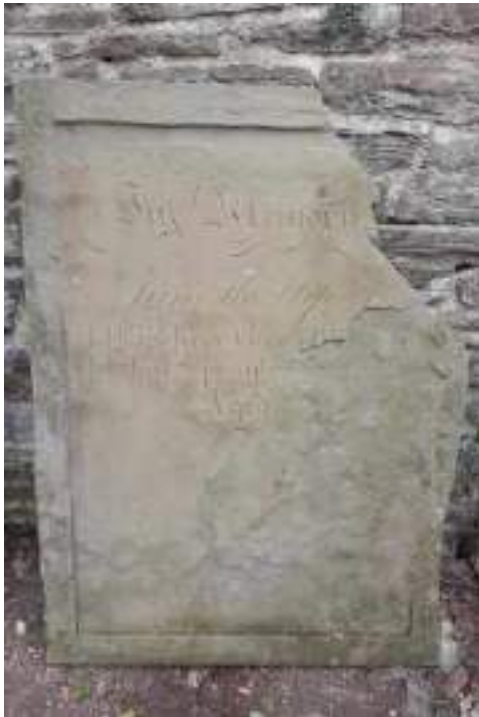
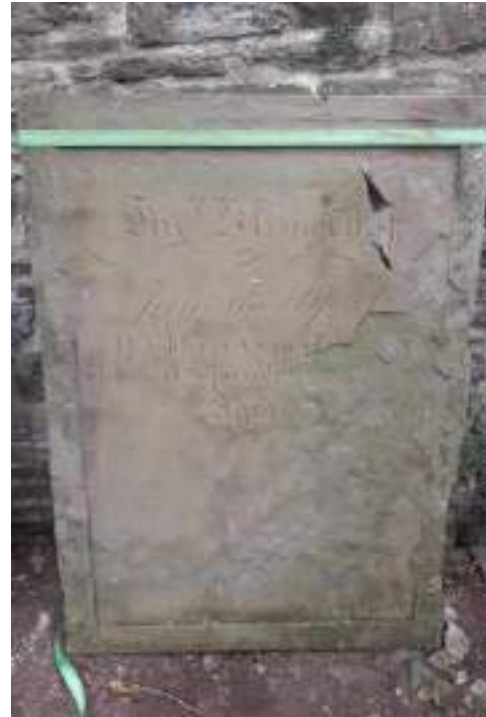
The front inscription before and after re-joining broken sections. Resin was kept well-back from the front face so it was not visible and the effected joins look as 'natural' as possible. Note the loss of detail to both vertical, raised borders and the bottom right-hand corner, much of the carved upper surface has been lost from this very laminar stone type.

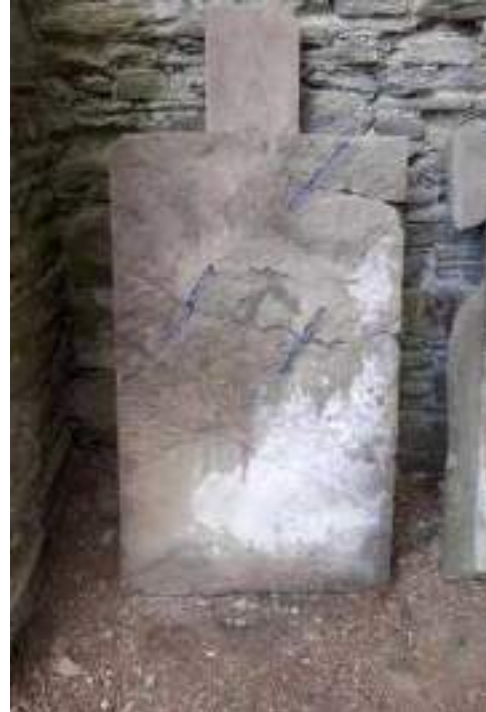
The front (viewer's left-hand side) and the rear (right-hand side) of the same panel showing the number of mechanical fixings to provide additional support in the side-to-side fractures. The slab was too thin to insert dowels in the centre, so 12 x 3mm stainless-steel flat-bar is inserted at right-angles across fractures, into cut channels and secured with epoxy-resin. The panel is upside down and stayed that way until re-building, so as not to stress the two horizontal joins unnecessarily, which could have failed given the overall weight/height of the slab.

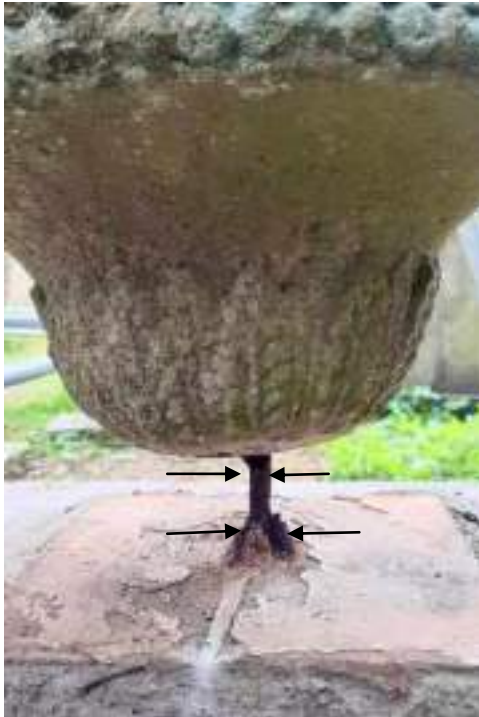
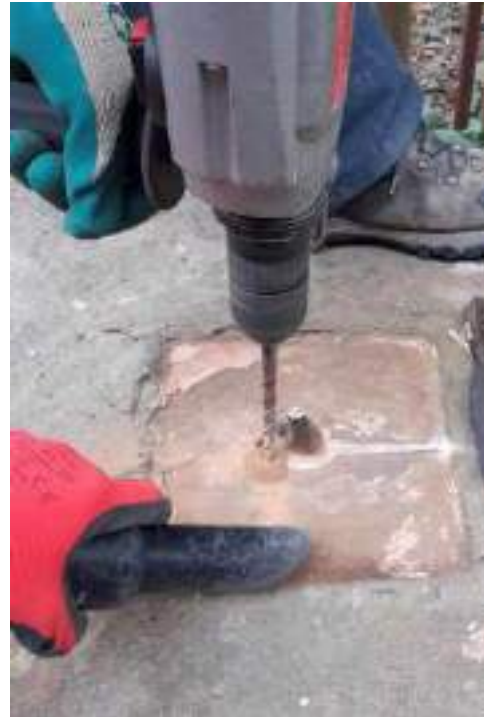
The expanded dowel spanning vertically between the capstone and the bottom bed of the It had split the thin base into four sections but luckily not disrupted the capstone. Note the actual size of the original dowel, which was secured with molten lead and the expanded size of the corroded metal (both indicated).

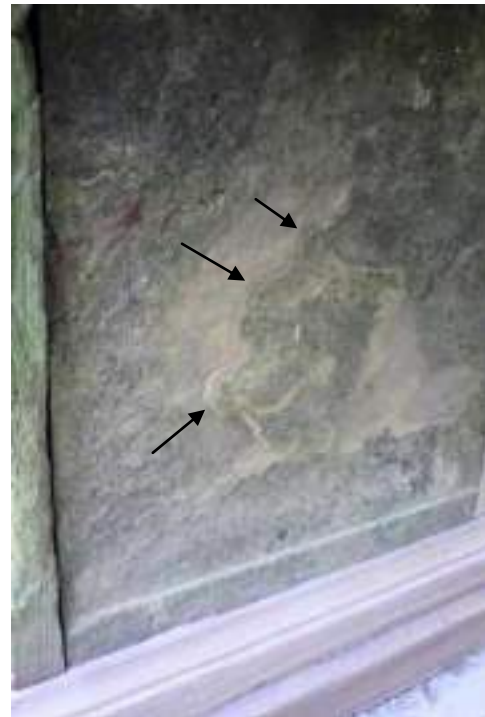
The capstone being lowered into position. Slate shims were required on the top-bed of the core to make it level, as the bottom-bed of the capstone was so uneven. The right-hand image shows mortar repairs (indicated) inserted into vulnerable areas previously tacked with epoxy-resin spots to prevent further damage/loss. Much of the original carved surface has been lost from this very laminar local sandstone.

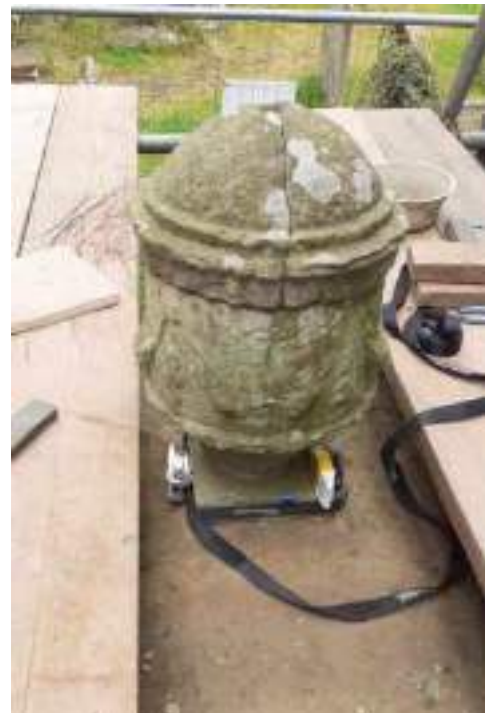
The thin square-base beneath the urn split into four sections by the force of the previous corroded iron-fixing. Lead shims are incorporated to create a uniform joint which isn't often possible when bedding a heavy stone element on a small footprint of mortar. The repaired urn-lid which was split into three sections by the dowel spanning between the two upper elements. The resultant joint lines were filled to slow-down (not prevent) the ingress of moisture.

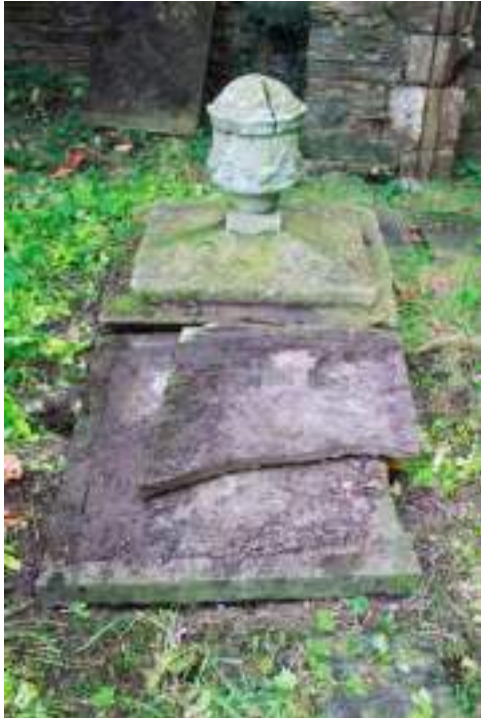
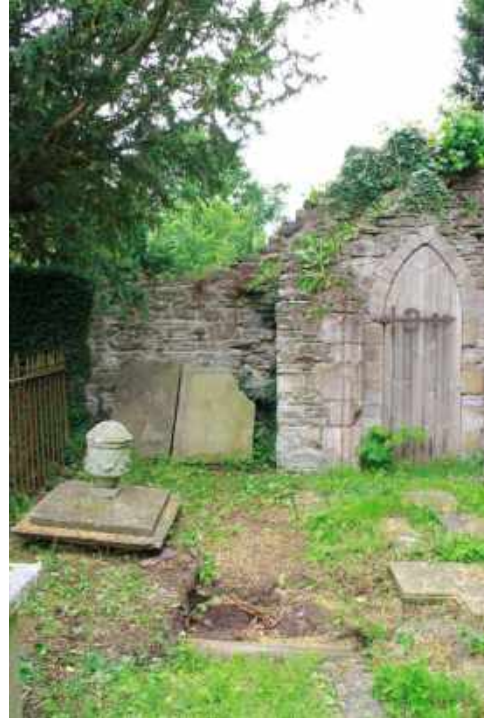
On the left, the dismantled box-tomb prior to any treatments. On the right, the extant elements moved to allow rain-washing and slow drying over the winter. Note the proximity of the mature over-hanging tree, which will contribute significantly to the colonisation of stone, mortars and concrete with biological growths which are not benign.

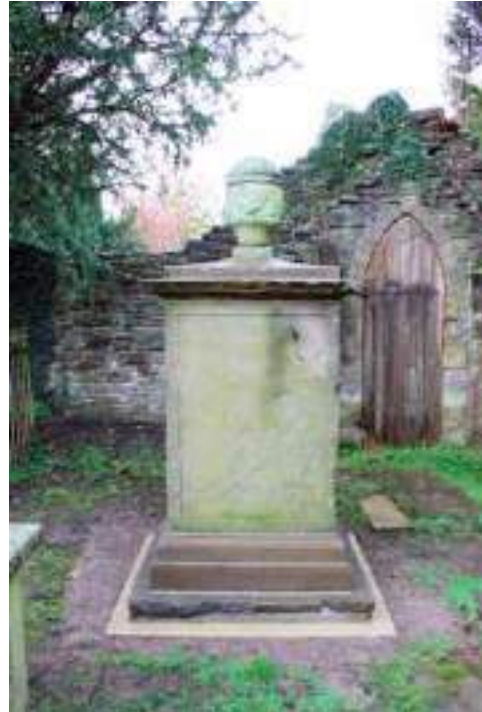
The re-built box-tomb on its new concrete pad. Note the eroded and physically damaged nosing (outer edge) of the capstone which casts biological rich water directly onto the moulded stone plinth beneath. Despite the architectural detailing and proximity of the over-hanging tree, the long-term integrity of this beautifully proportioned and decorated memorial is now assured.

- 6.2 It is also worth noting that the outer nosing or extremity of the capstone is much eroded and had suffered some isolated physical damage during dismantling and stacking of the stone elements. As such the capstone is not shedding rainwater away from elements below as designed to do and is actually directing rainwater onto the aged stone in some areas. This was witnessed during/after several heavy rain-showers. That said the memorial as a whole is in a much better state of preservation than it was - stacked badly on an uneven surface and its re-erection/conservation has ensured its long-term future.

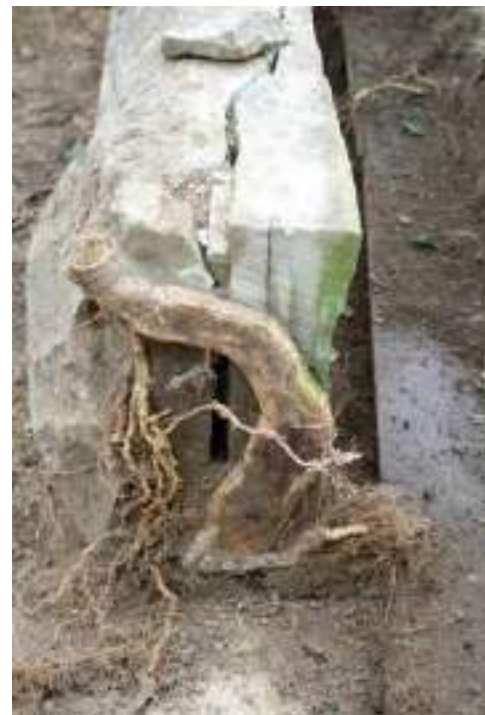
On the left, the south-west corner block having been forced off, on the right, vertical fractures through one of the plinth blocks. The ivy had grown the same width as the joint before widening back out within the tomb chest.

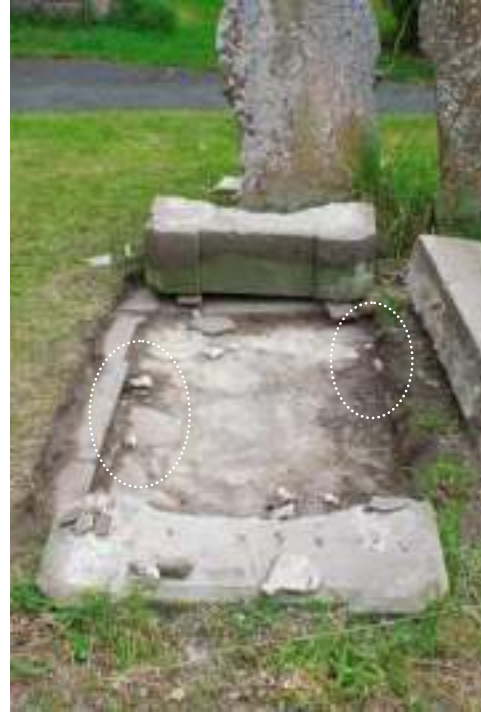
During the dismantling process, note how little gap there is between the long panels. In the right-hand image, tied plastic bags (indicated) can be seen on frill-girdles cut into the ivy stems. This was treated with a toxic, Potassium Sulphamate paste which will kill the roots system below ground level. The compacted stone base did not require lifting/dismantling, which was wider than the outer footprint.

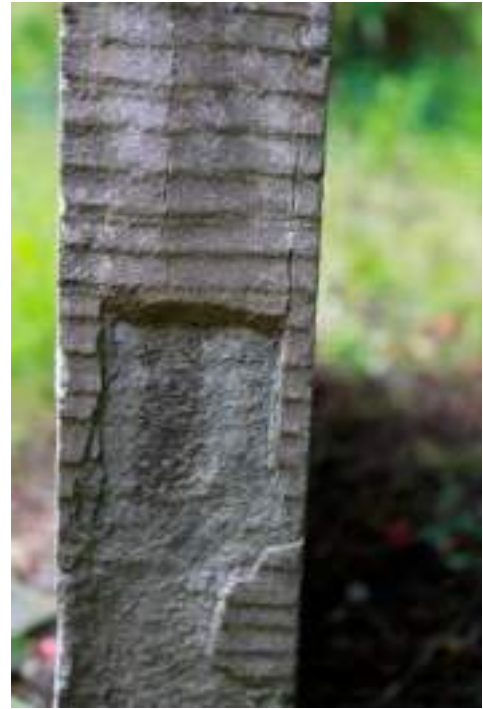
The north side of the slab before and after treatment, the stone is spalling not delaminating, as it is at 90 degrees to the bedding-plane partly as a result of the force/shock required to produce the tooled or 'batted' surface on the edge of the slab. The darker area on the now exposed substrate is an inherent ferrous mineral, which is another point of weakness and reason for localised failure. Coloured repair mortar was packed up into the vulnerable edge as far as possible.

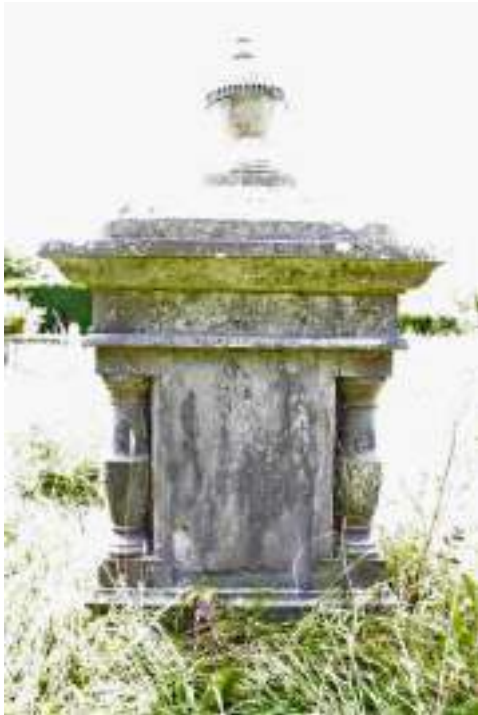
The north elevation of the Thomas memorial before and after all treatments. Delaminated stone along the bottom bed of the box-tomb was rationalised back to sound substrate, with support fillings inserted along the length of the previously tacked edges. Note the poor angle of the ball-finial. Low-relief, foliate-decoration to the frieze (indicated) beneath the capstone is all but lost visually.

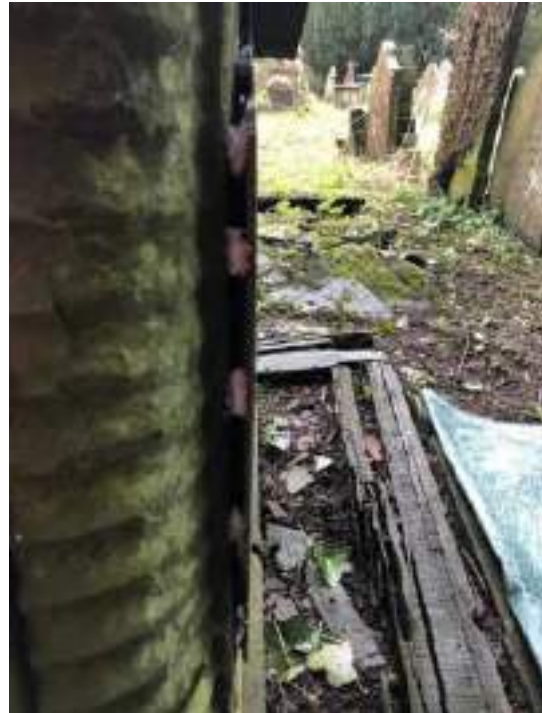
Emergency consolidation was carried-out by us in 2019 to the section of carved surface which was springing. Spots of resin were inserted along its length, to bond it back to the substrate and prevent un-wanted movement. Small sections had repair mortar packed in as far as possible, and then liquid grout was introduced to fill the void horizontally. This process was repeated until the void was filled vertically from the bottom to top of the lamination.

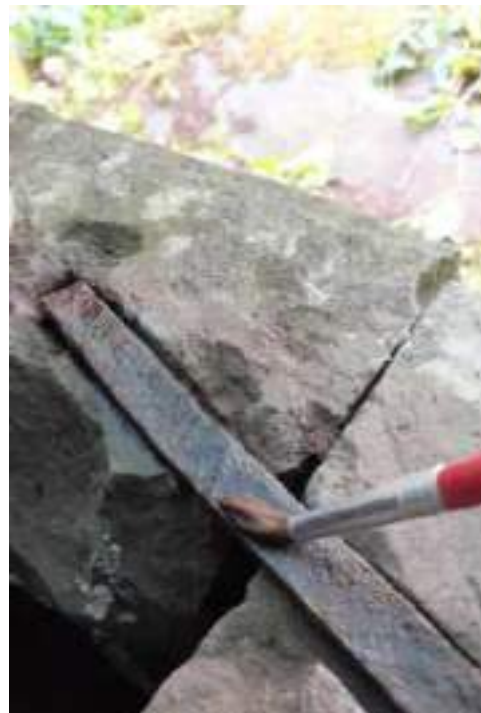
Iron fixings were found to be in a sound condition on the north-east and south-east corners. They were removed (easily) and abraded with a steel polishing-mop, then treated with coats of corrosion inhibitor (on the left). Once dry this was protected by two applications of a water-clear acrylic-resin (on the right). Once the coating was dry the fixings were secured into position with an epoxy-resin.

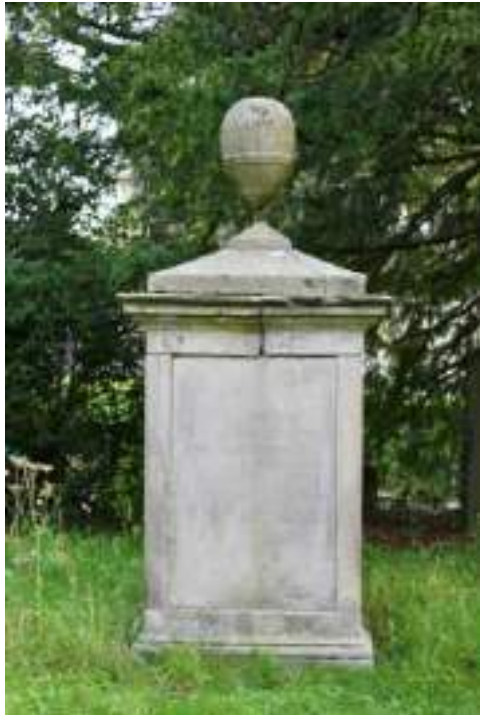
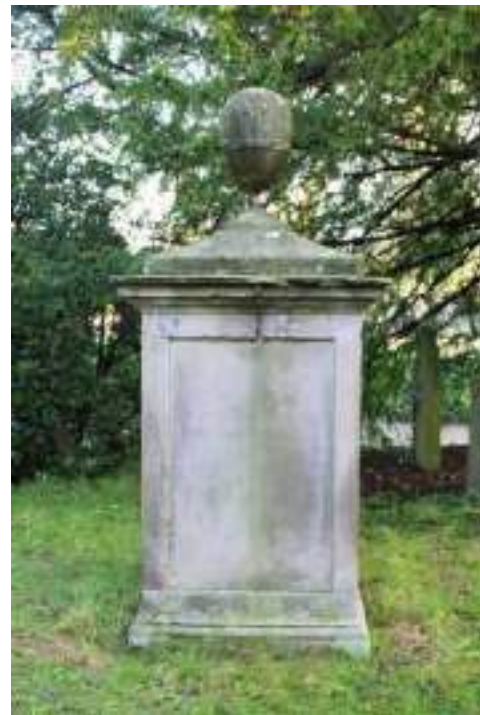
The memorial to William Thomas before (left) and after treatments. Outwardly there appears to be very little difference, however before treatment the memorial could have been pushed-over with a concerted effort, given its top-heavy design and failure of corroded iron-fixings. Note the greater level of colonisation with black biological growths to the ovoid ball-finial between July and December. No cleaning took place on this object.

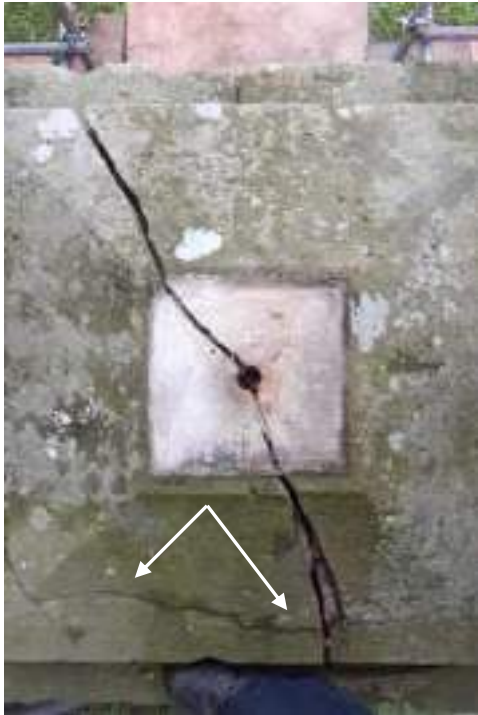
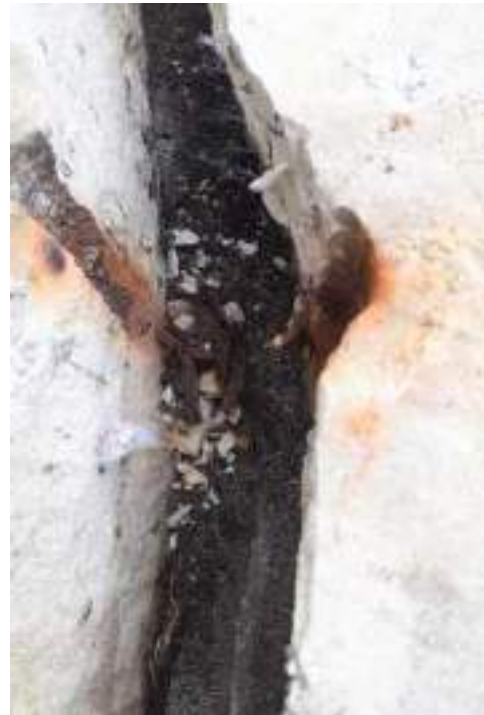
The capstone having been fractured into 2 larger sections with a thin slither, also fractured on the north fall of the block. Iron staining is visible in/on the vertical dowel-hole, with delaminated dead-metal collected at the bottom of the hole. The capstone is naturally bedded (as it should be) note the horizontal lamination (indicated) which had to be taken into account when manoeuvring the sections down and back up.

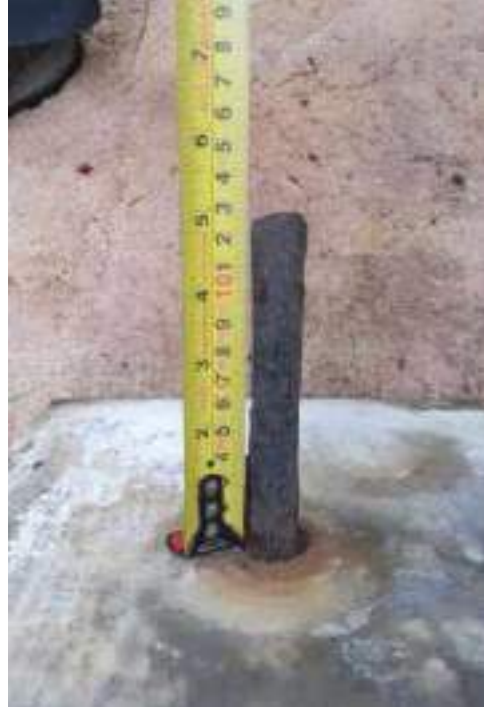
It was easier to separate the compromised sections at ground-level as well as making lifting easier. Note the section of missing neck, which was forced off at an earlier date. On the right, the underside of the expanded dowel which split the capstone. Expanding iron can exert huge forces on a strong albeit natural material.

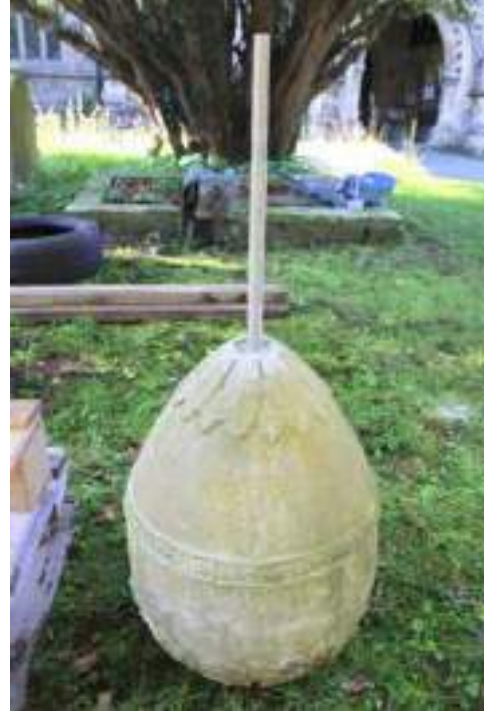
The missing section of the stone neck before dismantling. On the right, the new threaded stainless-steel dowel, secured plumb into a now deeper hole in the ball-finial with epoxy-resin. Drilling-out the corroded dowel from the ball was difficult as it had been set in with lead and there very little room between the edge of the lead and the small diameter of the carved stiff-leaf detail.

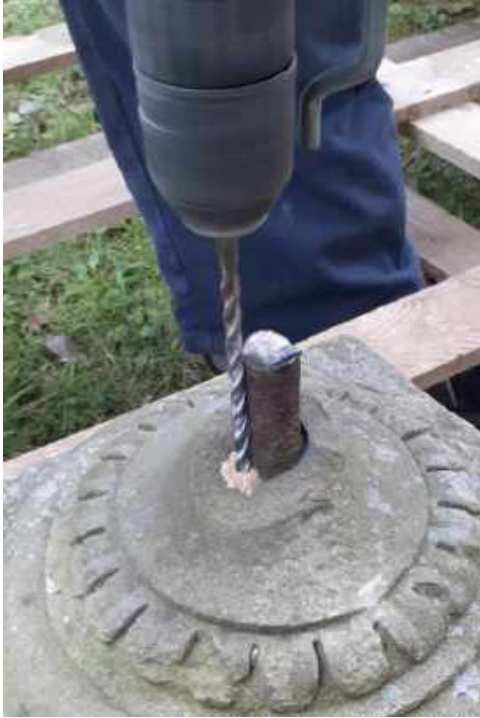
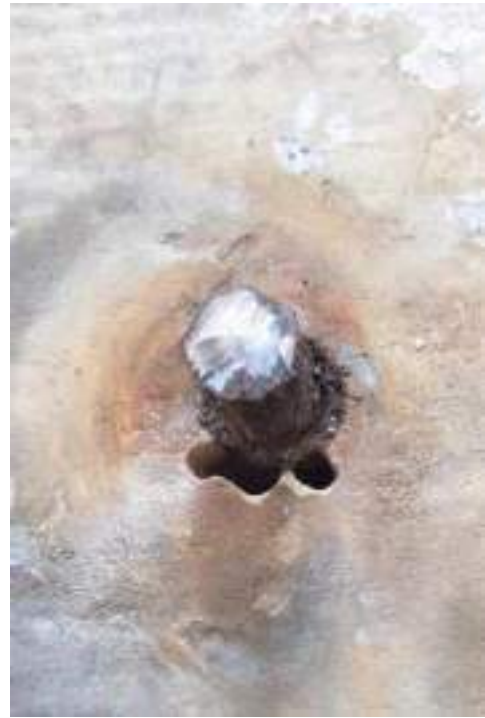
Drilling out the remains of the expanded iron-fixing from the urn-base. The right-hand image highlights the extent to which iron expands and it was lucky not to fracture this much smaller block. Great care is taken when drilling around expanded metal to remove it. A third of the way around the perimeter is usually enough to free such fixings.

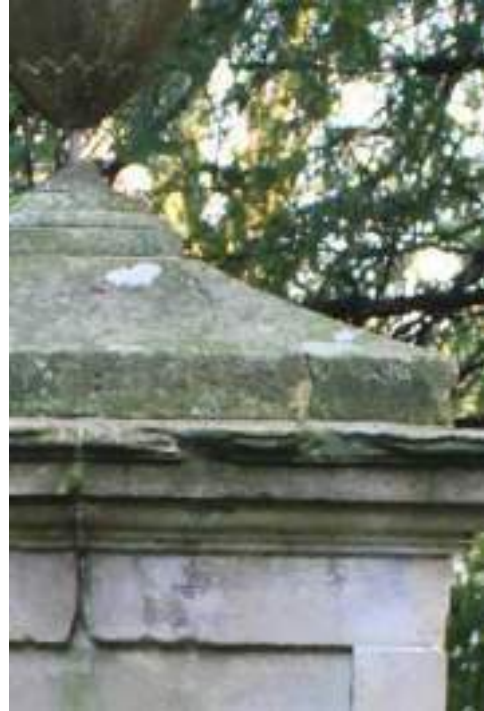
The south elevation of the memorial after all treatments and re-building has taken place. The fracture in the capstone was a natural fit and went back together tightly. Note the green colonisation already in a matter of months, on the new vertical joint in the entablature.

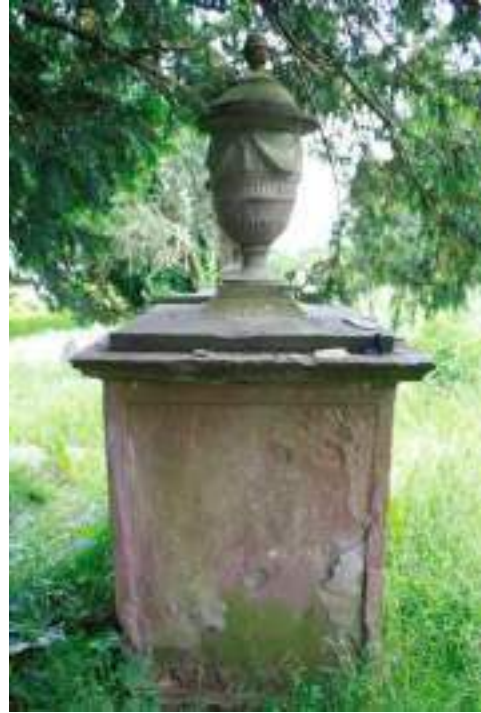
The memorial before any treatments, note on the left the branches are actually touching the upper sections of the urn. This shouldn't have been happening to a listed memorial. The left image highlights the angle of subsidence, whilst the right shows the amount of the moulded plinth that is now below ground level.

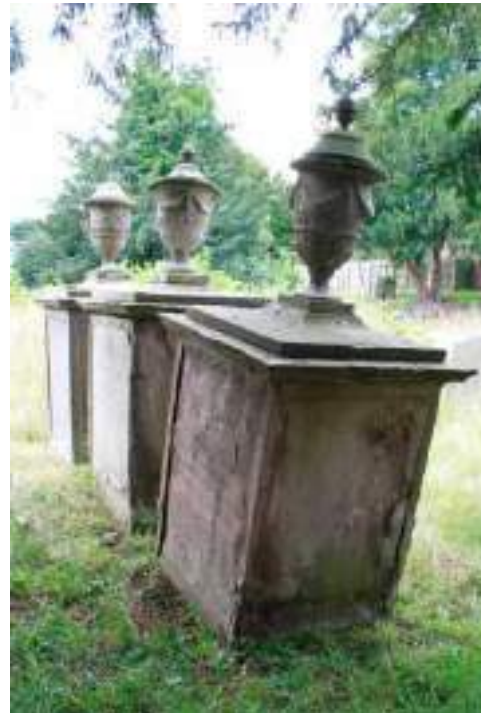
After our initial removal of over-hanging branches, showing the now off-set positioning of the upper urn sections, which were loose and could have been dislodged/damaged during high winds, with the tree moving enough. Despite the perhaps alarming stance of the memorial, the joints are parallel and tight with no signs of separation. The bed joint beneath the capstone was in a relatively sound condition.

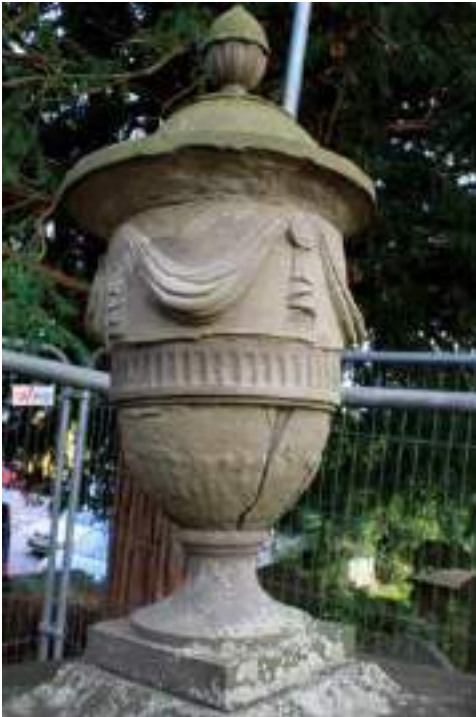
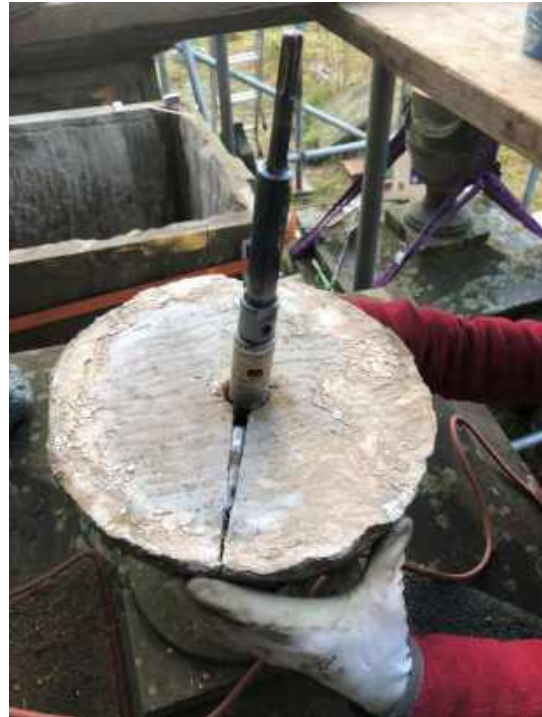
On the left, the urn prior to dismantling, note the lid above the swag or draped layer is loose and could have been dislodged in high winds, causing damage to these carved elements. On the right, the top-bed of the diminishing lower-urn during removal of the expanded iron-dowel. The existing fracture, both sides were full of organic debris and insects.

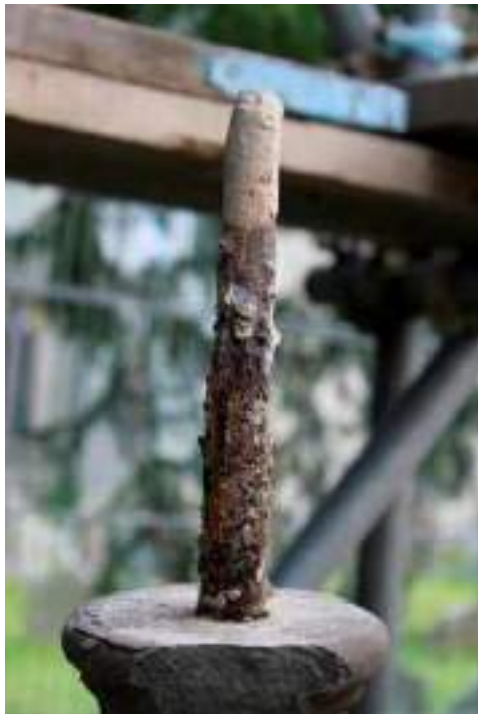
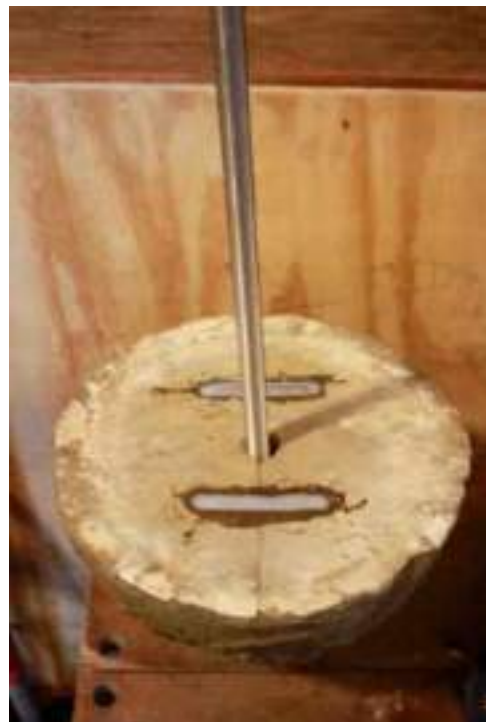
On the left, after removal of the fractured lower section, see how the delaminating iron-dowel had expanded into the available space before forcing the stone apart, exerting huge pressure to split the block. On the right, the repaired lower urn section with new, threaded stainless-steel dowel issuing from the top. The drill-hole between the steel (which cannot corrode) was filled with a pourable anchor grout used in civil engineering.

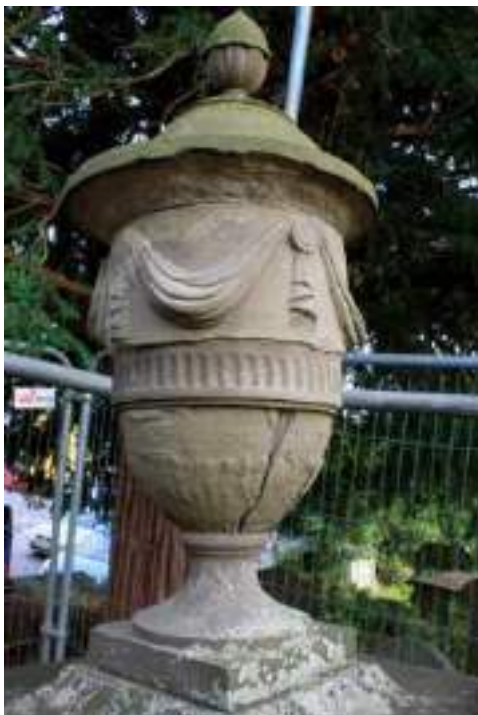
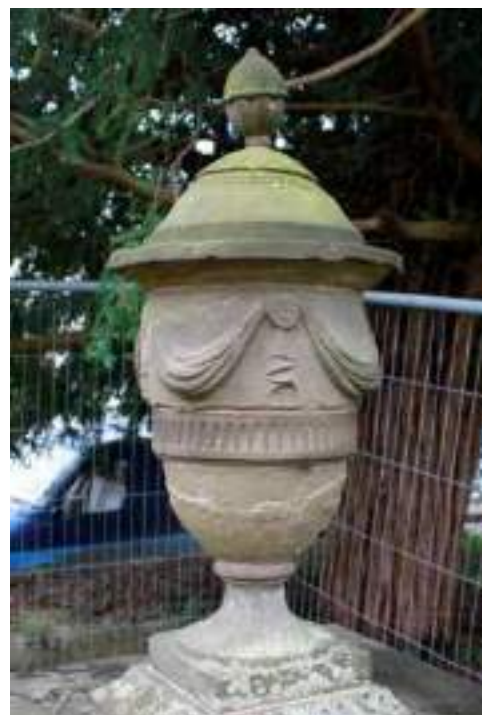
On the left, the whole urn before any treatments, note how the top two courses are stepped over, being loose. On the right, the restored urn after all treatments. Note the extent of carved detail missing from the faintly fluted-base prior to treatments as opposed to carved elements above. The diminishing neck could be used as a template for the neighbouring crudely repaired neck/base, if needs be in the future.

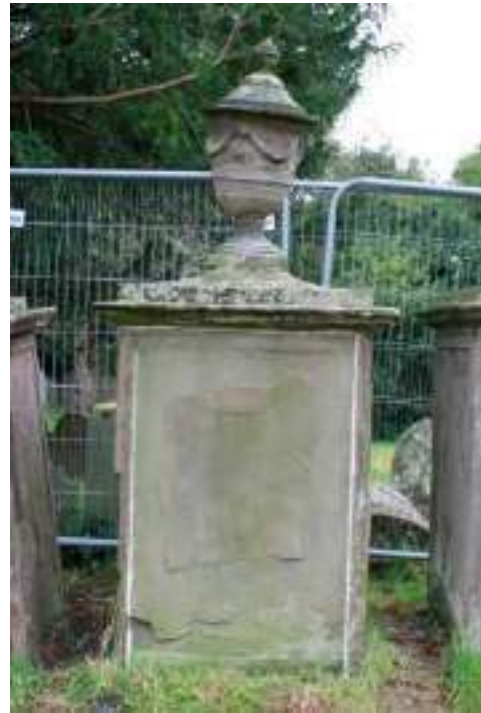
The memorial to Mary Hughes before and after all treatments. On the left, the Yew tree branches brushing the urn, prior to being pruned back. The box panel on this elevation was actively loose when the capstone and urn were lifted off. The new pointing mortar is the same colour as the original fat-lime mix.

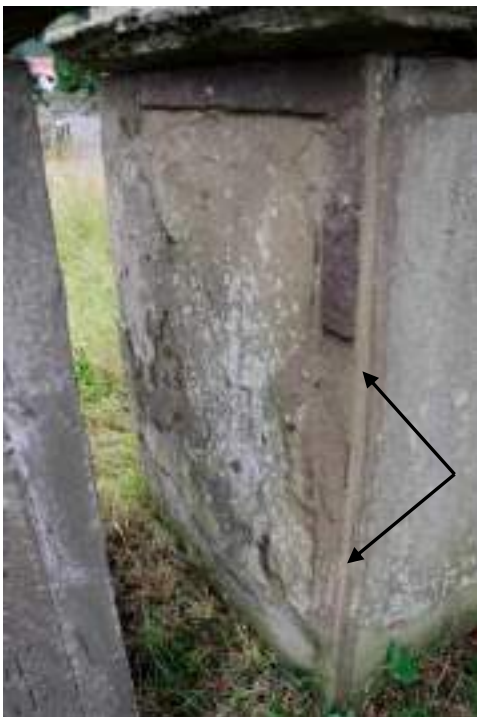
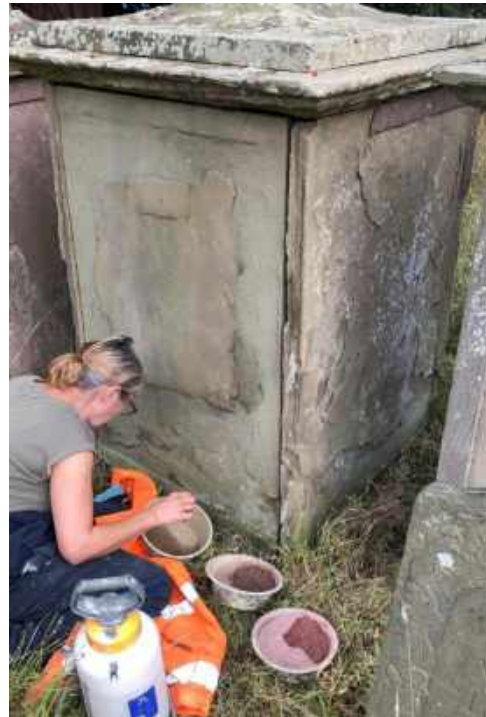
On the left, the south elevation highlighting the simple border in the foreground (indicated) has delaminated and detached from this 'long' side. This side was rationalised hard prior to inserting support fillings. On the right, support fillings being inserted into vulnerable edges, before the capstone is removed/replaced. Note the plinth is not visible on these two elevations with ground level having risen to cover it.

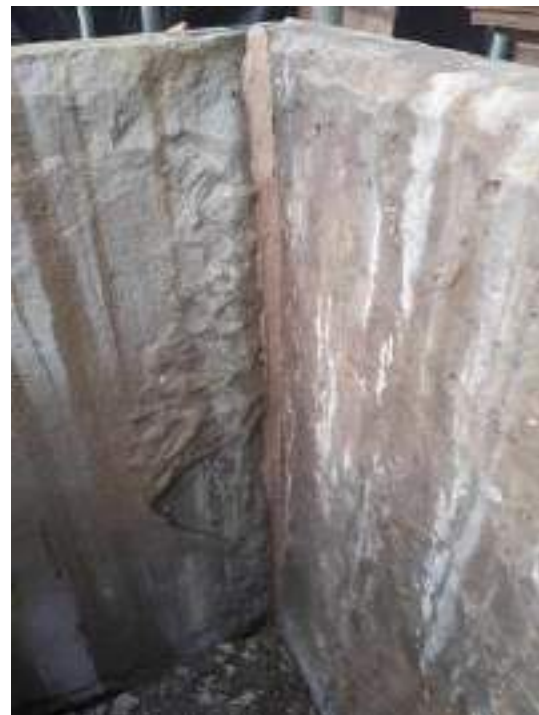
When the capstone was removed the stone panel in the foreground, closest to the chain, moved forward against the ratchet-strap. If the strap hadn't been there it would likely have fallen against the capstone being lowered. On the right, the inside of the box-tomb after the internal mitres have been removed of defective mortar and new mortar packed in, to increase rigidity and prevent moisture entering the structure. There was no plant-growth of any kind in either of the partially dismantled box-chests.

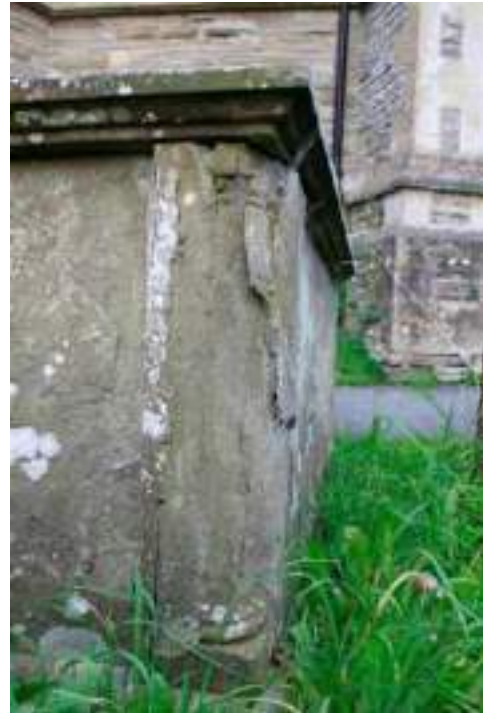
On the left, the south-west corner shows a transverse fracture through the lid and the extent of material loss to the main dedication panel, with the top quarter now lost horizontally, the exposed substrate is very fragile and displays extensive flaking. On the right, the north-east corner, carved detail is completely lost from the curved corner block.

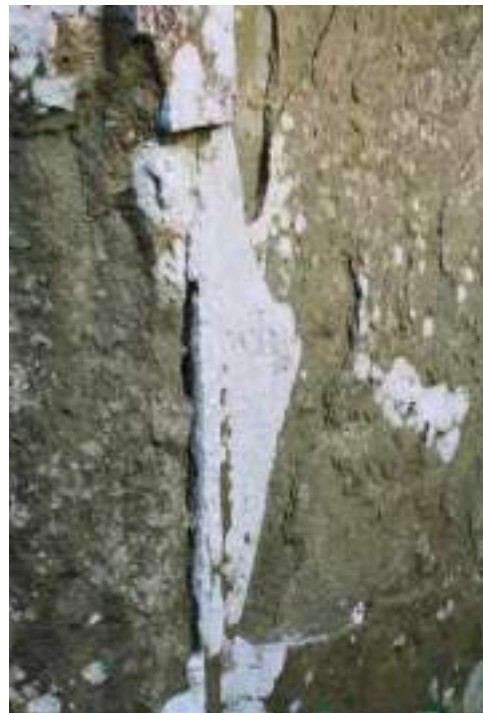
The south-west corner on the left isn't just a wide joint. The left-hand corner block should have a rebate which sits over the dedication panel, but is long-gone. The island of aged, white lichen where the carved detail has been lost and rounded stone indicates this has been missing for a long time. The right image highlights the extent of delamination and flaking to this poor-quality, laminar stone.

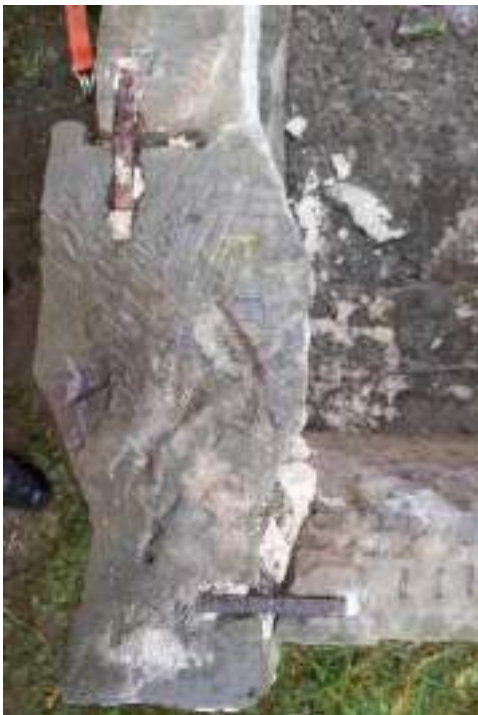
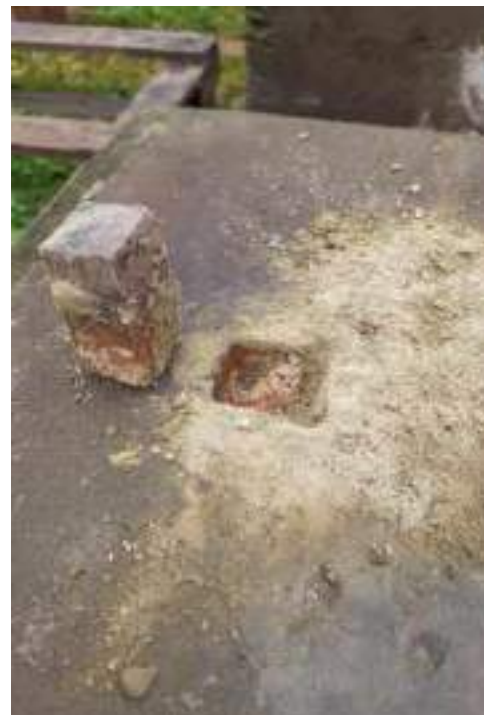
Iron cramps in the top-bed of the tomb chest secured with sound, lime-mortar and square-section studs in the bottom bed of the tomb chest, which weren't replaced. The studs prevented even more movement in the subsiding memorial. These weren't replaced as the memorial will be stable on its new re-enforced concrete sub-base.

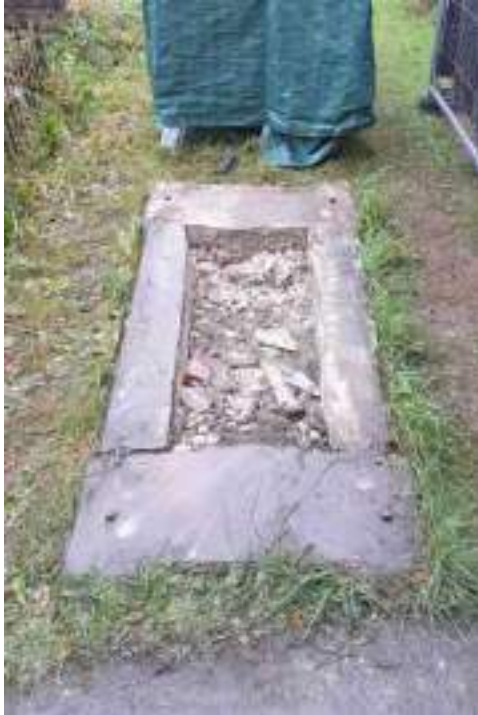
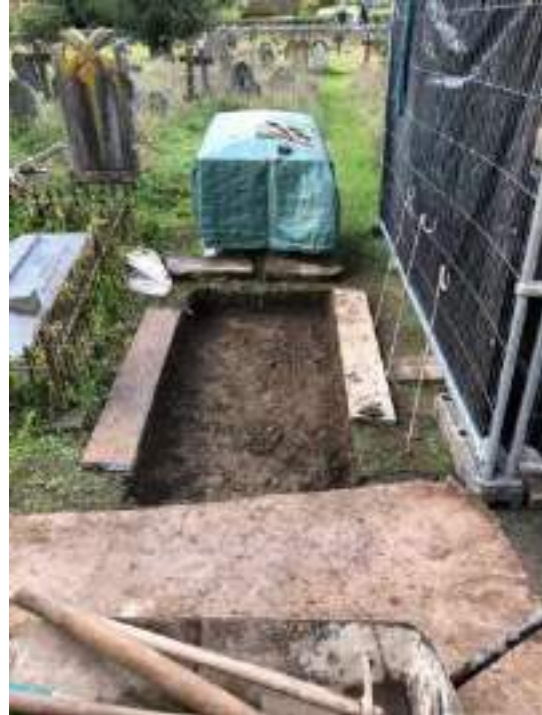
On the left the plinth showing how much subsidence has taken place and how much the churchyard has risen over the 186 years since it was likely built. On the right, the plinth blocks have been moved. There were only two re-cycled tomb chest slabs at the far, east end, providing any sort of sub-base. Note the proximity of the railings and underlying kerb-set to the north.

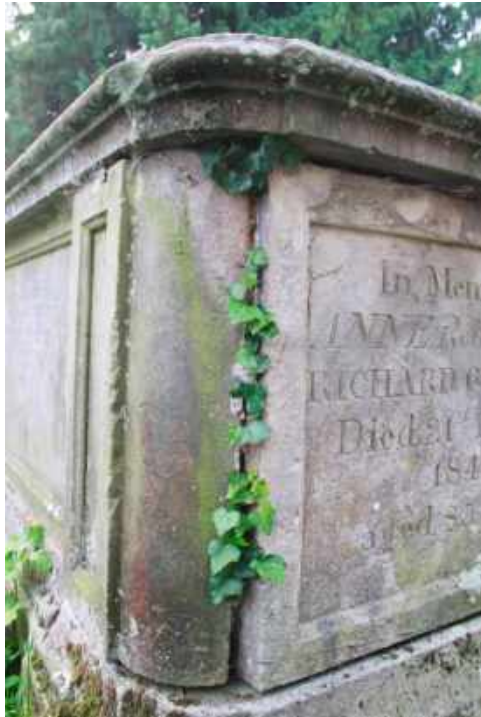
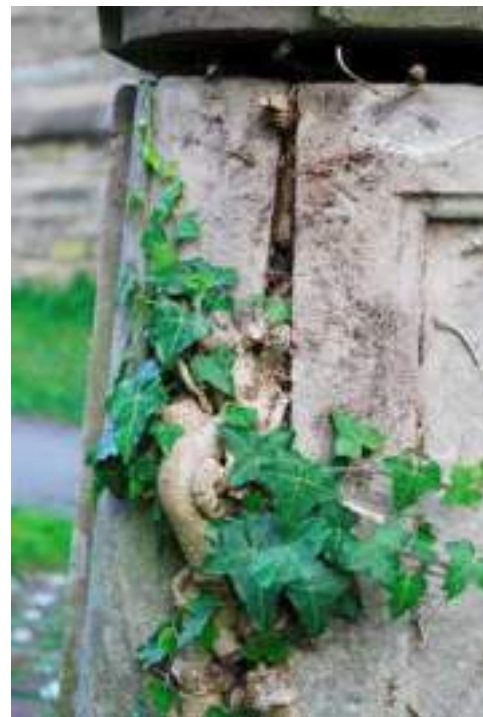
On the left, the north-west corner block being forced out, despite point-loading along the north elevation. On the right, the south-east corner block with its now very dove-tailed joint caused by ivy growth. The joint should be as it is at the top, instead of widening significantly towards the bottom-bed.

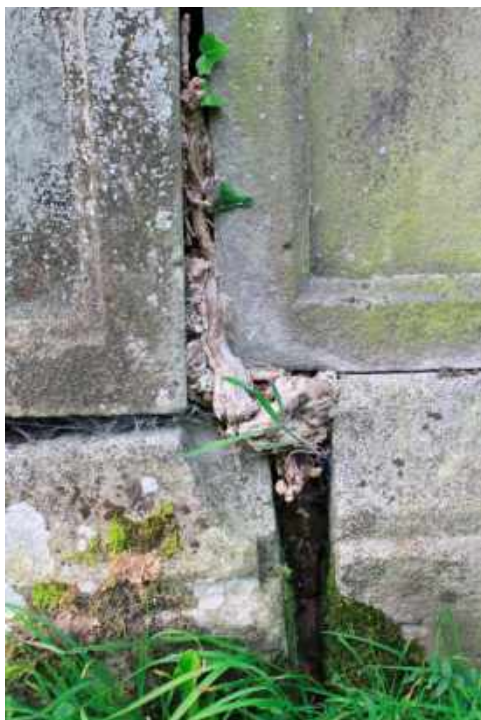
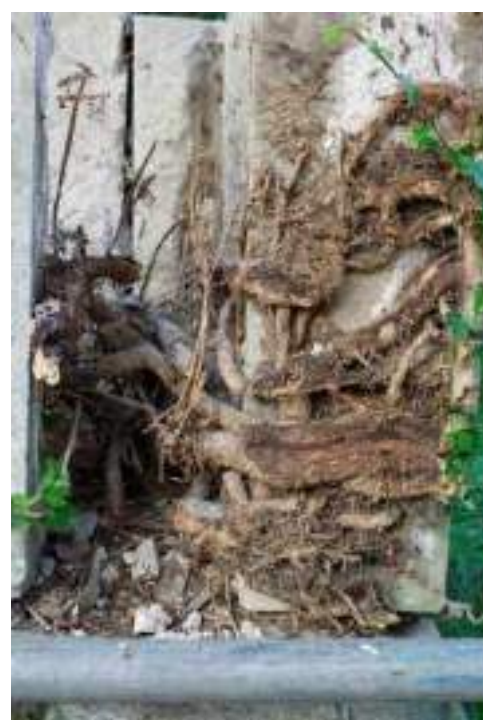
Detail of disruption over two courses, forcing significantly heavy blocks apart and breaking fixings (albeit corroded) apart. On the right, after removal of one of the corner blocks showing how the stems are compressed in the joint but still able to exert enormous, damaging forces over time.

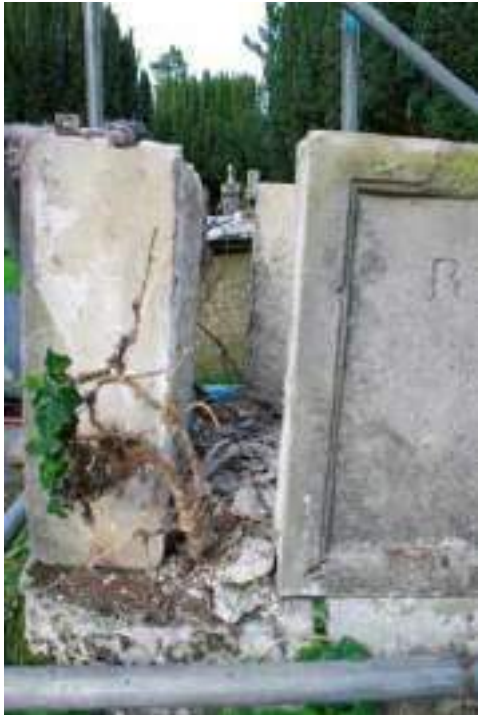
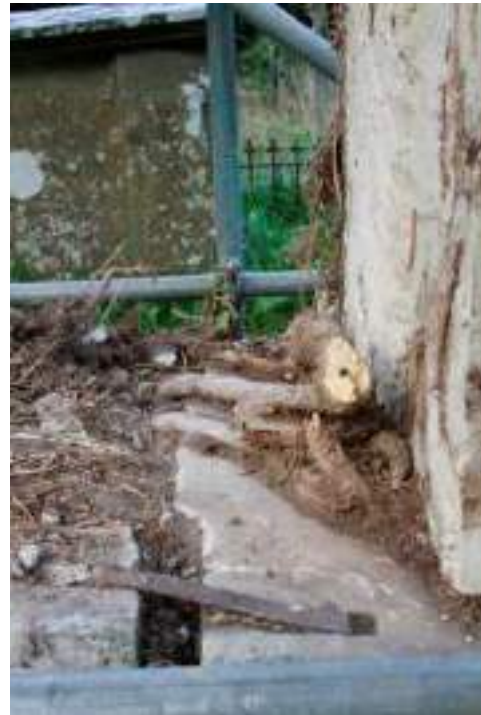
On the left, the south-west corner block having been removed, showing the stems continuing down into the next course. Note how there is no bedding in the bottom-bed of the tomb chest panels. On the right, the south-east corner showing the substantial fixing has been pulled apart with the corroded turn-down, left in the left-hand socket. The joint should be 5mm wide not 30mm
