Final Conservation Report for Churchyard Memorials

St John the Baptist Church - Bishops Castle - Shropshire

The Diocese of Hereford

Elliott Ryder Conservation

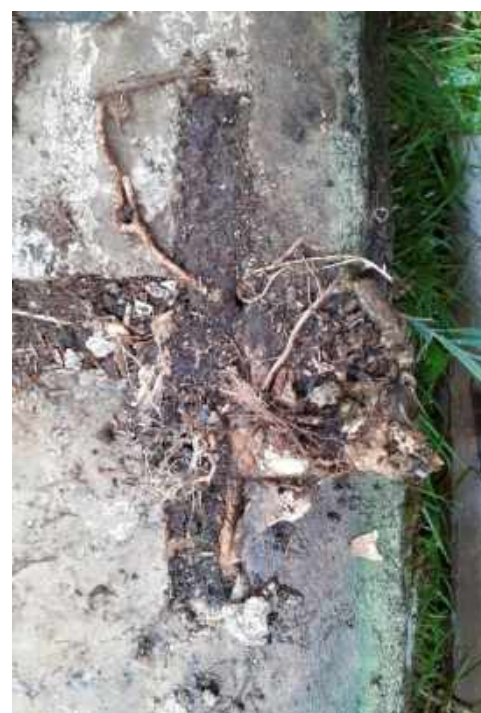
Corroded iron fixings which have delaminated to now flaky metal, serving no useful purpose. Luckily there was no iron-staining to speak of, despite there being easy access for excess moisture, with which to initiate the process. On the right, ivy stems grow easily beneath the fixing, ready to force this one apart.

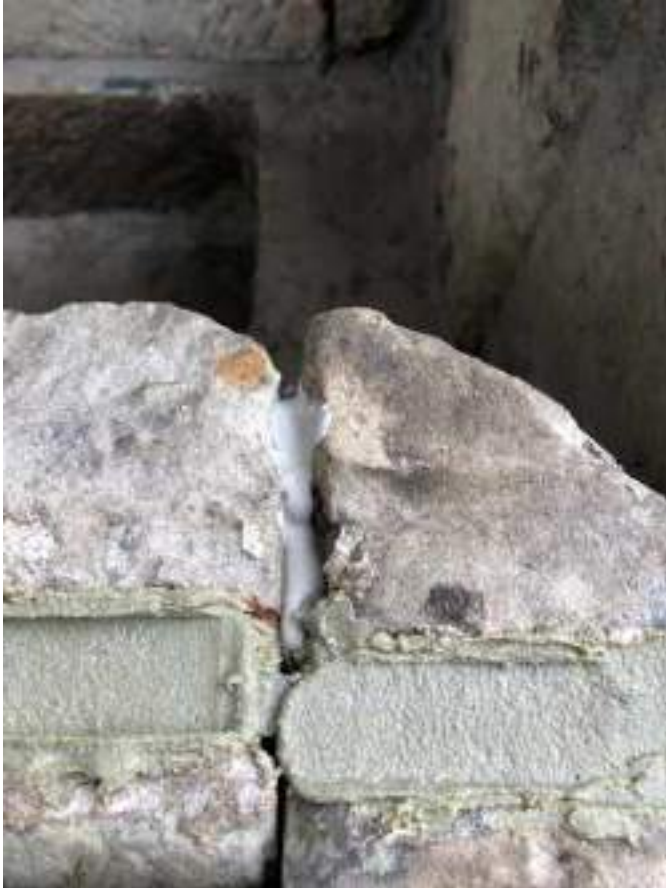
Detail of the gunnable pointing mortar injected into the rear of the fine-joint that coarse mortar would not fill. Coarse mortar was packed in on top of it. Both mortars are based on NHL3.5 and so are compatible. The greeny-grey epoxy-resin securing the underlying stainless-steel cramp into position. Note the channel appears misaligned. If both sides of the channel were parallel (as they were before dismantling) there would have been a dove-tailed joint on the front face and this detail, will never be seen. Compromises such as this have to be made to give a homogenous appearance to the whole memorial, when re-built. There didn't appear to be much care in its manufacture or construction.
