Final Conservation Report for Churchyard Memorials

St John the Baptist Church - Bishops Castle - Shropshire

The Diocese of Hereford

Elliott Ryder Conservation

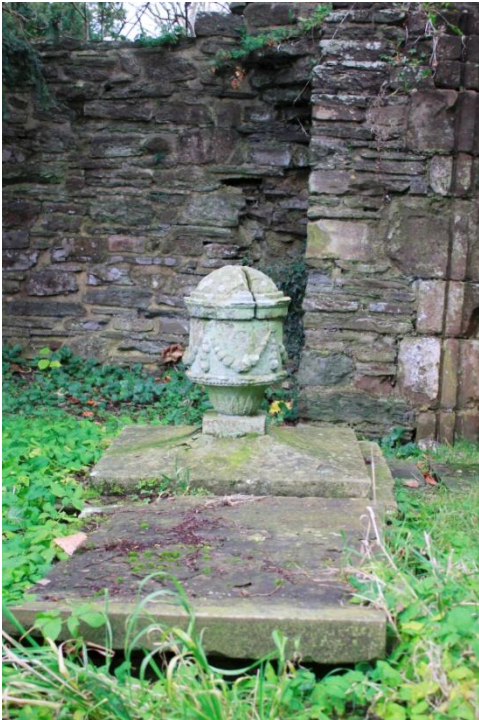
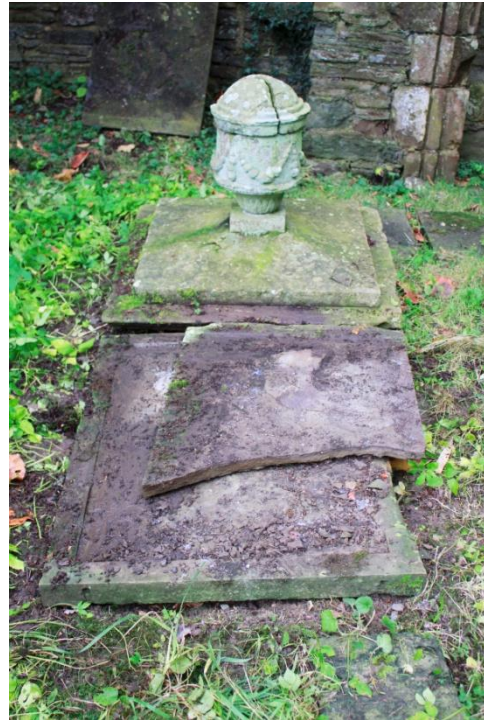
The box-tomb elements stacked haphazardly on top of each other with several of the side panels having fractured as a result of point-loading from uneven weight distribution. Note the extent of soil and debris on the upper surfaces and fractures through the urn-lid clearly visible.

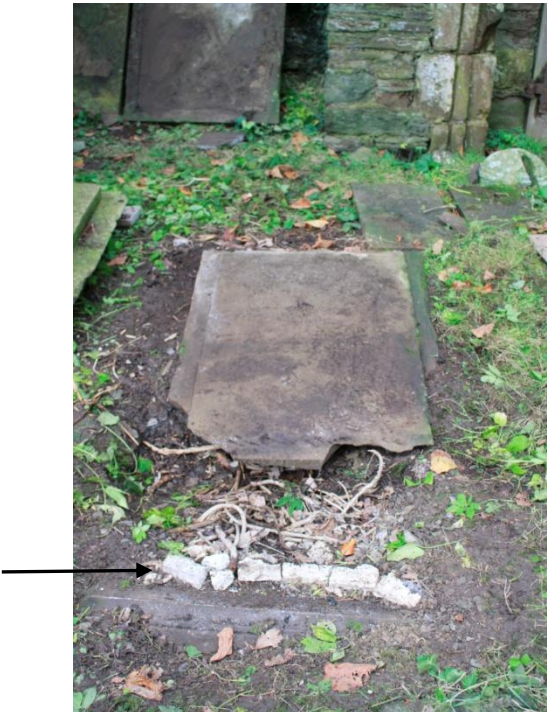
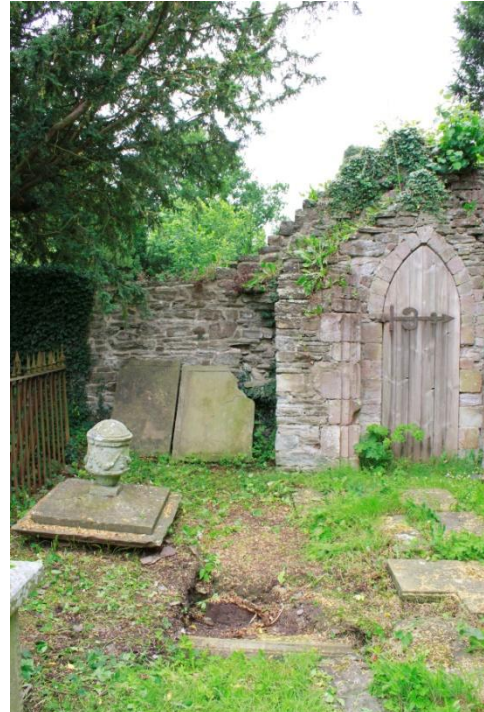
The bottom side panel with fractured elements safely removed. Note the remains of very thick white mortar (indicated) which formed a joint between the bottom bed of the inscription panel and top bed of the plinth which you can just see beneath ground level. This indicates an overly wide joint, due to structural instability. The right-hand image shows some of the elements leaning against a nearby wall, to be rain-washed over the winter and the capstone and urn moved away to one side, to enable erection of a lifting scaffold.

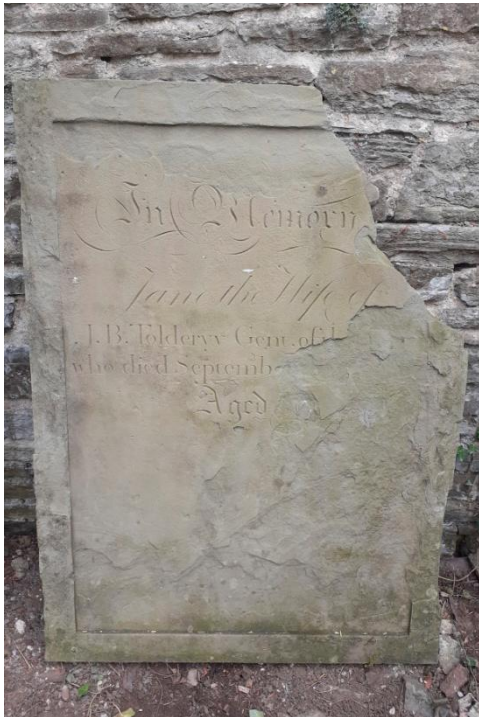
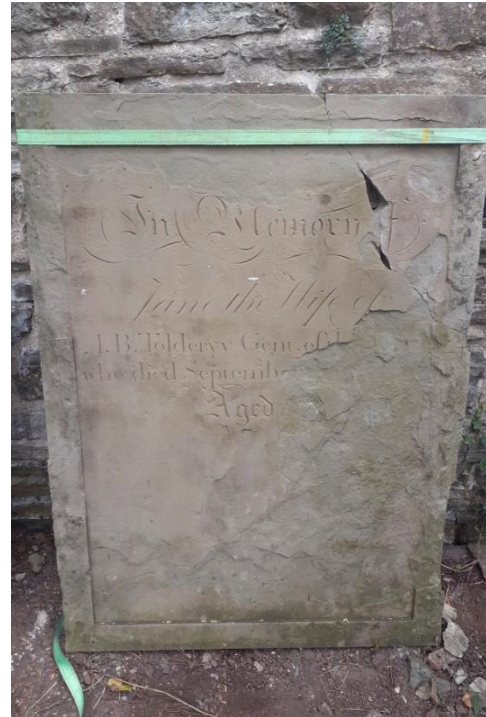
The front inscription before and after re-joining broken sections. Resin was kept well-back from the front face so it was not visible and the effected joins look as 'natural' as possible. Note the loss of detail to both vertical, raised borders and the bottom right-hand corner, much of the carved upper surface has been lost from this very laminar stone type.

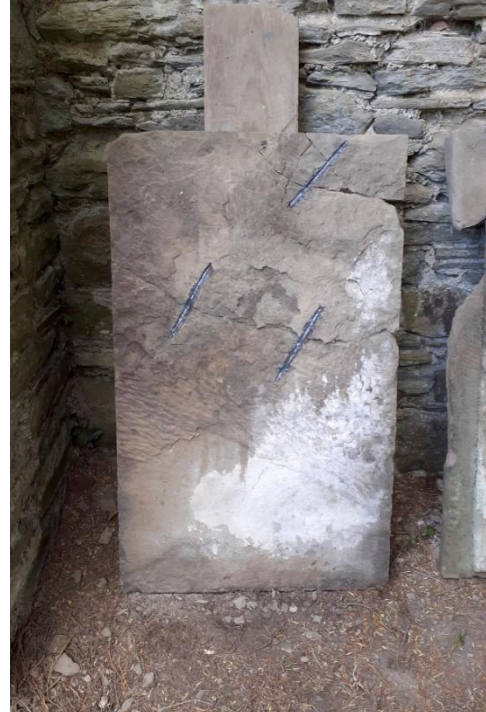
The front (viewer's left-hand side) and the rear (right-hand side) of the same panel showing the number of mechanical fixings to provide additional support in the side-to-side fractures. The slab was too thin to insert dowels in the centre, so 12 x 3mm stainless-steel flat-bar is inserted at right-angles across fractures, into cut channels and secured with epoxy-resin. The panel is upside down and stayed that way until re-building, so as not to stress the two horizontal joins unnecessarily, which could have failed given the overall weight/height of the slab.

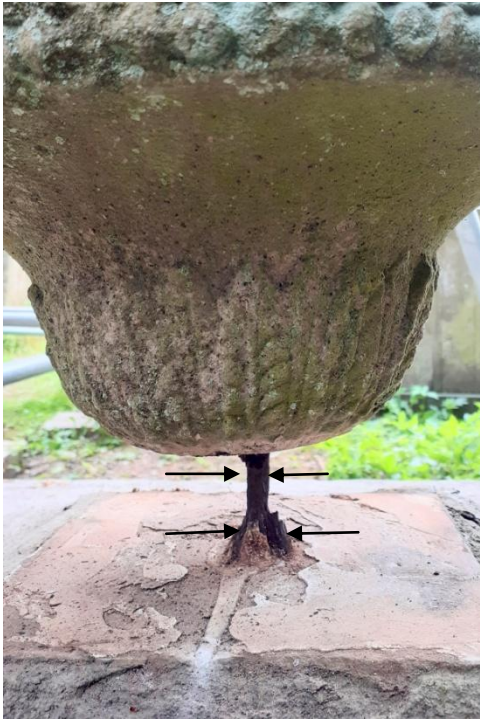
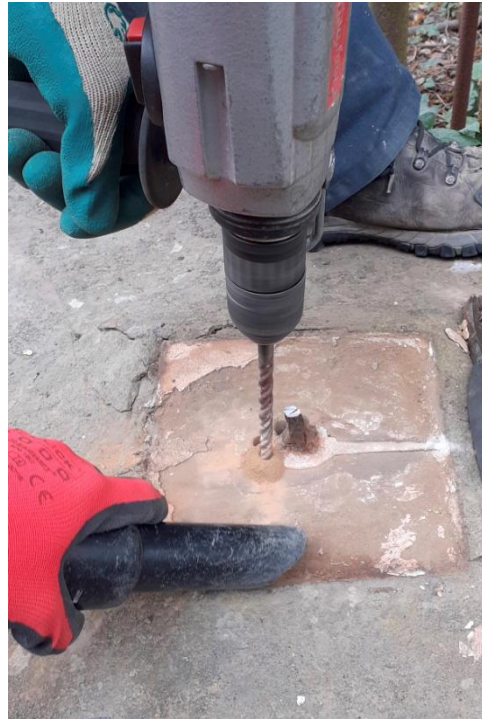
The expanded dowel spanning vertically between the capstone and the bottom bed of the It had split the thin base into four sections but luckily not disrupted the capstone. Note the actual size of the original dowel, which was secured with molten lead and the expanded size of the corroded metal (both indicated).

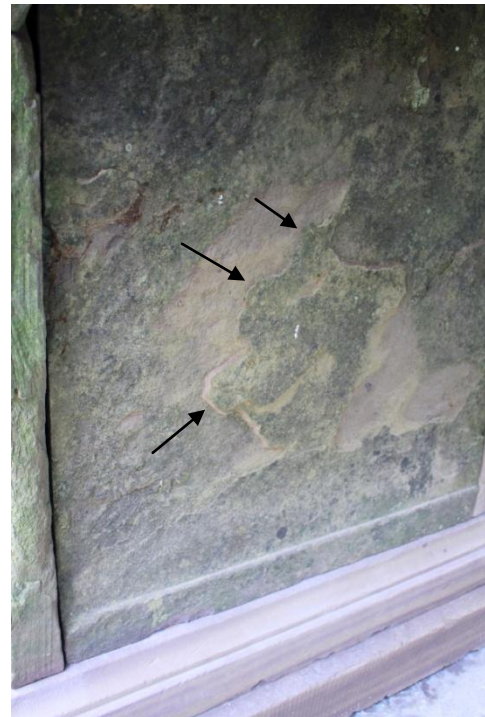
The capstone being lowered into position. Slate shims were required on the top-bed of the core to make it level, as the bottom-bed of the capstone was so uneven. The right-hand image shows mortar repairs (indicated) inserted into vulnerable areas previously tacked with epoxy-resin spots to prevent further damage/loss. Much of the original carved surface has been lost from this very laminar local sandstone.

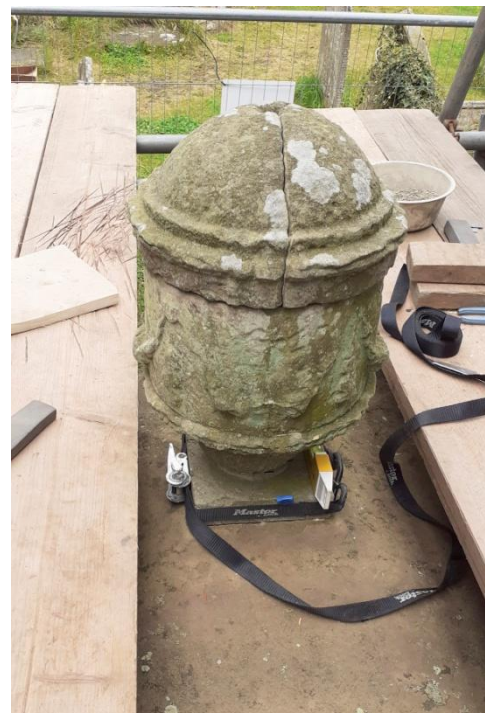
The thin square-base beneath the urn split into four sections by the force of the previous corroded iron-fixing. Lead shims are incorporated to create a uniform joint which isn't often possible when bedding a heavy stone element on a small footprint of mortar. The repaired urn-lid which was split into three sections by the dowel spanning between the two upper elements. The resultant joints lines were filled to slow-down (not prevent) the ingress of moisture.

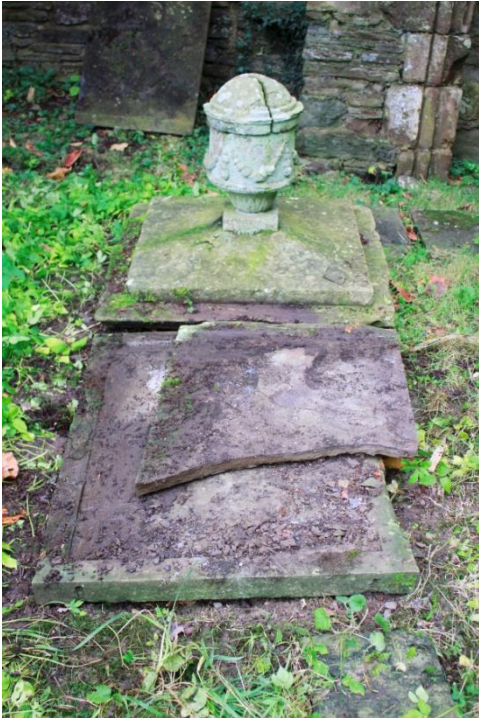
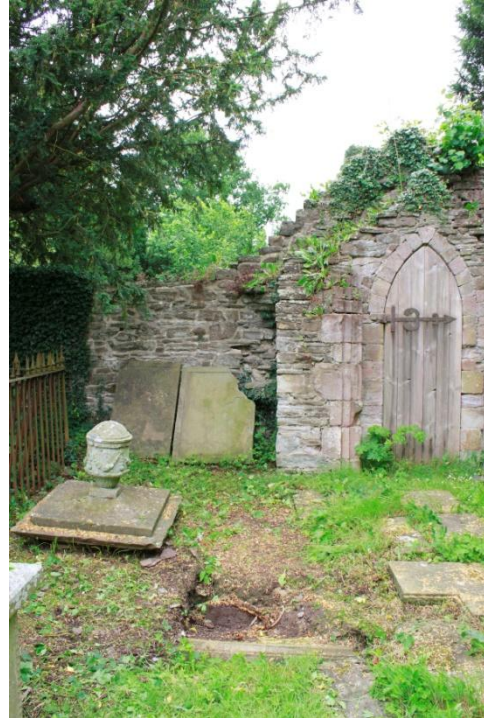
On the left, the dismantled box-tomb prior to any treatments. On the right, the extant elements moved to allow rain-washing and slow drying over the winter. Note the proximity of the mature over-hanging tree, which will contribute significantly to the colonisation of stone, mortars and concrete with biological growths which are not benign.

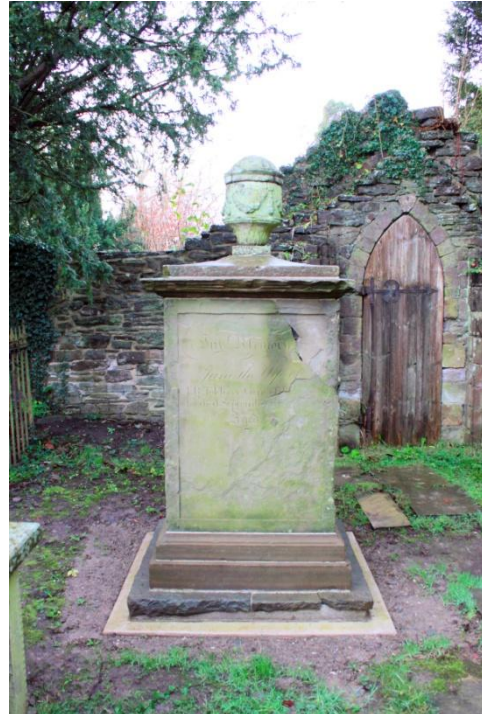
The re-built box-tomb on its new concrete pad. Note the eroded and physically damaged nosing (outer edge) of the capstone which casts biological rich water directly onto the moulded stone plinth beneath. Despite the architectural detailing and proximity of the over-hanging tree, the long-term integrity of this beautifully proportioned and decorated memorial is now assured.

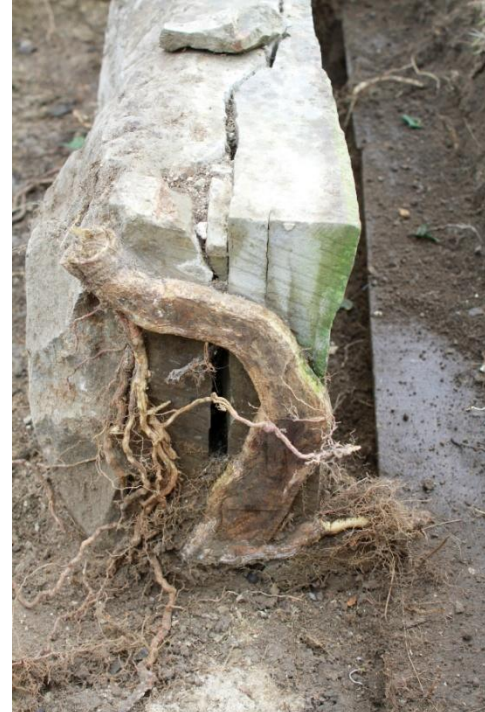
On the left, the south-west corner block having been forced off, on the right, vertical fractures through one of the plinth blocks. The ivy had grown the same width as the joint before widening back out within the tomb chest.

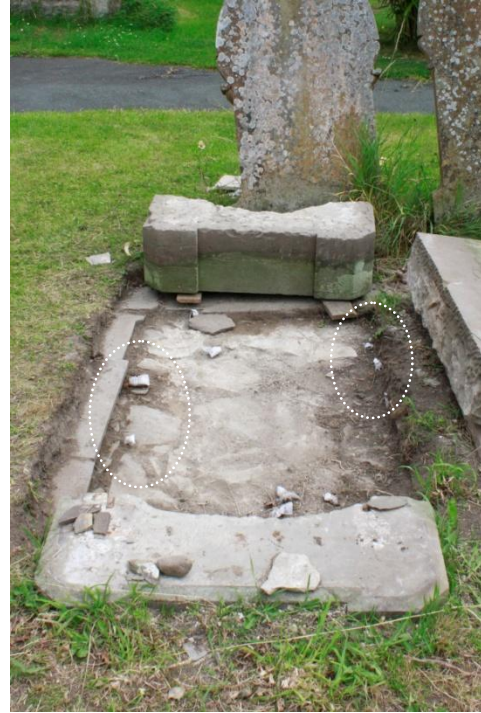
During the dismantling process, note how little gap there is between the long panels. In the right-hand image, tied plastic bags (indicated) can be seen on frill-girdles cut into the ivy stems. This was treated with a toxic, Potassium Sulphamate paste which will kill the roots system below ground level. The compacted stone base did not require lifting/dismantling, which was wider than the outer footprint.

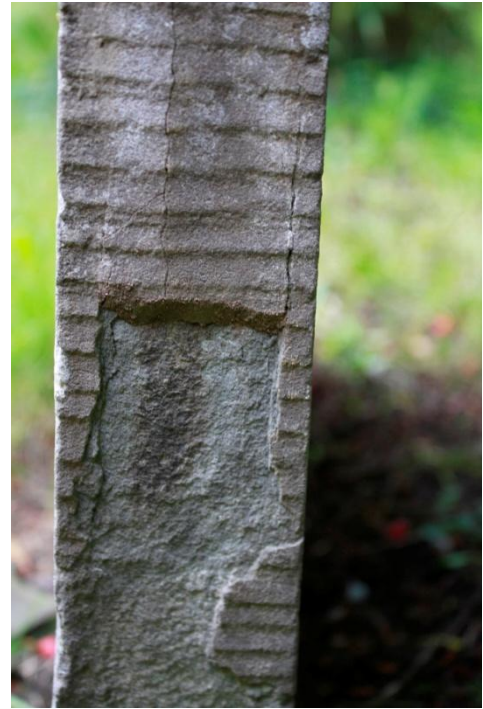
The north side of the slab before and after treatment, the stone is spalling not delaminating, as it is at 90 degrees to the bedding-plane partly as a result of the force/shock required to produce the tooled or 'batted' surface on the edge of the slab. The darker area on the now exposed substrate is an inherent ferrous mineral, which is another point of weakness and reason for localised failure. Coloured repair mortar was packed up into the vulnerable edge as far as possible.

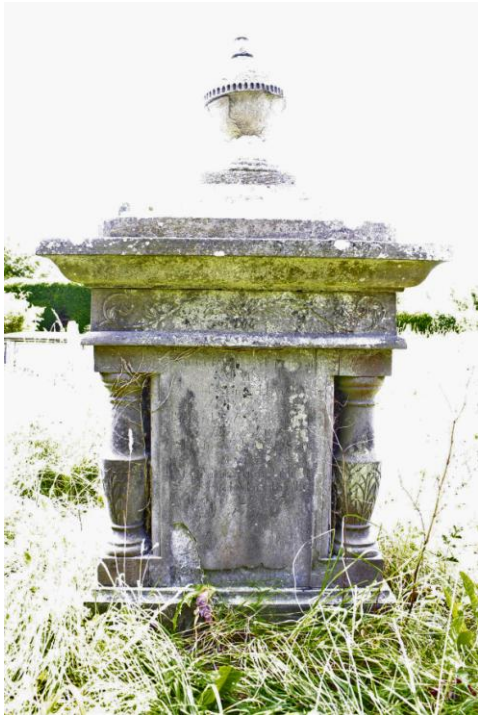
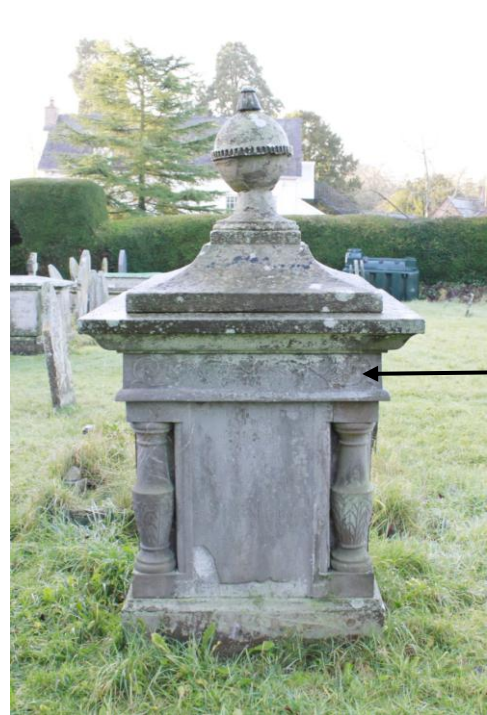
The north elevation of the Thomas memorial before and after all treatments. Delaminated stone along the bottom bed of the box-tomb was rationalised back to sound substrate, with support fillings inserted along the length of the previously tacked edges. Note the poor angle of the ball-finial. Low-relief, foliate-decoration to the frieze (indicated) beneath the capstone is all but lost visually.

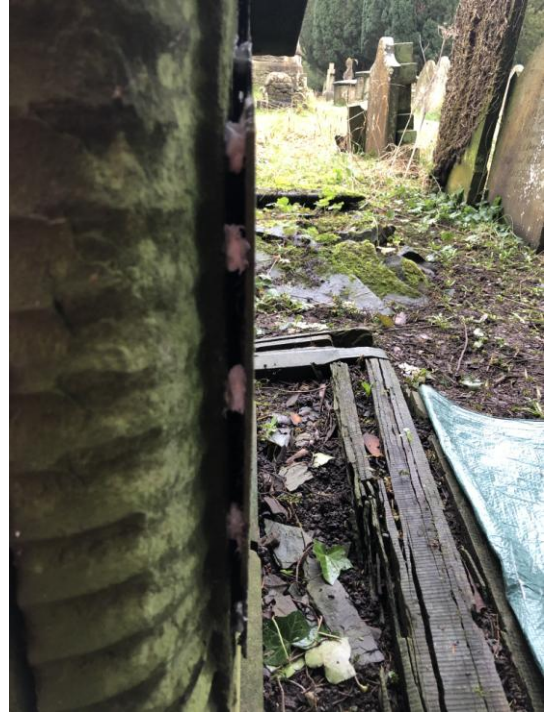
Emergency consolidation was carried-out by us in 2019 to the section of carved surface which was springing. Spots of resin were inserted along its length, to bond it back to the substrate and prevent un-wanted movement. Small sections had repair mortar packed in as far as possible, and then liquid grout was introduced to fill the void horizontally. This process was repeated until the void was filled vertically from the bottom to top of the lamination.

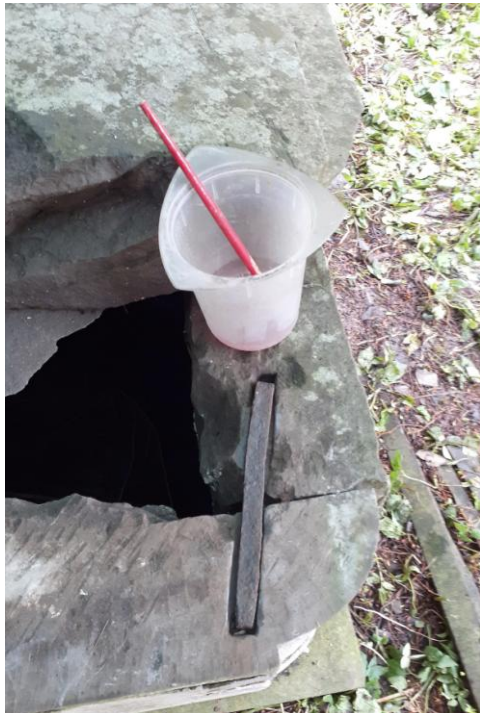
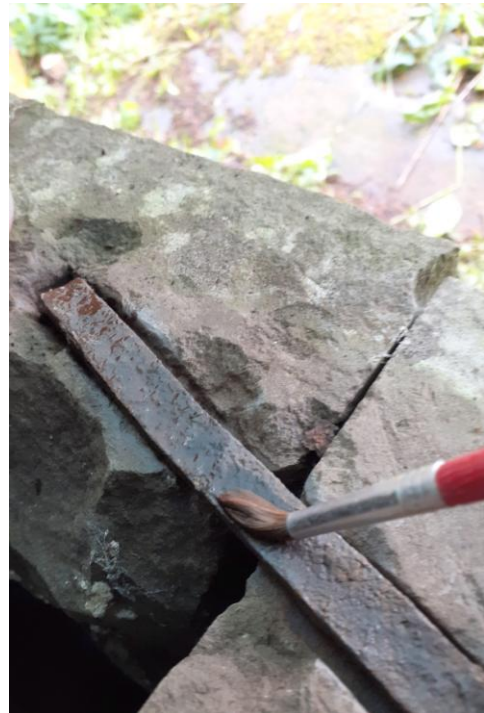
Iron fixings were found to be in a sound condition on the north-east and south-east corners. They were removed (easily) and abraded with a steel polishing-mop, then treated with coats of corrosion inhibitor (on the left). Once dry this was protected by two applications of a water-clear acrylic-resin (on the right). Once the coating was dry the fixings were secured into position with an epoxy-resin.

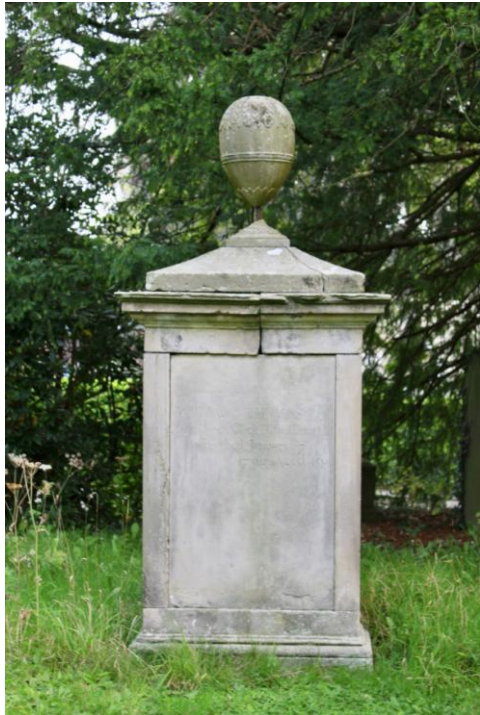
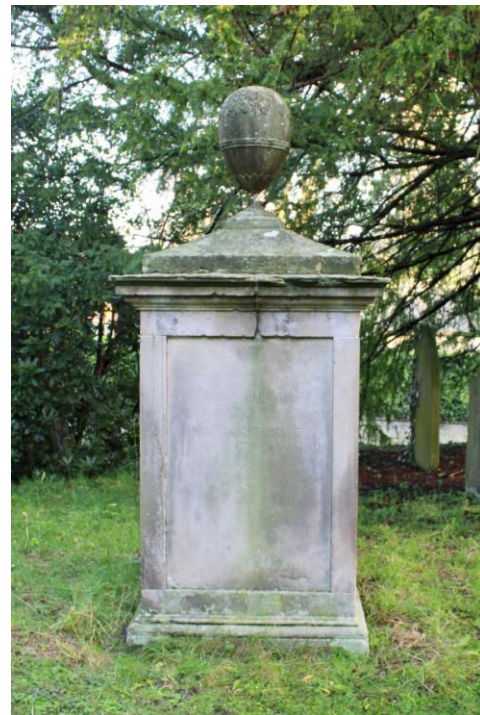
The memorial to William Thomas before (left) and after treatments. Outwardly there appears to be very little difference, however before treatment the memorial could have been pushed-over with a concerted effort, given its top-heavy design and failure of corroded iron-fixings. Note the greater level of colonisation with black biological growths to the ovoid ball-finial between July and December. No cleaning took place on this object.

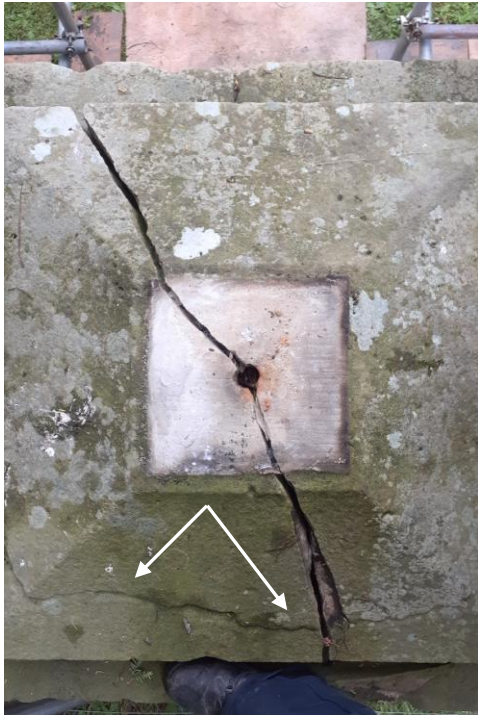
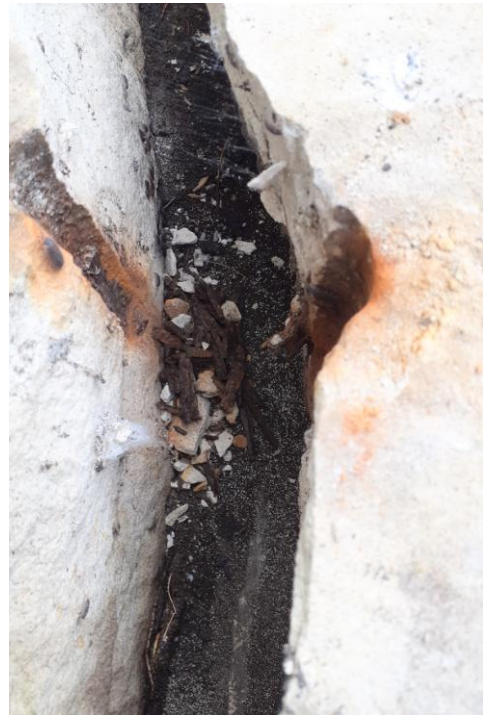
The capstone having been fractured into 2 larger sections with a thin slither, also fractured on the north fall of the block. Iron staining is visible in/on the vertical dowel-hole, with delaminated dead-metal collected at the bottom of the hole. The capstone is naturally bedded (as it should be) note the horizontal lamination (indicated) which had to be taken into account when manoeuvring the sections down and back up.

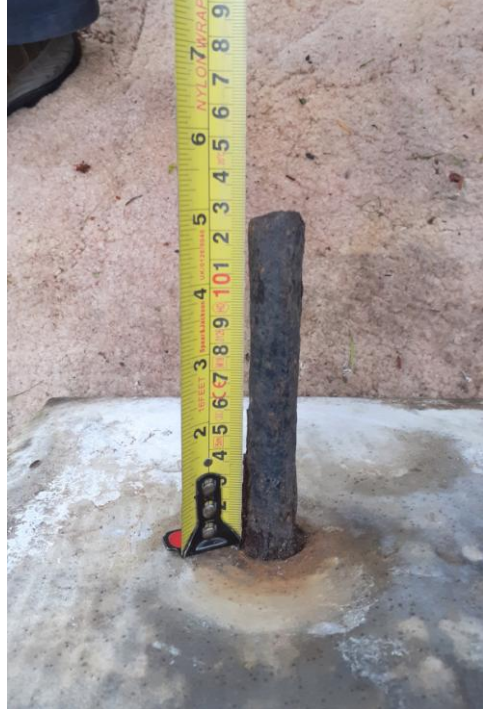
It was easier to separate the compromised sections at ground-level as well as making lifting easier. Note the section of missing neck, which was forced off at an earlier date. On the right, the underside of the expanded dowel which split the capstone. Expanding iron can exert huge forces on a strong albeit natural material.

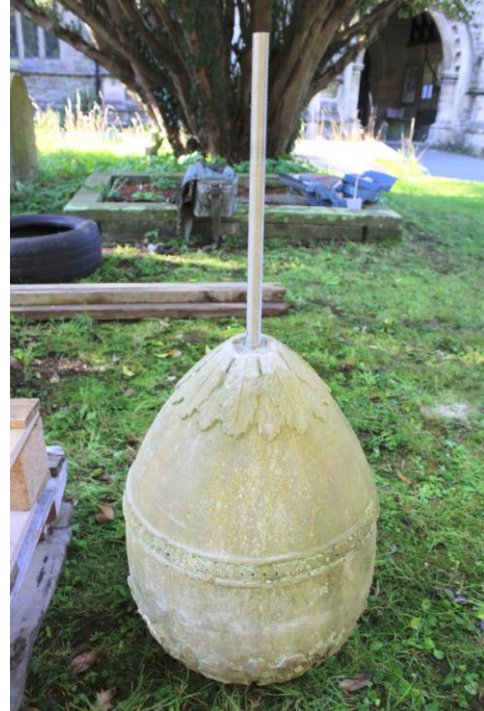
The missing section of the stone neck before dismantling. On the right, the new threaded stainless-steel dowel, secured plumb into a now deeper hole in the ball-finial with epoxy-resin. Drilling-out the corroded dowel from the ball was difficult as it had been set in with lead and there very little room between the edge of the lead and the small diameter of the carved stiff-leaf detail.

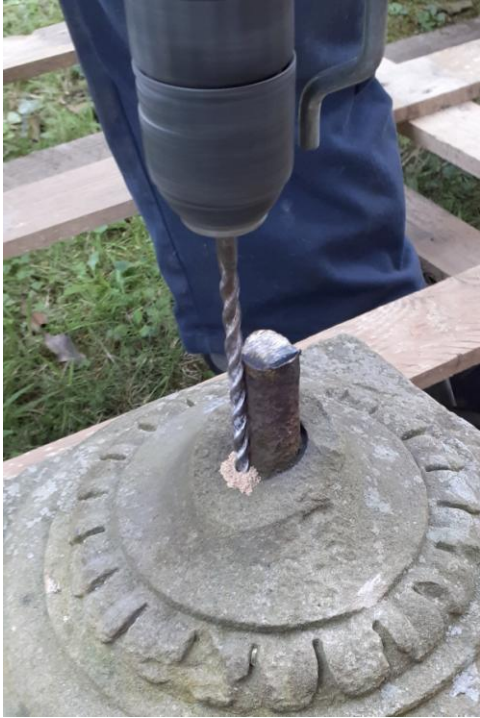
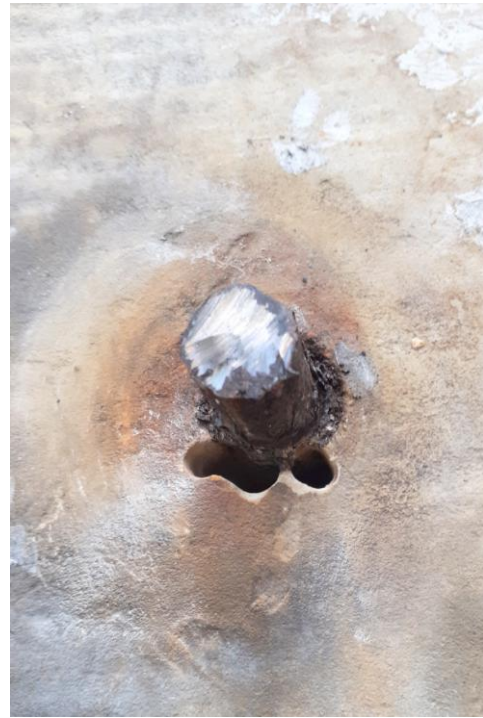
Drilling out the remains of the expanded iron-fixing from the urn-base. The right-hand image highlights the extent to which iron expands and it was lucky not to fracture this much smaller block. Great care is taken when drilling around expanded metal to remove it. A third of the way around the perimeter is usually enough to free such fixings.

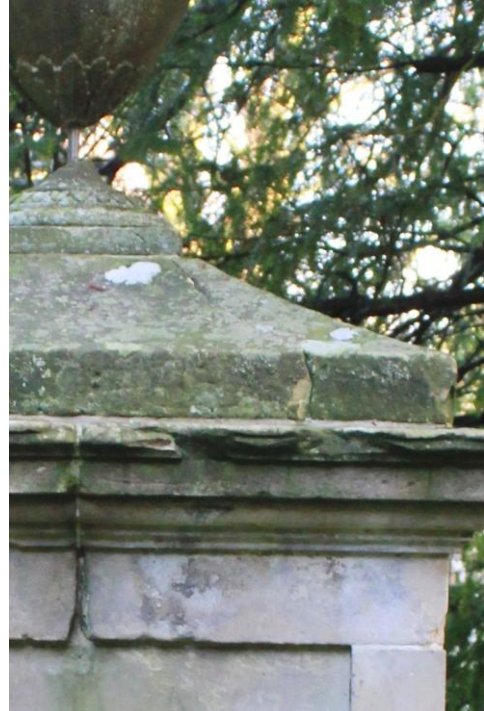
The south elevation of the memorial after all treatments and re-building has taken place. The fracture in the capstone was a natural fit and went back together tightly. Note the green colonisation already in a matter of months, on the new vertical joint in the entablature.

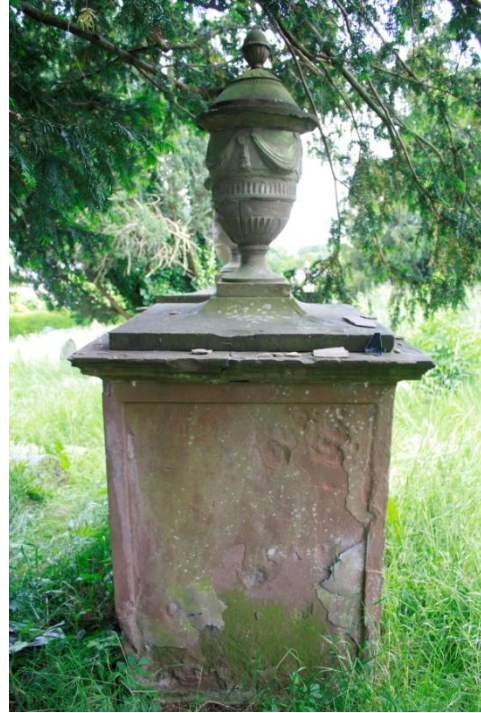
The memorial before any treatments, note on the left the branches are actually touching the upper sections of the urn. This shouldn't have been happening to a listed memorial. The left image highlights the angle of subsidence, whilst the right shows the amount of the moulded plinth that is now below ground level.

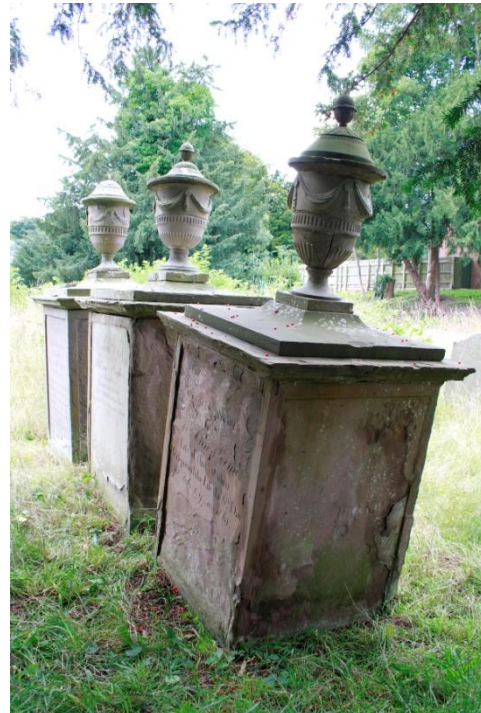
After our initial removal of over-hanging branches, showing the now off-set positioning of the upper urn sections, which were loose and could have been dislodged/damaged during high winds, with the tree moving enough. Despite the perhaps alarming stance of the memorial, the joints are parallel and tight with no signs of separation. The bed joint beneath the capstone was in a relatively sound condition.

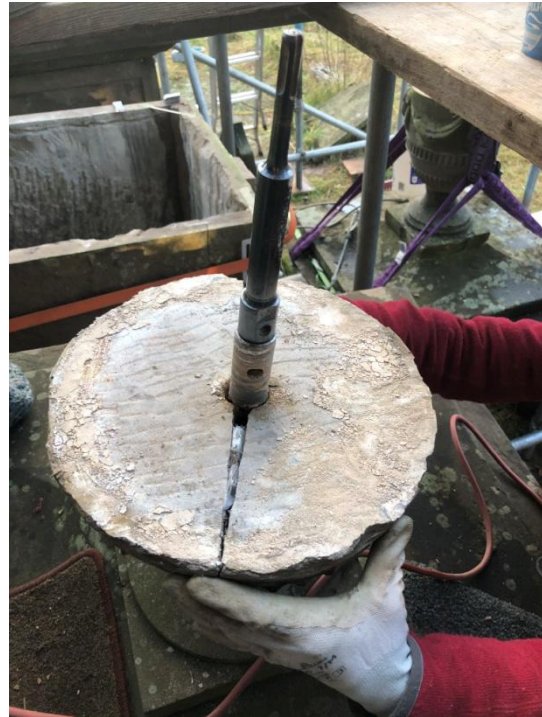
On the left, the urn prior to dismantling, note the lid above the swag or draped layer is loose and could have been dislodged in high winds, causing damage to these carved elements. On the right, the top-bed of the diminishing lower-urn during removal of the expanded iron-dowel. The existing fracture, both sides were full of organic debris and insects.

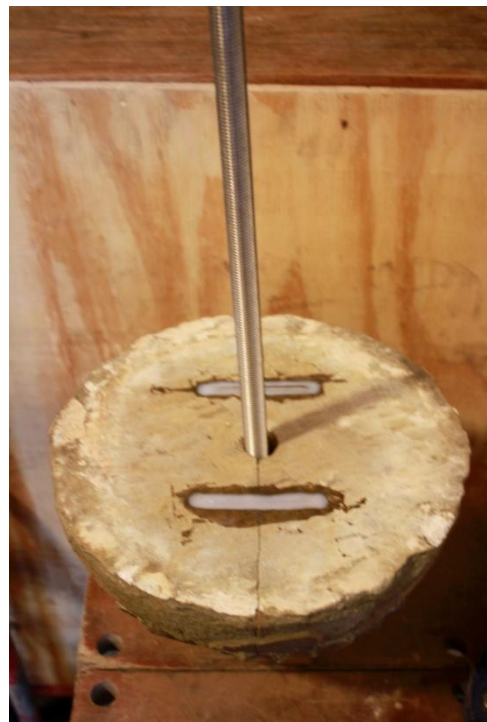
On the left, after removal of the fractured lower section, see how the delaminating iron-dowel had expanded into the available space before forcing the stone apart, exerting huge pressure to split the block. On the right, the repaired lower urn section with new, threaded stainless-steel dowel issuing from the top. The drill-hole between the steel (which cannot corrode) was filled with a pourable anchor grout used in civil engineering.

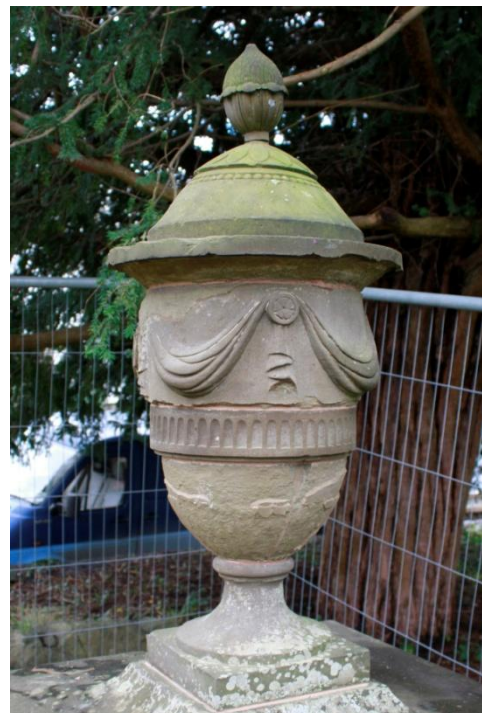
On the left, the whole urn before any treatments, note how the top two courses are stepped over, being loose. On the right, the restored urn after all treatments. Note the extent of carved detail missing from the faintly fluted-base prior to treatments as opposed to carved elements above. The diminishing neck could be used as a template for the neighbouring crudely repaired neck/base, if needs be in the future.

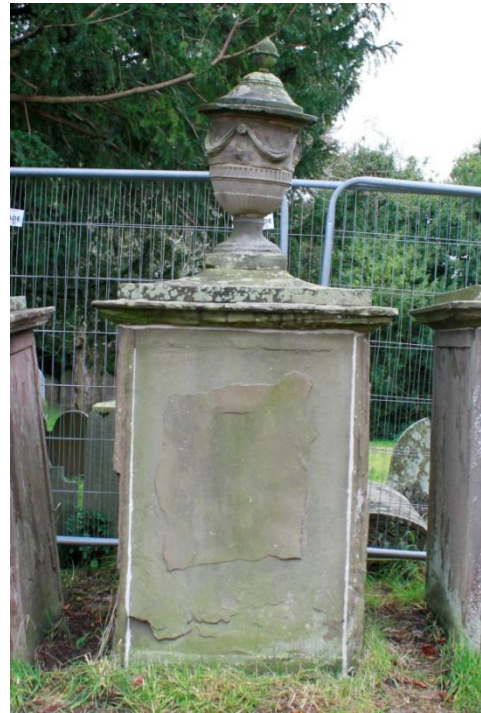
The memorial to Mary Hughes before and after all treatments. On the left, the Yew tree branches brushing the urn, prior to being pruned back. The box panel on this elevation was actively loose when the capstone and urn were lifted off. The new pointing mortar is the same colour as the original fat-lime mix.

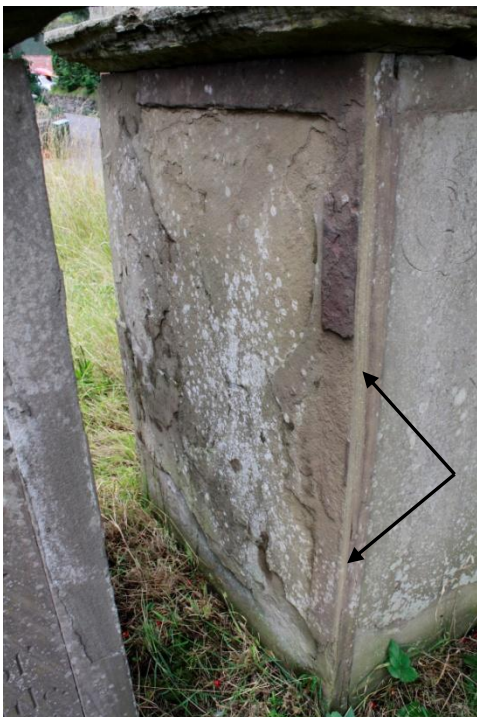
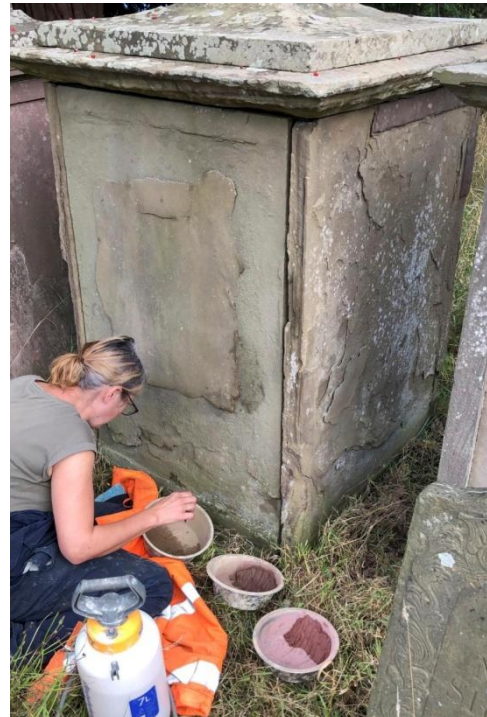
On the left, the south elevation highlighting the simple border in the foreground (indicated) has delaminated and detached from this 'long' side. This side was rationalised hard prior to inserting support fillings. On the right, support fillings being inserted into vulnerable edges, before the capstone is removed/replaced. Note the plinth is not visible on these two elevations with ground level having risen to cover it.

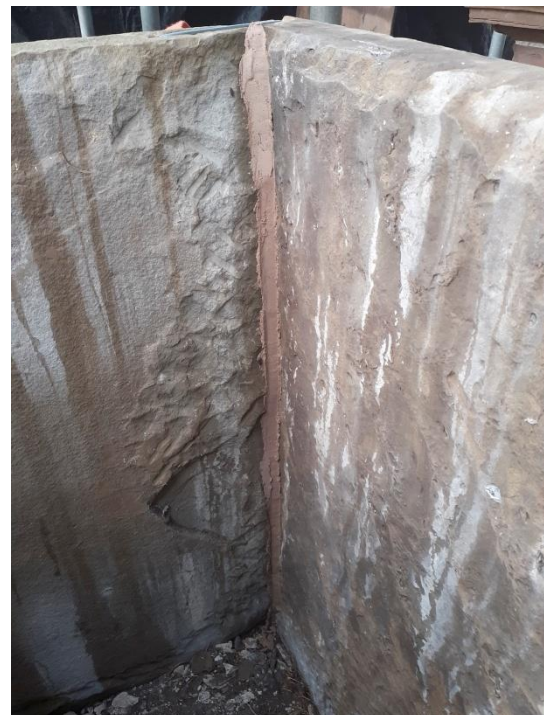
When the capstone was removed the stone panel in the foreground, closest to the chain, moved forward against the ratchet-strap. If the strap hadn't been there it would likely have fallen against the capstone being lowered. On the right, the inside of the box-tomb after the internal mitres have been removed of defective mortar and new mortar packed in, to increase rigidity and prevent moisture entering the structure. There was no plant-growth of any kind in either of the partially dismantled box-chests.

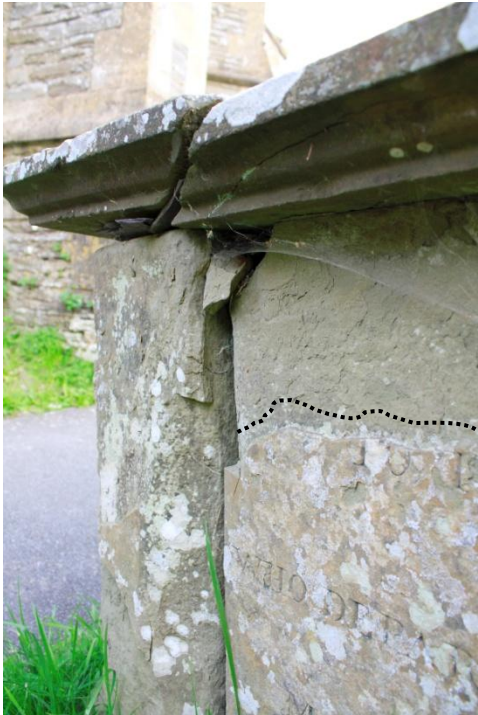
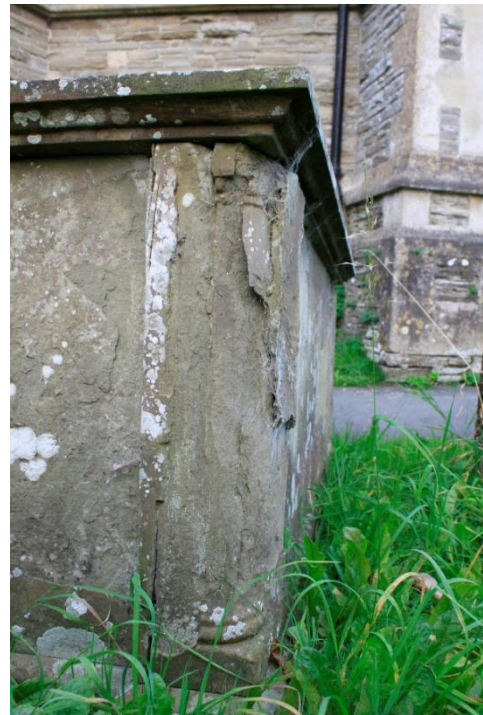
On the left, the south-west corner shows a transverse fracture through the lid and the extent of material loss to the main dedication panel, with the top quarter now lost horizontally, the exposed substrate is very fragile and displays extensive flaking. On the right, the north-east corner, carved detail is completely lost from the curved corner block.

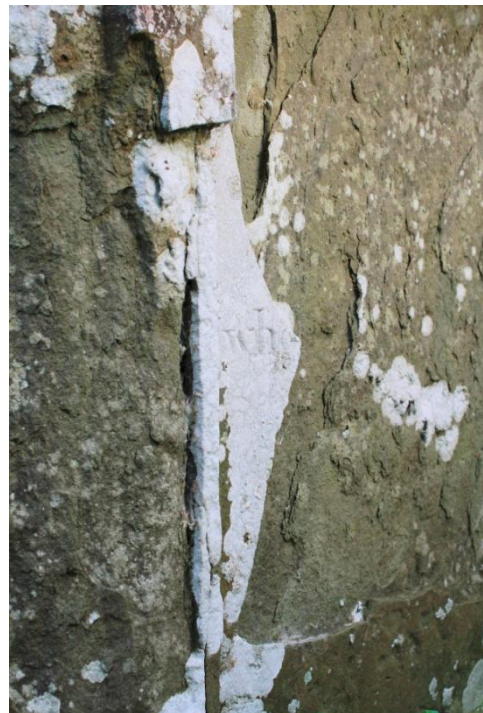
The south-west corner on the left isn't just a wide joint. The left-hand corner block should have a rebate which sits over the dedication panel, but is long-gone. The island of aged, white lichen where the carved detail has been lost and rounded stone indicates this has been missing for a long time. The right image highlights the extent of delamination and flaking to this poor-quality, laminar stone.

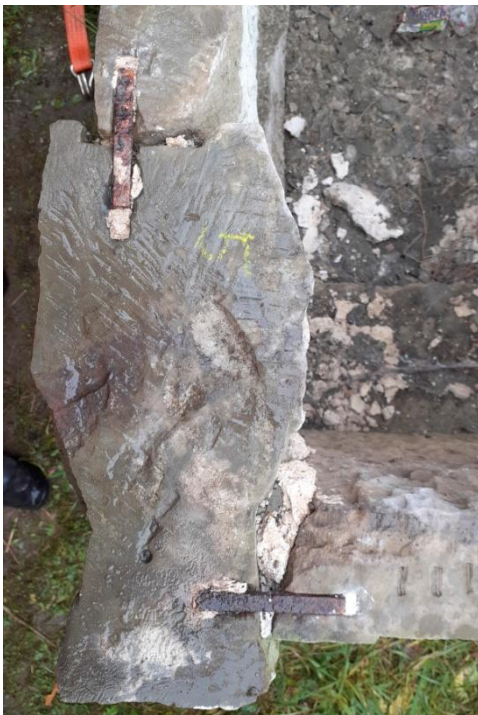
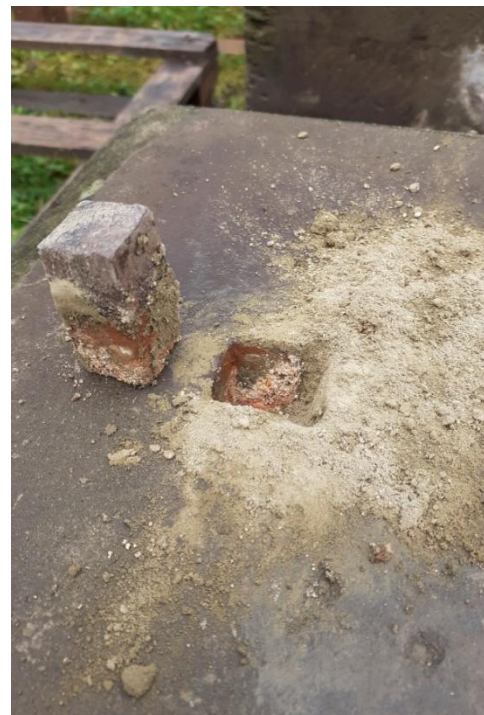
Iron cramps in the top-bed of the tomb chest secured with sound, lime-mortar and square-section studs in the bottom bed of the tomb chest, which weren't replaced. The studs prevented even more movement in the subsiding memorial. These weren't replaced as the memorial will be stable on its new re-enforced concrete sub-base.

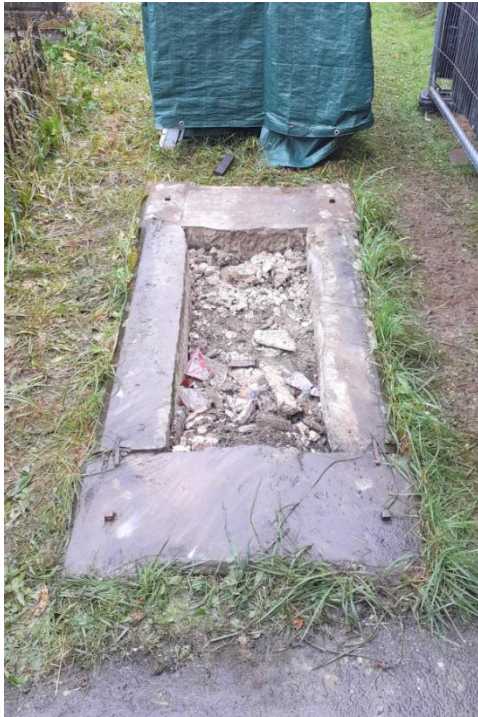
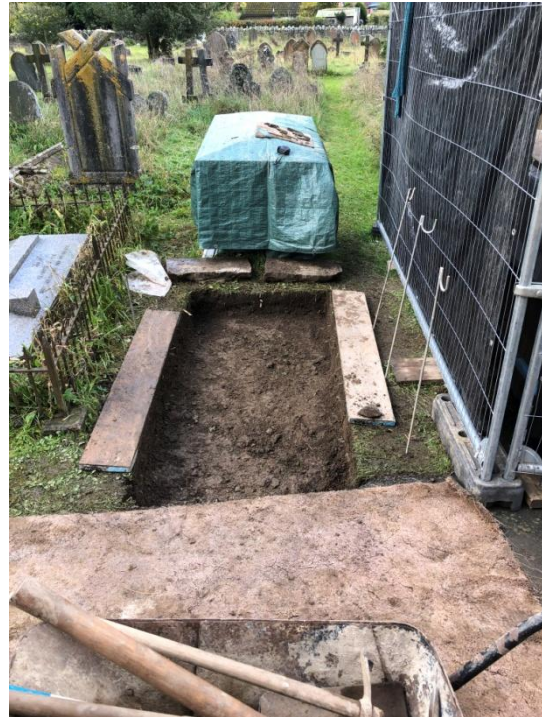
On the left the plinth showing how much subsidence has taken place and how much the churchyard has risen over the 186 years since it was likely built. On the right, the plinth blocks have been moved. There were only two re-cycled tomb chest slabs at the far, east end, providing any sort of sub-base. Note the proximity of the railings and underlying kerb-set to the north.

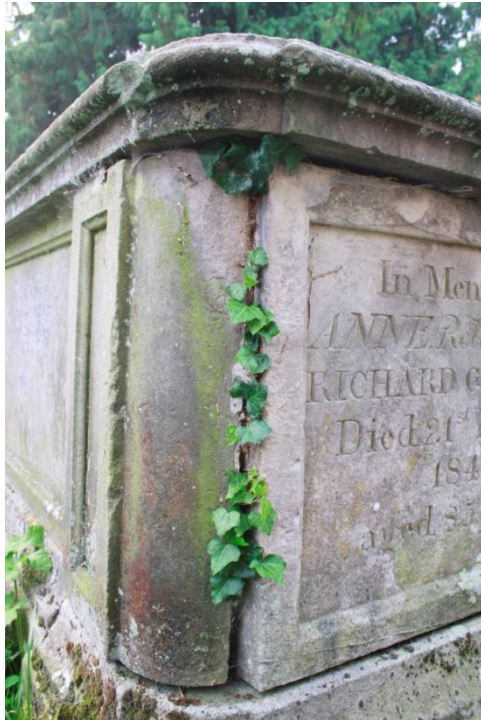
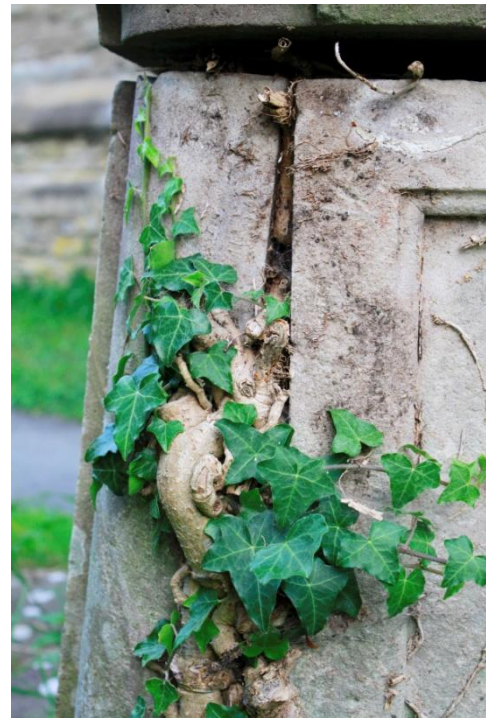
On the left, the north-west corner block being forced out, despite point-loading along the north elevation. On the right, the south-east corner block with its now very dove-tailed joint caused by ivy growth. The joint should be as it is at the top, instead of widening significantly towards the bottom-bed.

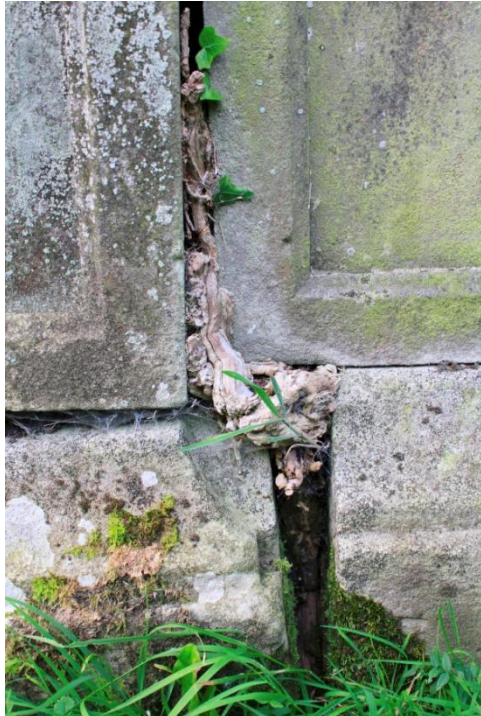
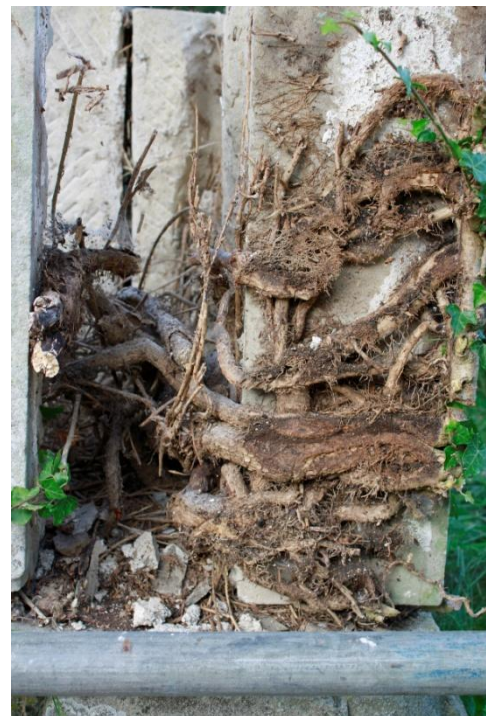
Detail of disruption over two courses, forcing significantly heavy blocks apart and breaking fixings (albeit corroded) apart. On the right, after removal of one of the corner blocks showing how the stems are compressed in the joint but still able to exert enormous, damaging forces over time.

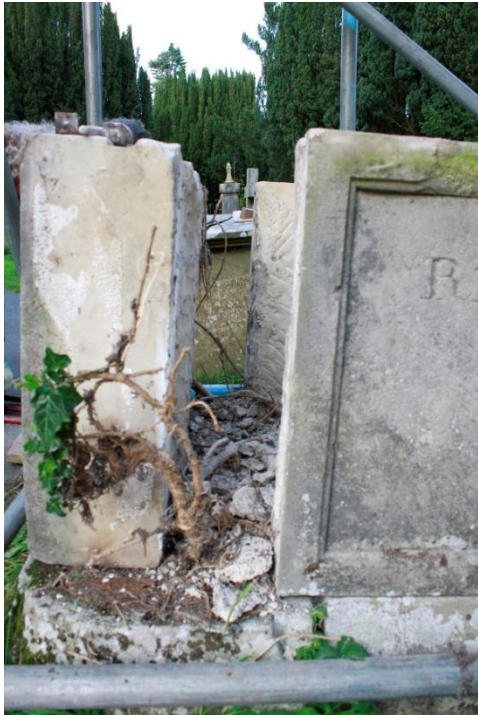
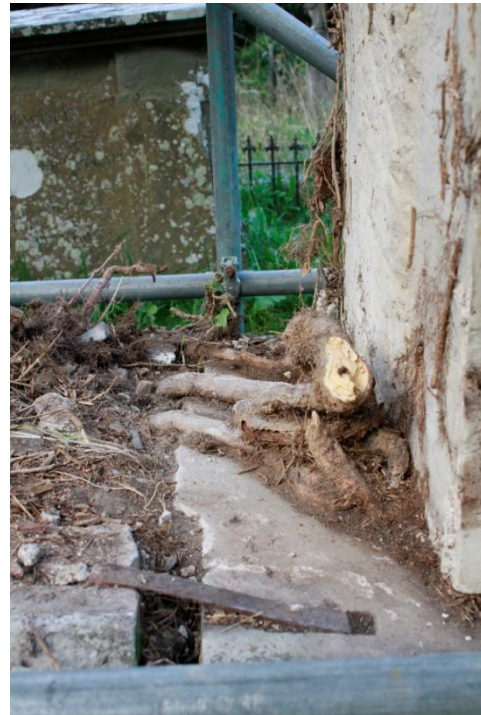
On the left, the south-west corner block having been removed, showing the stems continuing down into the next course. Note how there is no bedding in the bottom-bed of the tomb chest panels. On the right, the south-east corner showing the substantial fixing has been pulled apart with the corroded turn-down, left in the left-hand socket. The joint should be 5mm wide not 30mm

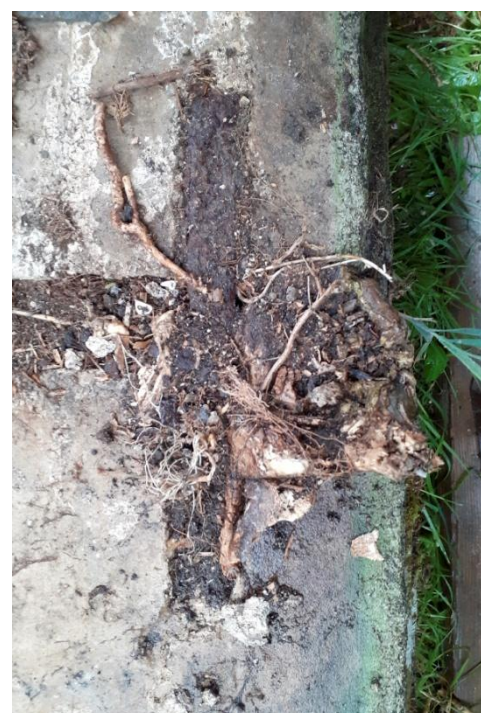
Corroded iron fixings which have delaminated to now flaky metal, serving no useful purpose. Luckily there was no iron-staining to speak of, despite there being easy access for excess moisture, with which to initiate the process. On the right, ivy stems grow easily beneath the fixing, ready to force this one apart.
