Final Conservation Report for Churchyard Memorials

St John the Baptist Church - Bishops Castle - Shropshire

The Diocese of Hereford

Elliott Ryder Conservation

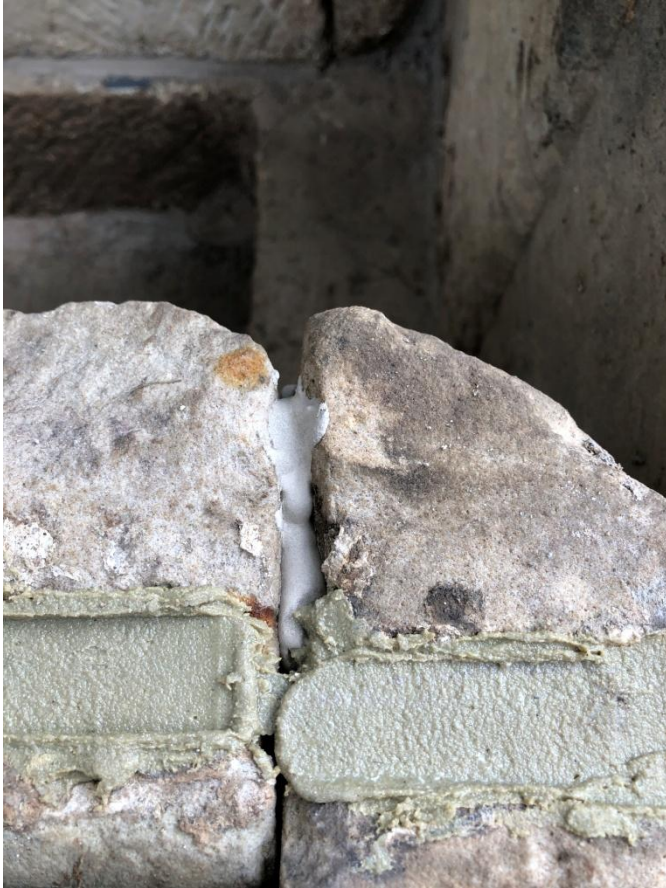
Detail of the gunnable pointing mortar injected into the rear of the fine-joint that coarse mortar would not fill. Coarse mortar was packed in on top of it. Both mortars are based on NHL3.5 and so are compatible. The greeny-grey epoxy-resin securing the underlying stainless-steel cramp into position. Note the channel appears misaligned. If both sides of the channel were parallel (as they were before dismantling) there would have been a dove-tailed joint on the front face and this detail, will never be seen. Compromises such as this have to be made to give a homogenous appearance to the whole memorial, when re-built. There didn't appear to be much care in its manufacture or construction.
