Final Conservation Report for Churchyard Memorials

St John the Baptist Church - Bishops Castle - Shropshire

The Diocese of Hereford

Elliott Ryder Conservation

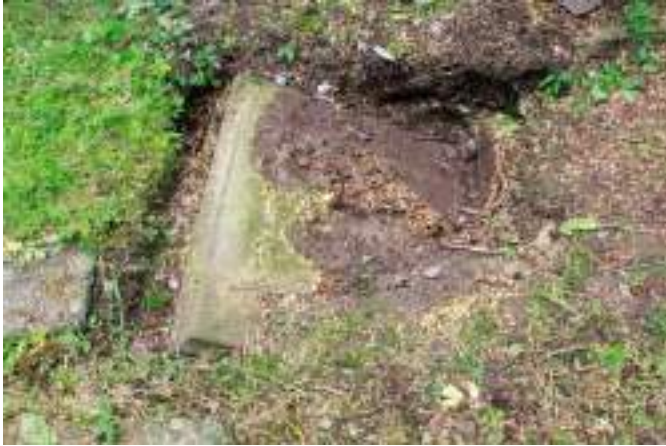
The top of the moulded plinth once all the side elements were removed. It was not apparent at this stage the presence of a rough (uneven) sub-base beneath that.

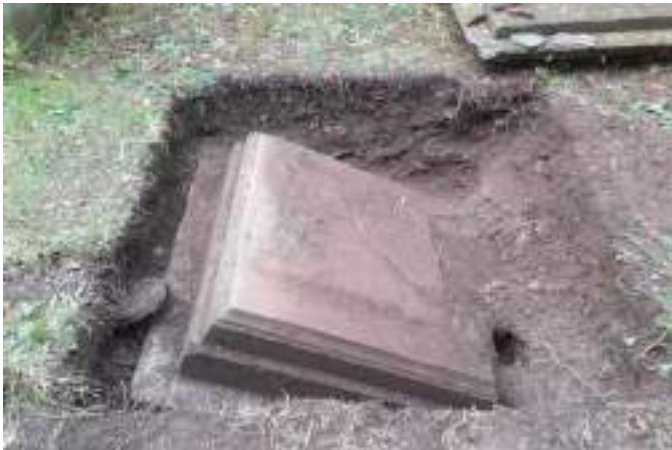
Carefully excavating the moulded plinth and sub-base, note the remains of an animal hole/tunnel at the bottom right-hand corner.

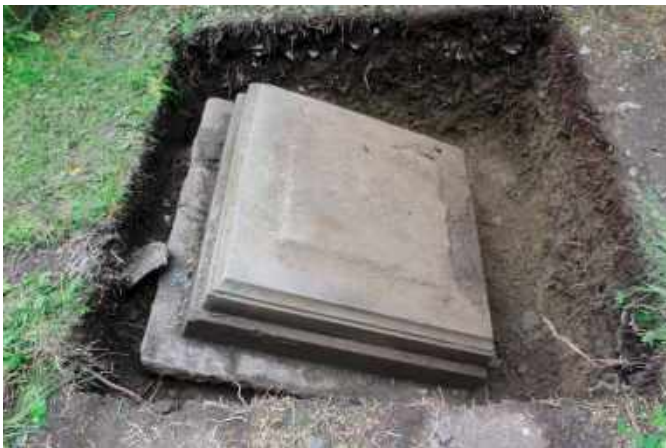
Three sides have been excavated to allow lifting slings to be wrapped around the west and east elevations, to give an even, albeit angled lift. The bottom bed of the angled corner (lowest in the ground) is very close to the internment beneath, so this area was not excavated further.

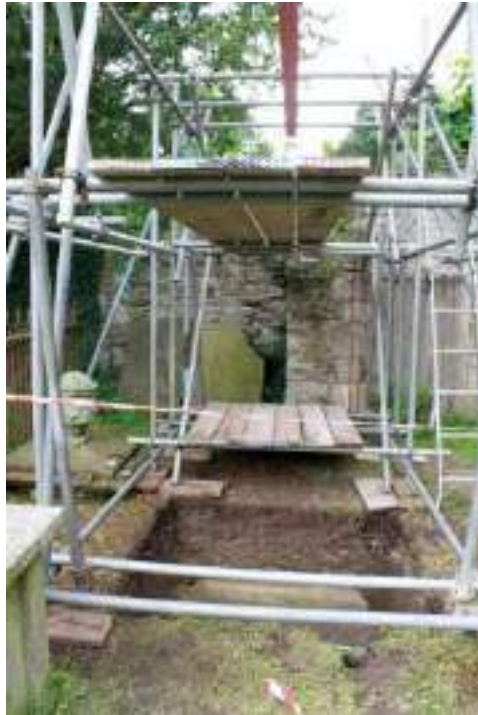
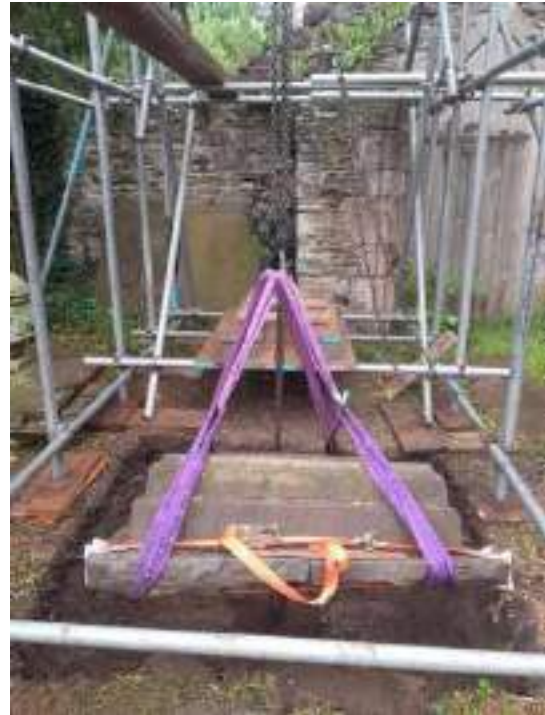
The sub-base and plinth before and during lifting/manoeuvring. Note the front of the sub-base which is in two pieces was secured with a ratchet-strap horizontally prior to lifting, to prevent either side moving during the lifting process. Note also the uneven thickness of the sub-base which would simply have been laid directly on the ground. This unevenness likely contributed to the instability of the 'whole'.

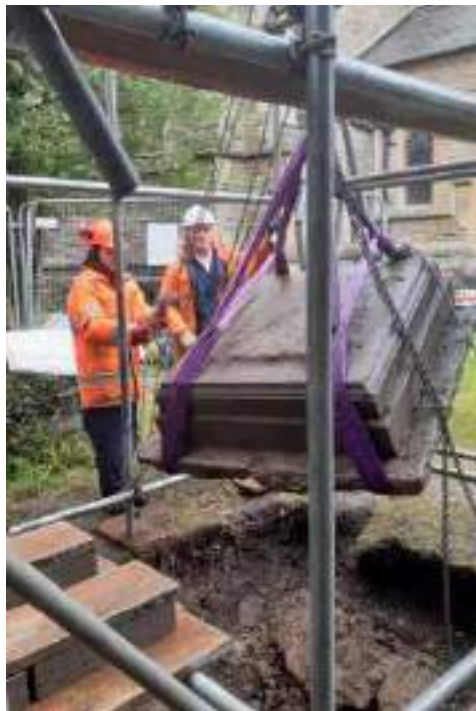
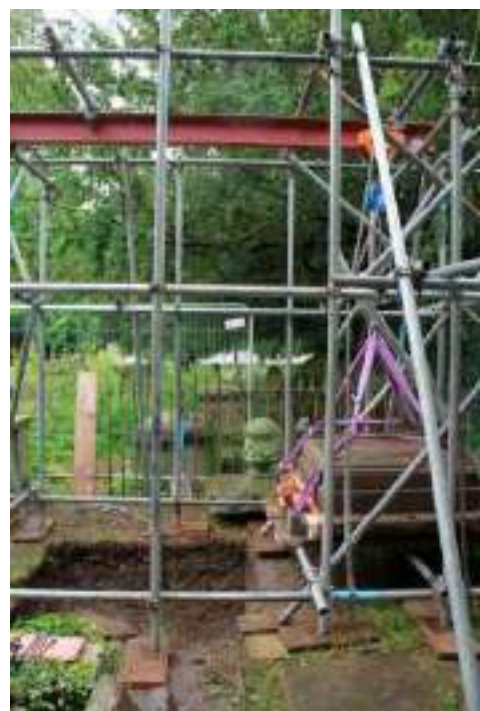
It was not safe to attach a ratchet-strap (as applied to the front) to the rear edge, lowest in the ground, before or during the lift, which had to be done quickly and smoothly. The mass had to be lifted at an angle before being lowered onto thick rollers onto the boarded platform and into a horizontal position, safer for re-lifting into its final position. The red 'I' beam with girder-trolley was used for smoothly manoeuvring the total mass horizontally, which weighed in excess of 850kg.

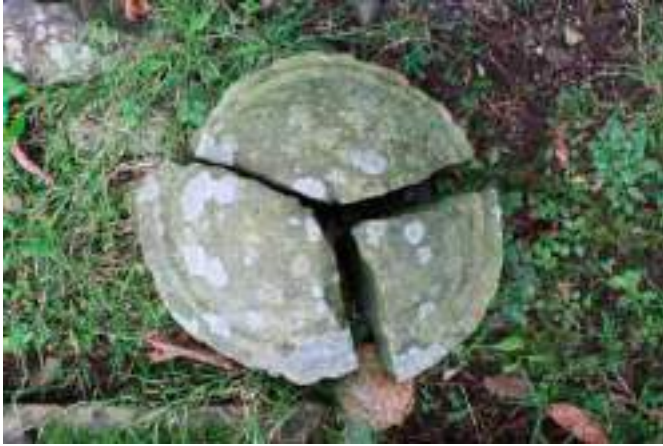
The urn-lid which was fractured by the corroded, internal iron-dowel. Given the level of erosion to the arrisses and biological growths on the break-edges, this is judged to be a very old fracture.

- 4.6 The sections of the composite urn were easily disassembled as the historic, lime-rich bedding mortar was saturated and seriously weakened as a result. The corroding iron dowels which had split the urn-lid into three pieces had been drilled out previously, leaving wider diameter holes to be filled. Threaded stainless-steel dowelling 12mm diameter was cut slightly shorter than the holes in the stone. The vertical dowel was secured into the diminishing base at the top of the capstone at a right-angle to the top bed. Given the weight of all the upper urn sections, resin securing the first dowel was allowed to harden fully over the course of a weekend. Once the dowel was firm the urn and lid sections were applied with resin in the corresponding dowel-holes with a thin layer of bedding mortar to provide a solid bed joint and exclude rain-water

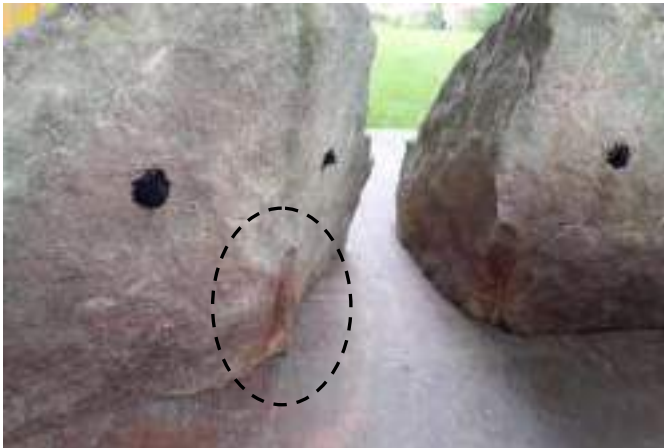
Corresponding spots of paint indicating where stainless-steel dowels were to be inserted. Note the corresponding iron staining (indicated) where the expanded vertical iron-dowel has forced the stone apart.

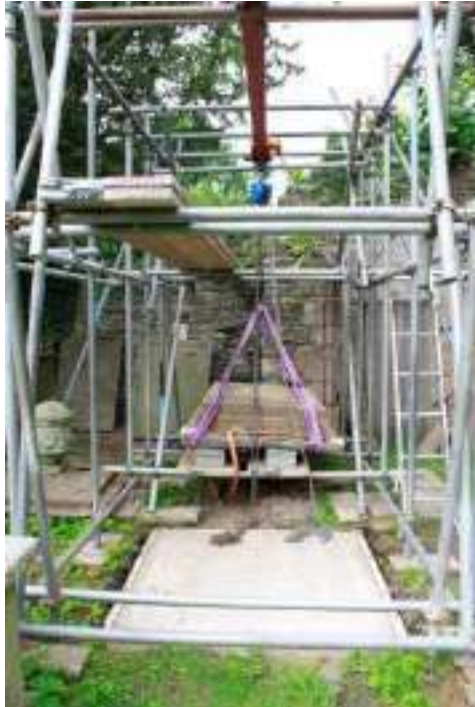
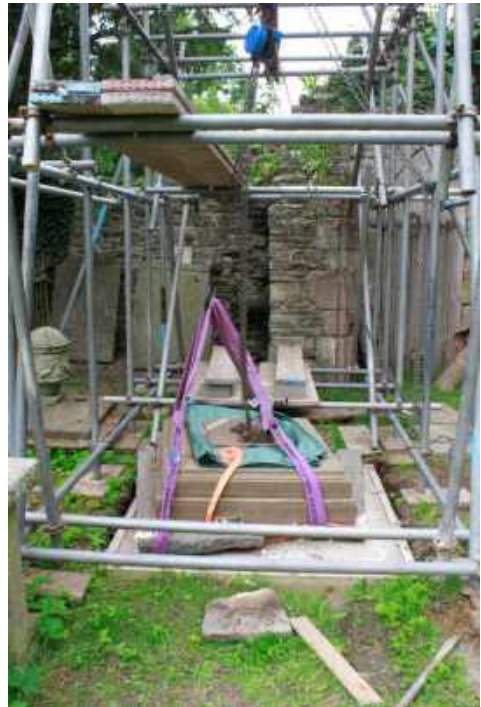
Once the concrete padstone had reached compressive-strength, the sub-base and plinth were moved horizontally and lowered into position. Unfortunately whilst lowering the 'whole', the right-hand half of the sub-base fractured and detached from the moulded plinth, with only mortar between the two courses and no fixings.

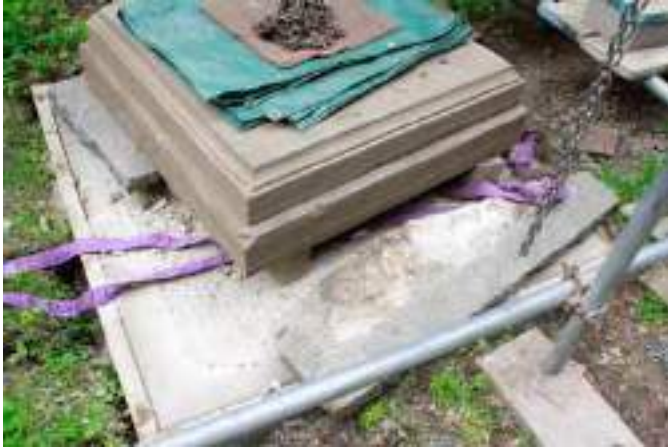
Fortuitously the fracture allowed us to reduce the very uneven nature of the bottom bed, which had a keel like protrusion and would have produced an ugly, wide joint with the concrete pad.

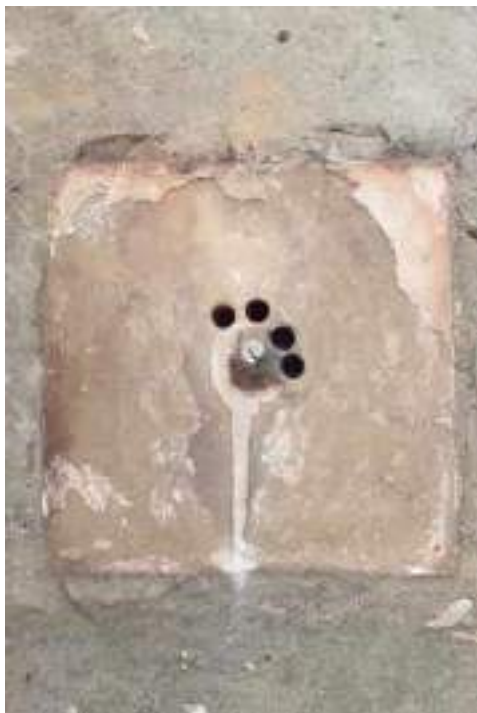
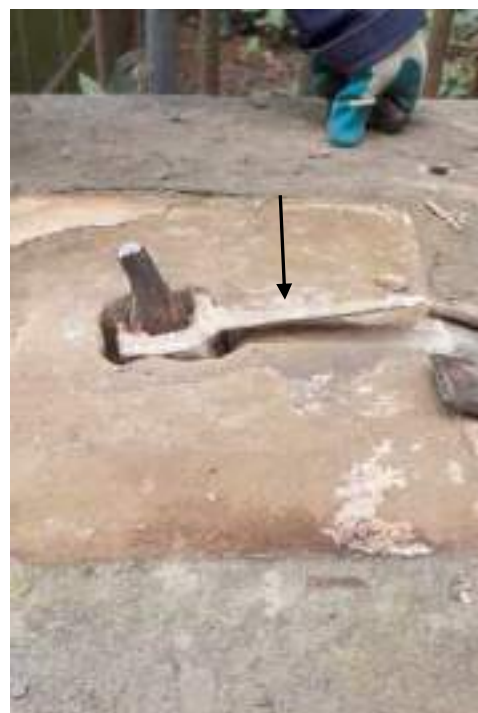
Drilling around the lead 'encased' iron-dowel to release it, which was completely ineffective and didn't prevent delamination of the ferrous metal. Note the route of the molten lead (indicated) introduced into an oversize vertical hole, but ineffective once excess moisture gets into the joint, when pointing fails. Original holes were re-used where appropriate, often needing to make them deeper, to accommodate longer stainless-steel dowels which will not corrode.

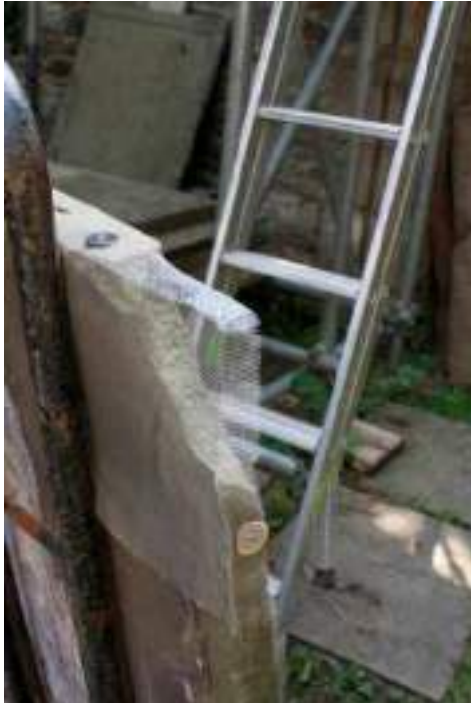
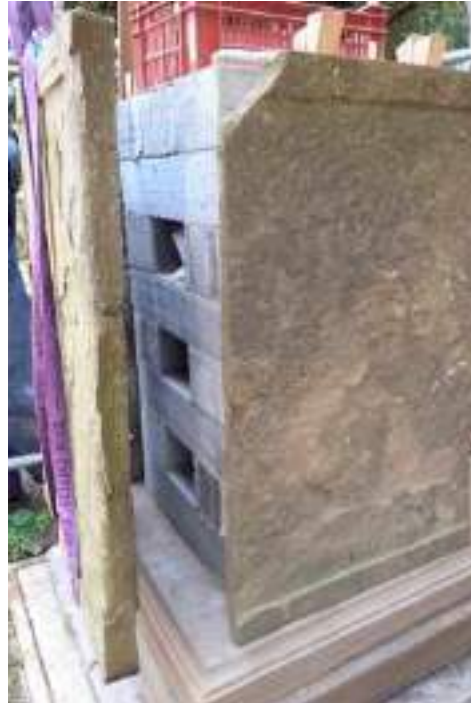
The corner of this block was missing, indenting new stone would have necessitated removing even more sound stone, therefore discreet stainless-steel mesh was secured on two elevations to prevent entry for birds or other mammals. The heavy fractured and repaired slabs were moved as little as possible to save the repaired joints from unnecessary stresses.

- 4.5 On the upper north-west side panel, a large-ish corner section was missing. Indenting new stone would have compromised the appearance of the memorial, removed unnecessary stone and been relatively expensive. The decision was taken to attach stainless-steel mesh to the rear surface of the side panel to exclude wildlife. This was attached by drilling into the rear surface of the panel and securing the over-size mesh with stainless-steel screws and penny-washers into shallow rawlplugs.

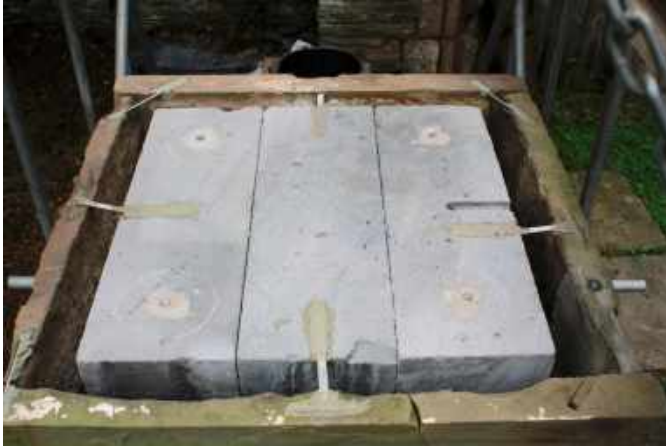
Three of the original corner fixings were re-used after enlarging the holes. The bottom right-hand corner was missing. The outer top light-weight blocks had vertical fixings securing them deep into the course below. All four panels were secured to the core to give far greater structural stability.

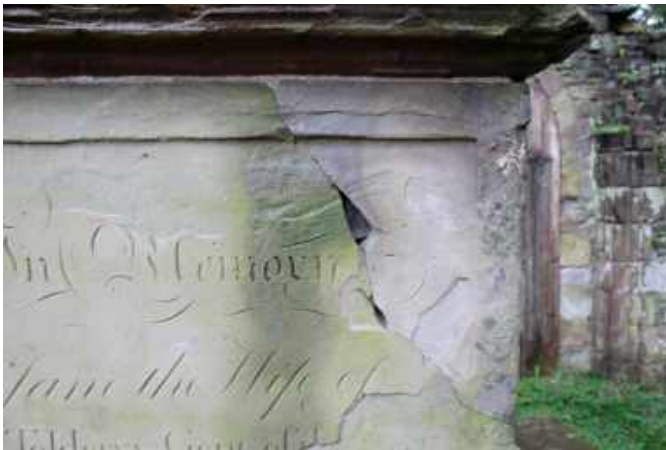
The joint between the capstone and front inscription panel. The areas of loss from the break edge were not filled as it would have been visually jarring. Coloured mortar within the void was angled such that rain on this surface would flow downwards and not into the core. The much eroded nosing of the overlying capstone is designed to shed water away from the four side panels, but does that far less effectively now given the levels of erosion and deterioration witnessed.

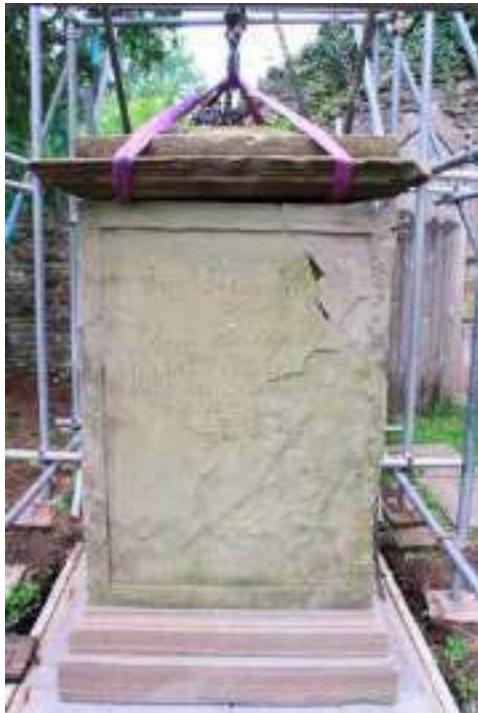
The capstone being lowered into position. Slate shims were required on the top-bed of the core to make it level, as the bottom-bed of the capstone was so uneven. The right-hand image shows mortar repairs (indicated) inserted into vulnerable areas previously tacked with epoxy-resin spots to prevent further damage/loss. Much of the original carved surface has been lost from this very laminar local sandstone.

- 4.7 Once the whole memorial was built, vulnerable edges/laminations had coloured mortar support fillings (Lithomix®) inserted along their lengths to provide strength to previously tacked (with resin) edges. On several wider laminations liquid grout was also introduced by mortar-gun, to fill the voids where mortar could not be packed deep enough. Such a grout is merely a filler and does not re-bond delaminating surfaces but fills gaps between the surfaces such that these areas can't be easily crushed. No attempt was made to recreate missing mouldings or areas of missing stonework.

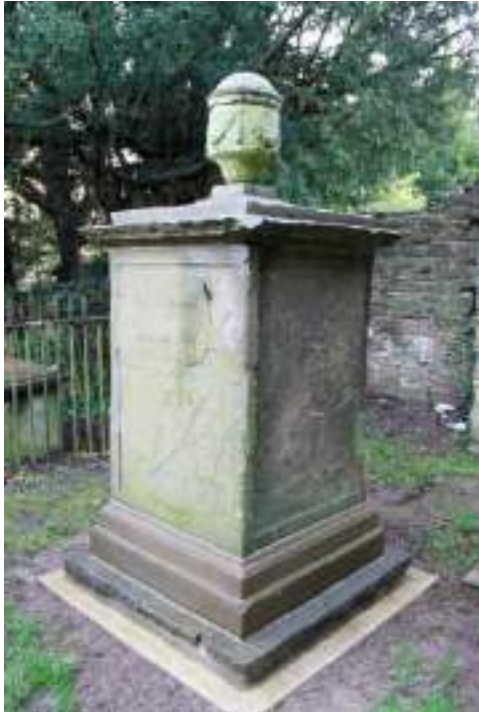
- 6.2 It is also worth noting that the outer nosing or extremity of the capstone is much eroded and had suffered some isolated physical damage during dismantling and stacking of the stone elements. As such the capstone is not shedding rainwater away from elements below as designed to do and is actually directing rainwater onto the aged stone in some areas. This was witnessed during/after several heavy rain-showers. That said the memorial as a whole is in a much better state of preservation than it was - stacked badly on an uneven surface and its re-erection/conservation has ensured its long-term future.

The re-built box-tomb on its new concrete pad. Note the eroded and physically damaged nosing (outer edge) of the capstone which casts biological rich water directly onto the moulded stone plinth beneath. Despite the architectural detailing and proximity of the over-hanging tree, the long-term integrity of this beautifully proportioned and decorated memorial is now assured.

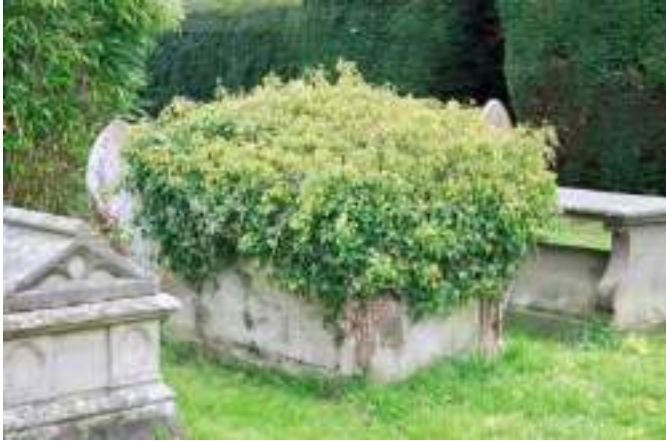
- 1.1 The tomb-chest was in a chronic condition due largely to the poor quality of individual stone elements, poor stone selection and architectural detailing and the insidious long-term effect of ivy growing through the tombchest, left un-checked or maintained. The majority of the plinth blocks are edge-bedded (at right-angle to its natural sedimentary bedding-plane) and as a result have delaminated severely, which appears to be common for the local stone employed in fabrication of this memorial and many of the others reported on.

- 1.4 The ivy was seen to have grown through vertical joints in the tombchest, forcing some of the corners out of alignment by nearly 100mm. The main roots/tendrils had exploited weaknesses in the delaminating stone slab and completely forced their way through a weak area to the west of the lid. Smaller tendrils had grown through horizontal bedding planes to such an extent that the stone would not have provided an effective lid/covering for the tomb-chest beneath and would have let water in through multiple repairs, requiring resin, fixings and mortar. The relatively poor-quality, local, laminar stone slab, was too thin and long to perform its architectural function in the long-term.

A general view of the memorial before any treatments. Note thankfully none of the neighbouring memorials are afflicted in the same way with the insidious effects of ivy growth.

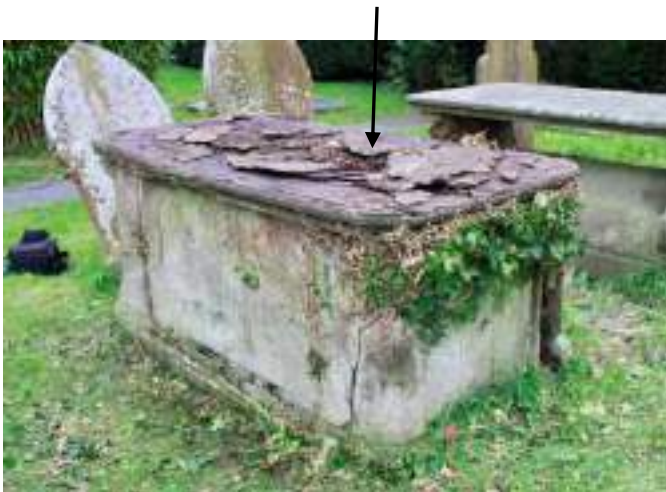
The much de-laminated upper surface of the tomb chest lid, which the ivy stems had exploited, puncturing through the weakened sandstone in the area indicated. Growths can clearly be seen issuing from the horizontal and vertical joints.

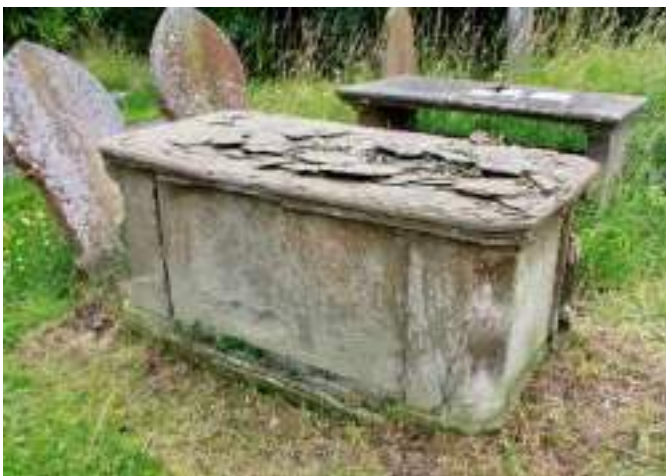
The tomb chest after being rain-washed clean over the course of a winter. Despite the level of disruption witnessed, the memorial plinth blocks are still largely level, which was a factor in determining not to dismantle the sub-base, which is always a last resort.

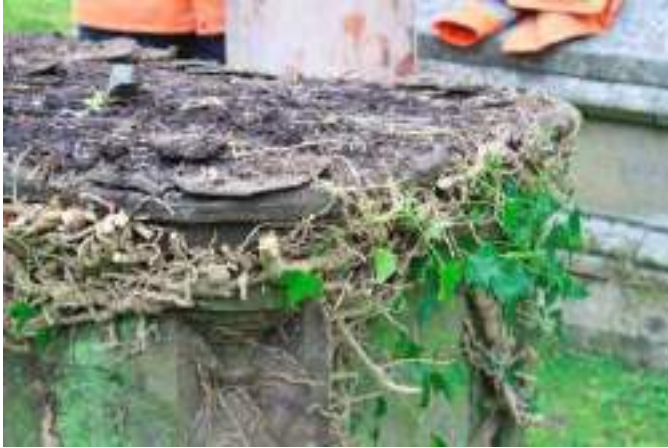
During removal of ivy growths, which couldn't be removed properly until the tomb chest was dismantled fully. Note the extent of soil debris on the top-bed of the slab from the breakdown of ivy-leaves over many years.

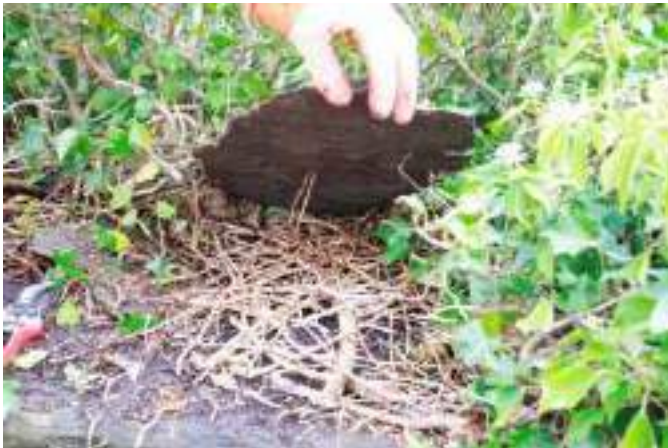
The ivy tendrils had exploited the laminations of this weak laminar stone, growing along bedding planes and forcing layers apart.

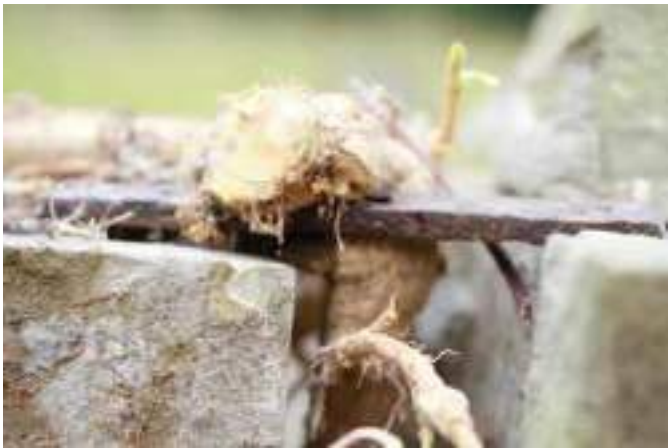
The ivy roots had forced apart many large, heavy sections but kept this dog-cramp (double turn-down) in place, by growth around it. The thick stems had forced these large stone blocks apart horizontally.

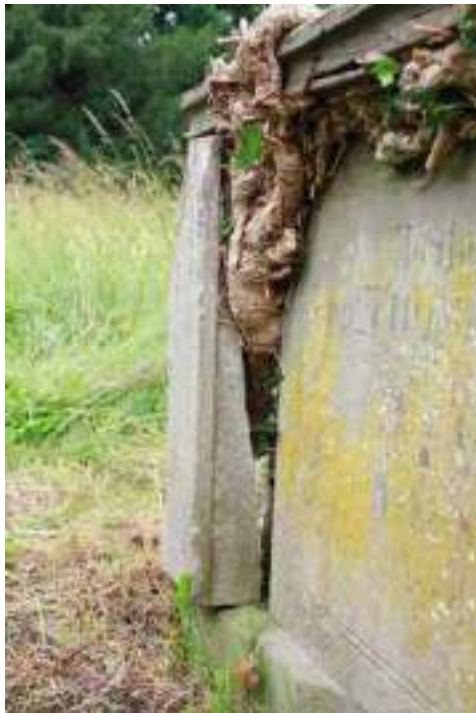
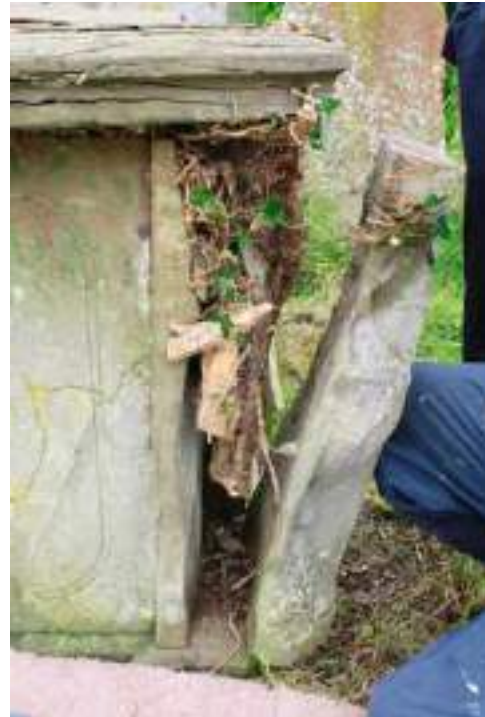
The extent of the stem expansion, compromising the load-bearing capacity of the tomb chest itself. The right-hand image highlights the weak, laminar nature of this local building stone, when looking at the moulded corner detail of the slab. Note no attempt was made to clean the memorial with the yellow, green and white lichens providing a visually pleasing patina of age.

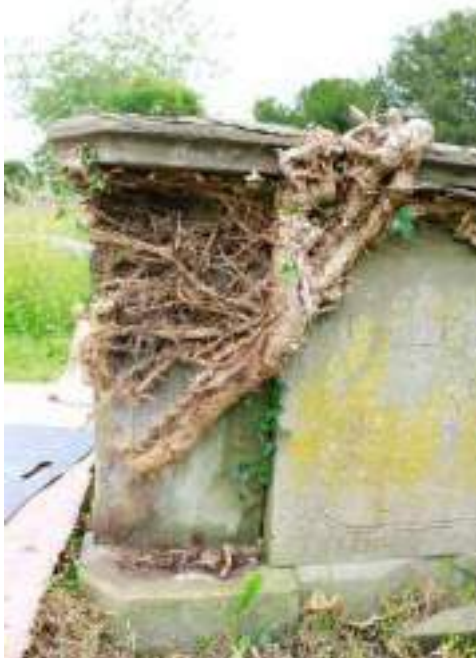
On the left, the south-west corner block having been forced off, on the right, vertical fractures through one of the plinth blocks. The ivy had grown the same width as the joint before widening back out within the tomb chest.

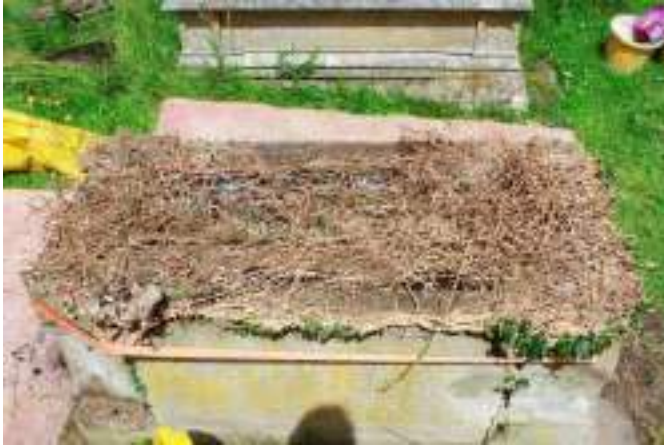
The maze of ivy growths within the tomb chest, once the lid was removed in sections. Much of the growth was dead but some was still healthy. Note the new green leaves in the foreground, even after removing the majority of the growth on top of the lid.

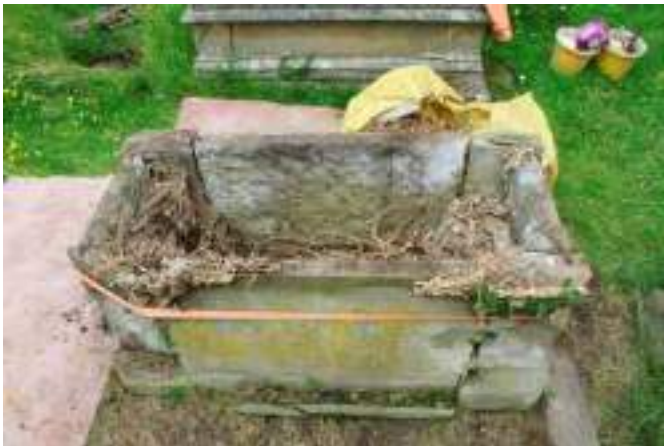
Having cut back much of the growths where possible. The stems were within the supporting sections of walling and would have to be removed once these sections were dismantled. Once the lid was removed several of the smaller side elements became unstable, as all the fixings had failed, which required the use of a ratchet strap to keep other sections in place.

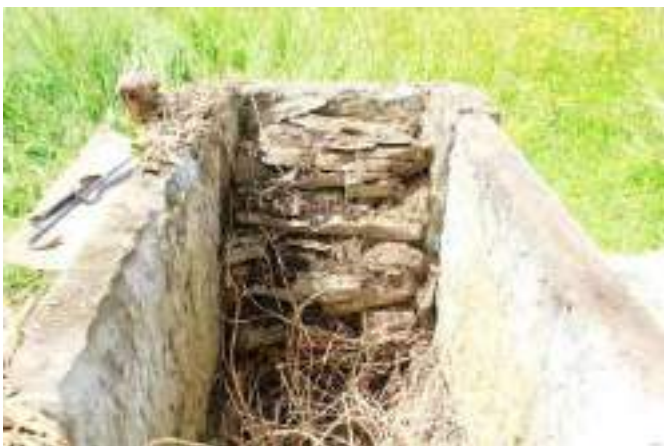
The rear of the west elevation and the random nature of the initially supporting core. Once the fixings are compromised it creates instability, with an angled mass leaning against the short panels. Built with thick mortar, both cores had absorbed and retained moisture from the compromised, much wider open joints, with easy access for rainwater and all its associated problems.

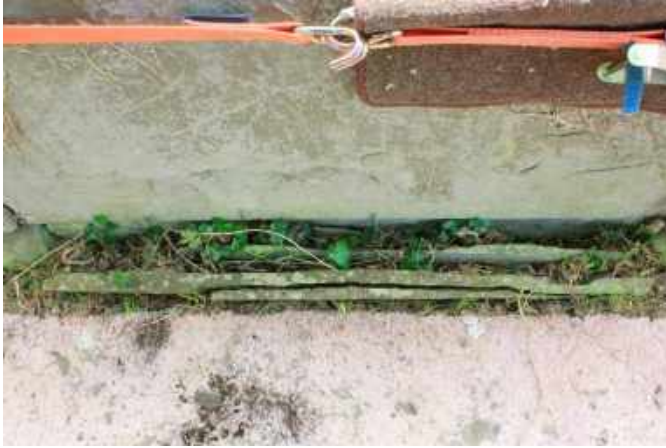
The extent of delamination in the plinth block, which has obviously been an historic problem judging by the extent of established plant growths within the laminations. The stone is edge bedded, that is rotated 90 degrees from its original sedimentary bedding plane, with weather better able to exploit the weak laminar stone.

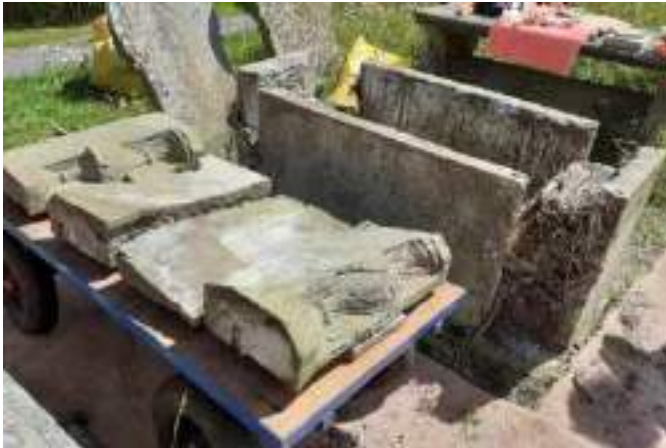
The smaller, carved corner blocks which join the short and long sides together. Note the three right-hand blocks and how severely delaminated they are, with the middle of the three having lost all carved detail.

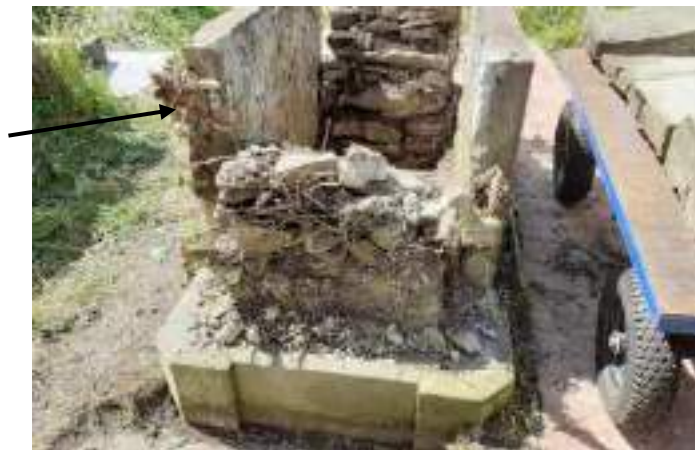
The east elevation after removal of the short panel, highlighting the extensive roots within the core structure and the small mass of roots within the joint between the north long panel and where the corner block was (indicated). The chamfered plinth (short) block in the foreground is in its natural bedding plane and is in a much better state of preservation as a result, bedding planes constantly in compression therefore unable to be exploited.

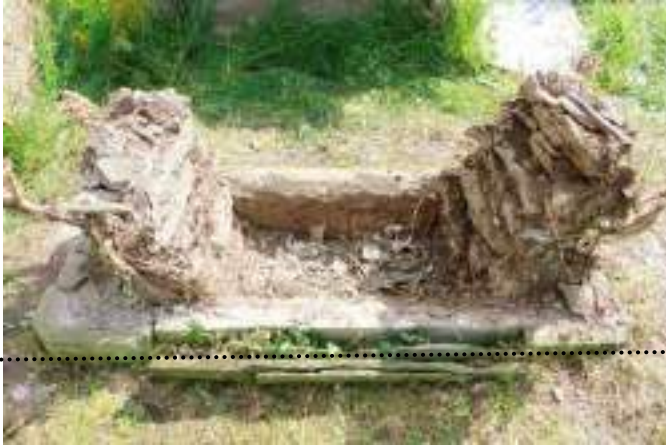
All of the side panels removed leaving the angled 'supporting' core and ivy stems, which appear to have grown out of the corners, most likely the points of least resistance. The front plane of the long (south) plinth block, should be behind the outer edge of the short blocks (indicated) but has delaminated/moved to such an extent.

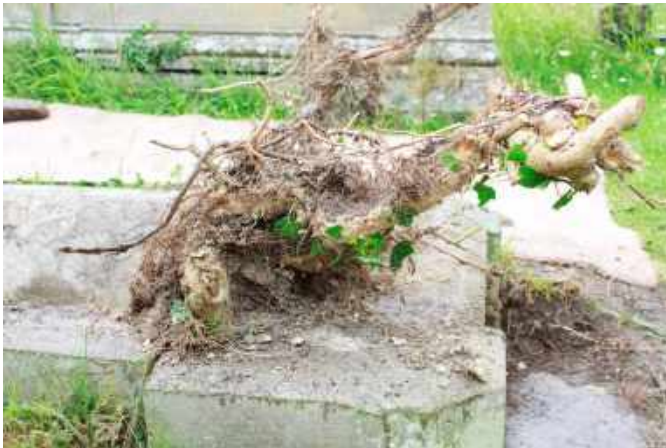
The extent of aged ivy roots at the south-east corner, showing some small healthy leaves, indicating the plant stem was alive.

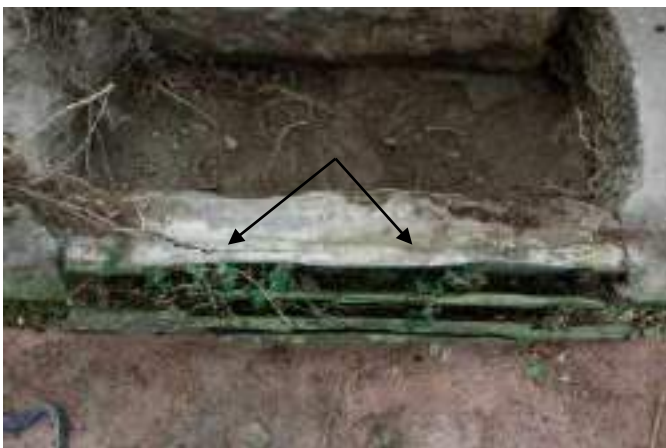
The plant stems removed as far as possible before removing three of the four plinth blocks. The opposite (north) plinth block showing an equal amount of disruption, with an inherent delamination about to be exploited (indicated).

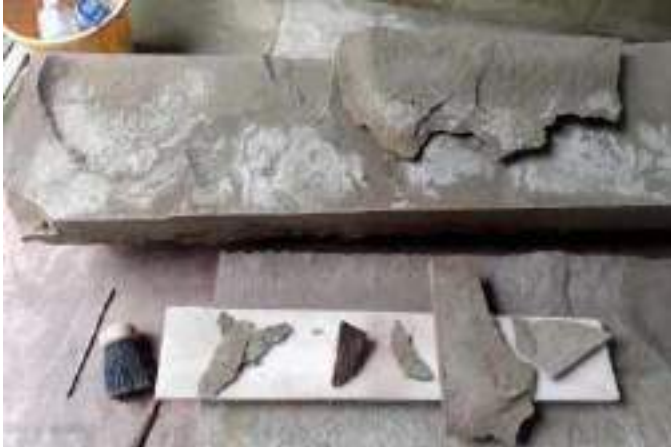
The extant sections were wet-cleaned and allowed to dry before being re-joined. The white accretion on the surfaces is efflorescence from soluble salts, caused by soil and organic materials.

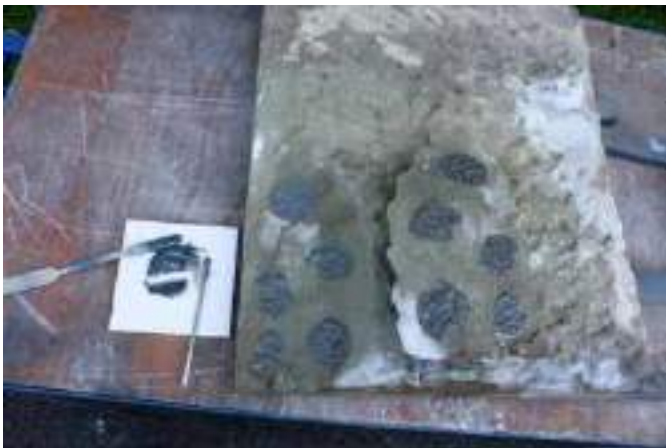
The rear of one of the 'short' tomb chest panels, using the same system of spots, not a continuous layer. Note the rough 'punched finish' that is a surface left from a punch chisel, which has a blunt point. All 'finished' surfaces start like this moving through to the claw and flat chisels, to give a smooth surface. The carving process imparts significant shock into the stone surface, creating micro-fissures below the surface, which are exploited by weathering over the decades. This is a more significant problem on a poor-quality building stone such as this.

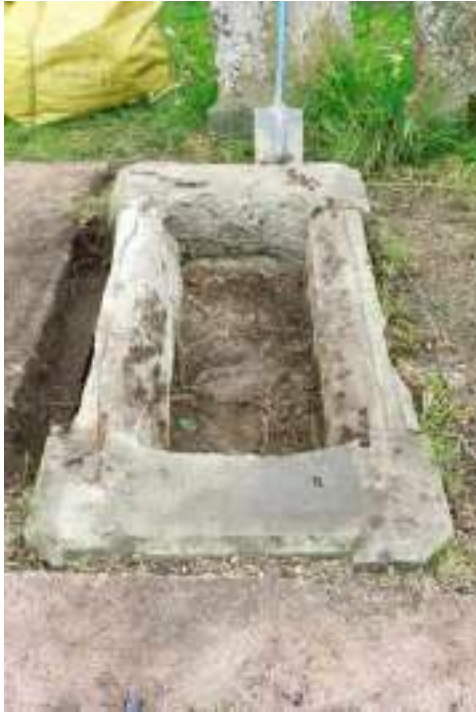
During the dismantling process, note how little gap there is between the long panels. In the right-hand image, tied plastic bags (indicated) can be seen on frill-girdles cut into the ivy stems. This was treated with a toxic, Potassium Sulphamate paste which will kill the roots system below ground level. The compacted stone base did not require lifting/dismantling, which was wider than the outer footprint.

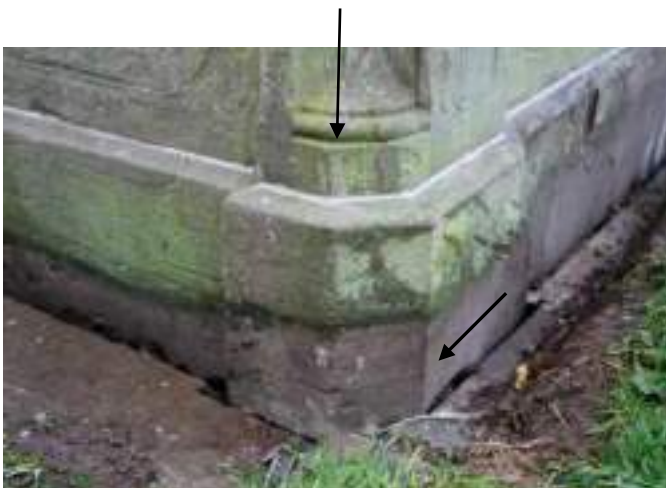
The new joint between the plinth and the tomb chest elements from a gunnable mortar. The direction of the bedding plane can clearly be seen in the different elements (indicated). The clean/dirty demarcation on the plinth is where the plinth has been covered with soil by the rising ground-level.

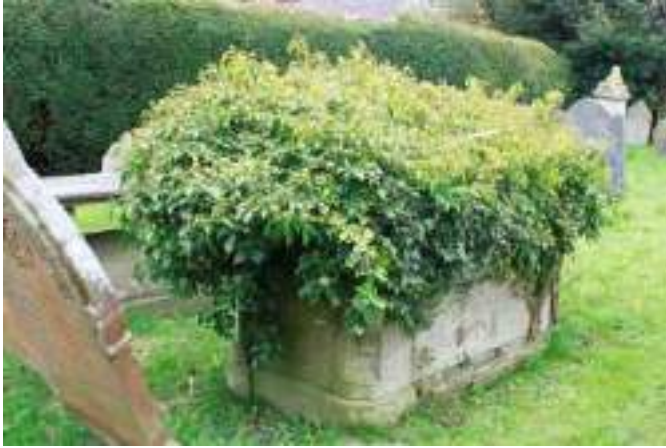
The tomb chest before any treatments, highlighting the extent of well-established ivy growth, which disguises the extent of structural damage to the memorial.

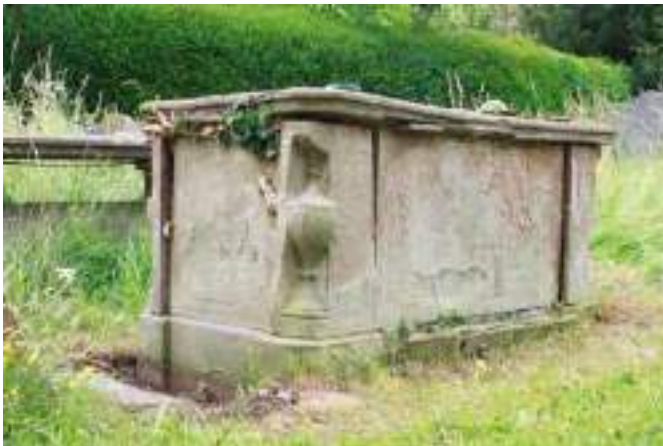
After removal of the surface growths, with stems still growing through the joints. Note the upward plane of the tomb chest lid in the foreground and the horizontal fracture through the slab as a result.

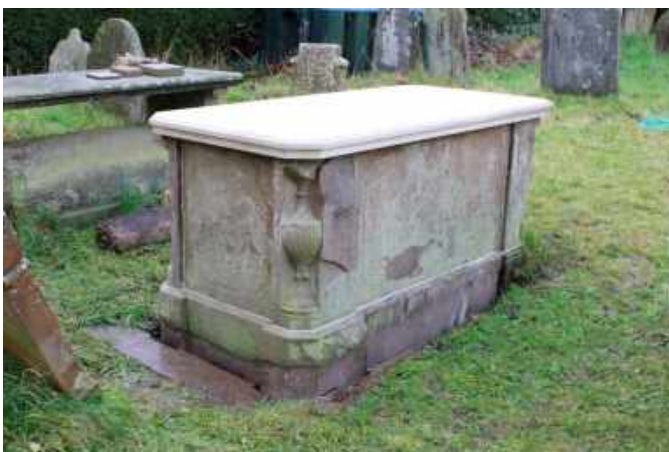
The tomb chest after all treatments, note the colour of the lid is because the stone is bone-dry, having been under-cover for many weeks. The three small, square, stone samples on the lid of the memorial in the background, is the true colour of the lid, with the samples having been outside for weeks.

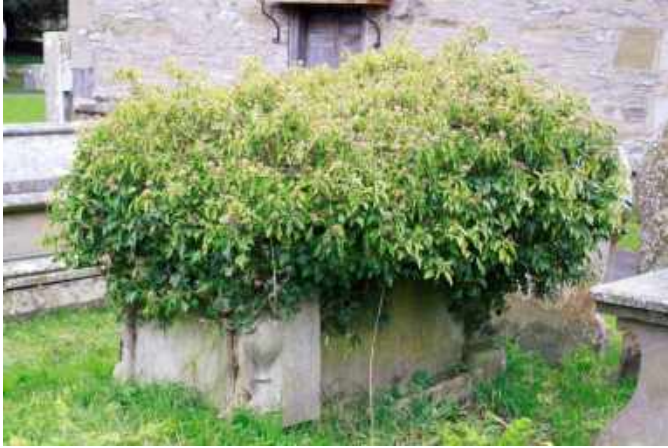
Another view of the tomb chest prior to any treatments. Ivy is well-established and a memorial enjoying a Grade 2 listing for so long, should not have been allowed to reach such a perilous condition.

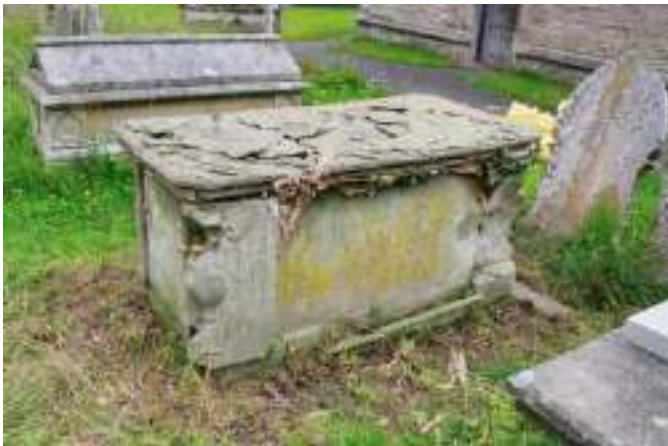
The majority of the ivy growths removed and the lid having been left to be rain-washed over the course of a winter. The full extent of disruption and delamination, now apparent over the whole tomb chest lid.

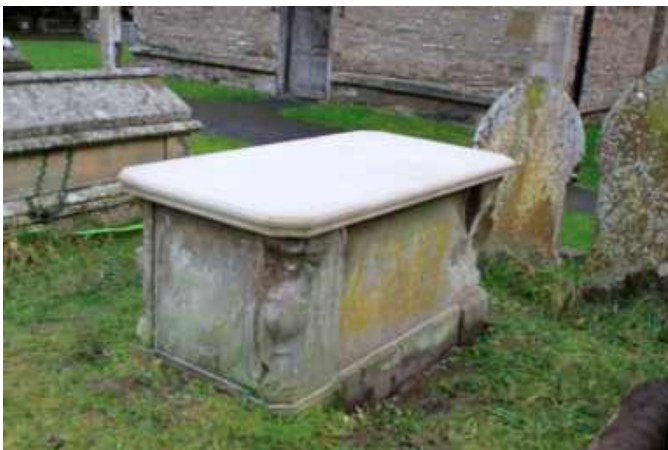
Another angle of the conserved/rebuilt tomb chest, with the new lid now able to properly shed rainwater away from the aged, side panels beneath. The overhang is minimal (the same proportions as the original) and could have been even wider in both planes to fully protect the tomb chest. The lid was a like-for-like replacement.

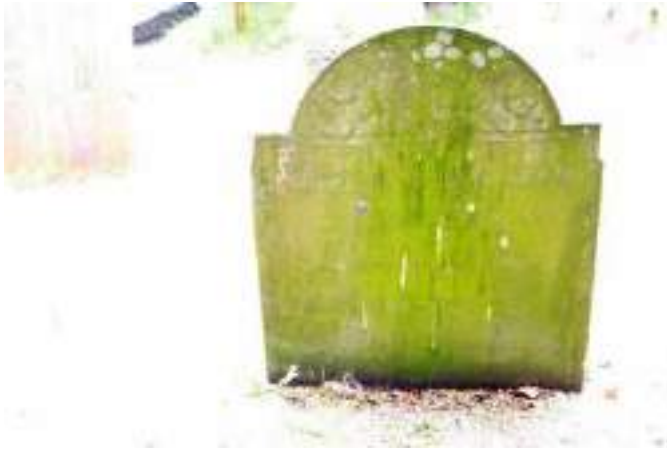
The over-exposed grave-slab before any treatments. This front surface is completely colonised with bright-green algae, with a small amount of light-grey lichen at the top. Bird guano was visible down the centre of this face. Note how the extent of finely carved, low-relief detail is lost visually on the semi-circular head.

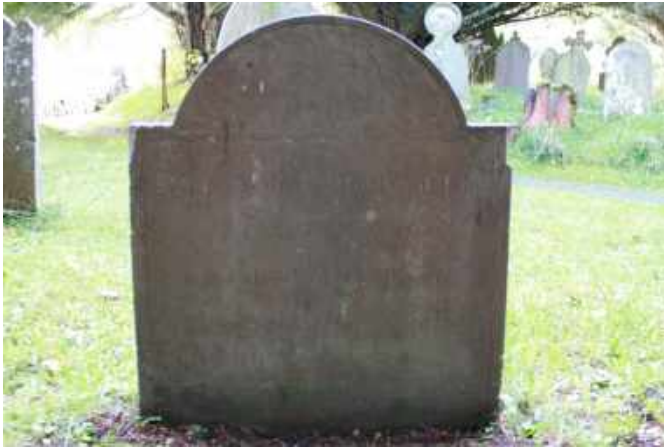
The rear surface of the graveslab seen from the adjacent path and grassed area. You have to stand beneath the tree to see the dedication and carved detail. Note the greater levels of white/grey lichens, due to greater in-direct light-levels. This surface is protected somewhat from direct sun-light, due to numerous mature trees in the foreground, but must receive weaker sunlight earlier in the morning.

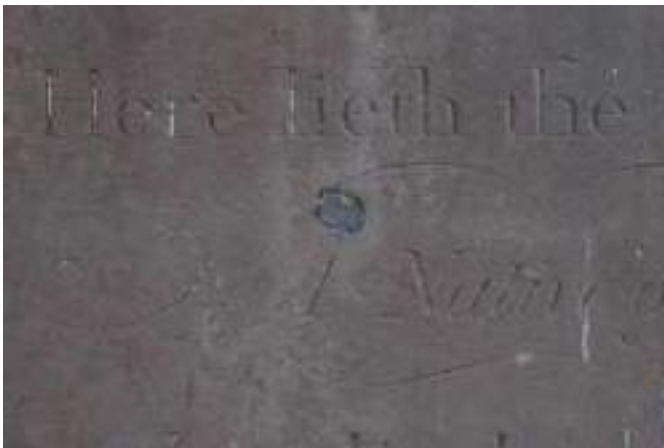
The warm colour and carved detail at the head of the slab, much more apparent after cleaning. More tenacious green algae at the intersection with the ground could not be removed further due to disaggregation of the stone in this area. This deterioration is not serious enough to warrant consolidation yet, which would be problematic, as the object cannot be isolated from moisture. Removing it from the ground for treatment would present ethical conservation issues.

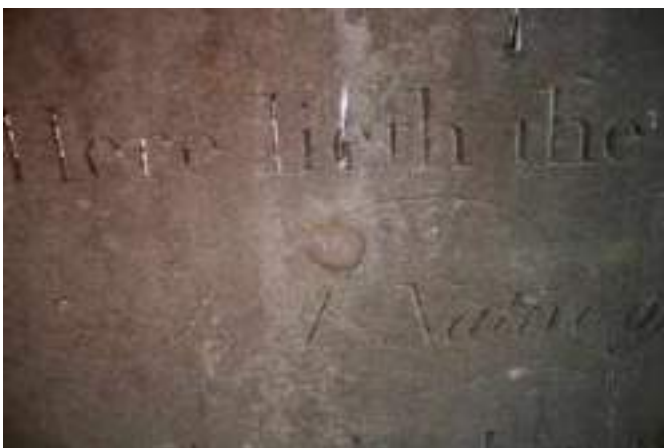
Detail of the quality of setting-out/lettering and the only blister on the carved surface. A large area around it (above and below) sounded hollow when tapped, caused by delamination of the now face-bedded slab. A fine, free-flowing liquid grout was injected behind the pre-wetted substrate in two cycles and surprisingly little was absorbed, indicating the lamination is not as bad as first thought.

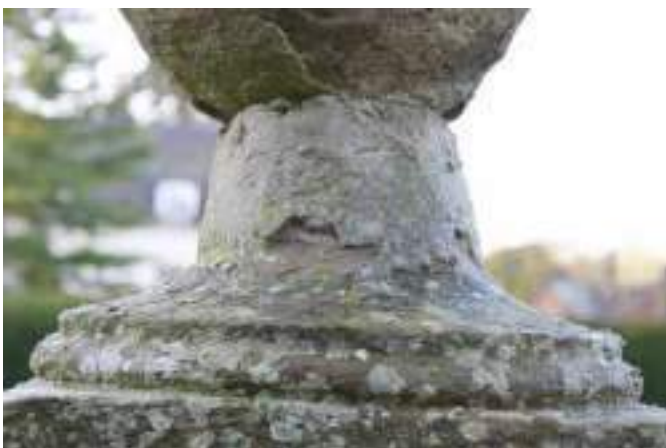
- 2.2 The ball-finial has been re-fixed badly in the past and is now at a jaunty angle. Although the cementitious repair would now be deemed inappropriate material, the crude and ugly repair to the diminishing urn-neck showing no signs of breakdown, or splitting and is colonised with well-established lichens and algae, indicating it is an old repair.

The ball-finial with crude cementitious repair around its diminishing neck. The ball is carved in one piece, which is made more difficult given the raised fluting around the centre, requiring the use of two reverse templates instead of one. Perhaps unsurprising the ball is so deteriorated given the amount of chiselling required for the numerous, decreasing chamfers, to create the curve – semi-spheres.

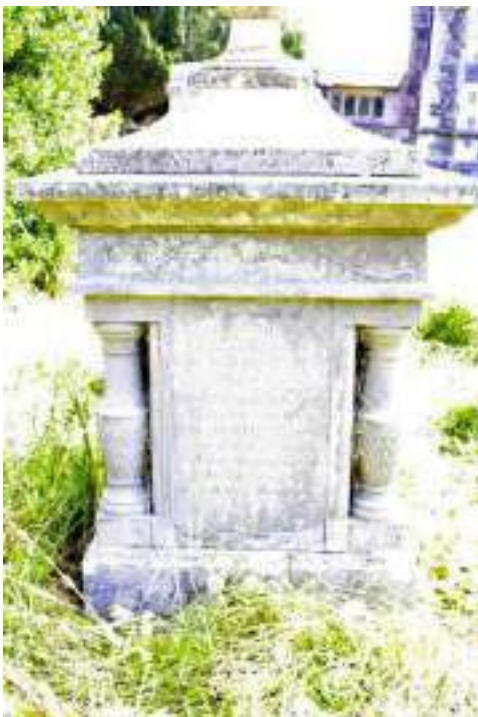
The north elevation of the Thomas memorial before and after all treatments. Delaminated stone along the bottom bed of the box-tomb was rationalised back to sound substrate, with support fillings inserted along the length of the previously tacked edges. Note the poor angle of the ball-finial. Low-relief, foliate-decoration to the frieze (indicated) beneath the capstone is all but lost visually.
