Final Conservation Report for Churchyard Memorials

St John the Baptist Church - Bishops Castle - Shropshire

The Diocese of Hereford

Elliott Ryder Conservation

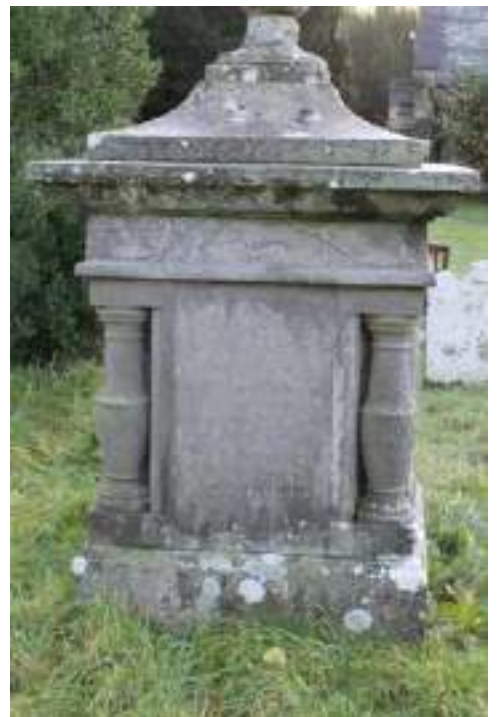
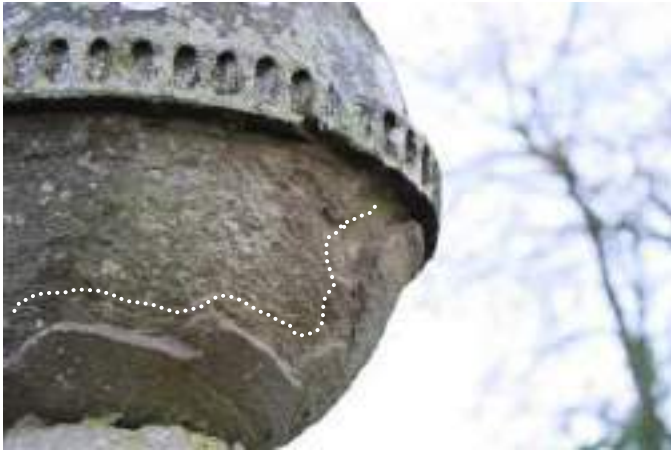
The west elevation of the Thomas memorial before and after all treatments. Delaminated stone along the bottom bed of this elevation was also rationalised back to sound substrate, with support fillings inserted along the length of the previously tacked edges. Carved detail to the frieze is a little easier to determine on this elevation.

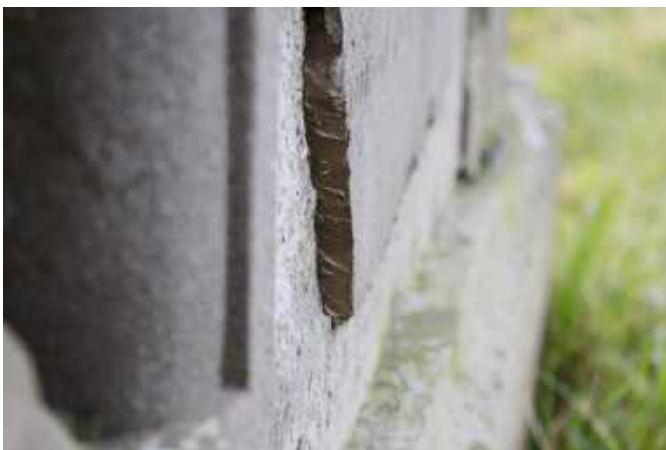
The lamination at the base of the inscription was tacked with resin previously and therefore was strong enough to pack repair mortar in, as far as possible. Grouting uphill is all but impossible so was discounted. Grouting could only be successfully achieved by filling the lamination and drilling into the carved surface at centres (indicated) to create a series of needle entry-points. This risks shattering the brittle, weakened layer and compromising the historic dedication, both of which are against conservation ethics.

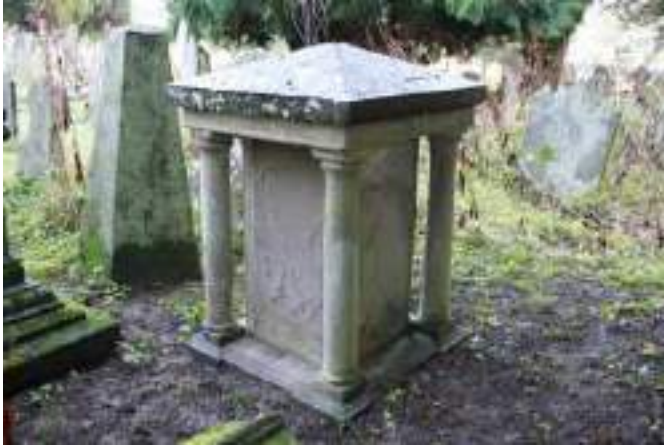
The fat-lime-rich mortar visible in the horizontal joint between the 'short' side-panel and capstone above. The joints are so fine on this memorial, indicating good-quality workmanship during its manufacture/erection and latterly, lack of movement in the structure, which has a relatively small footprint and obviously has well-established tree roots beneath it, as well as the likely internment below ground-level.

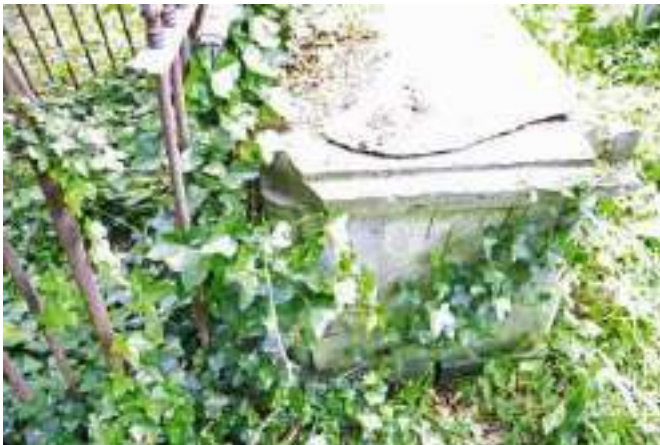
The Drew memorial before any treatments, note the broken and corroding wrought-iron railings resting against the stonework. Ivy was attached to the rear of the tomb chest and the railing had to be cut free to gain free access to the ivy. The ivy and bramble growths were removed in the Autumn of 2019 as well as emergency consolidation to vulnerable areas of delaminating stone.

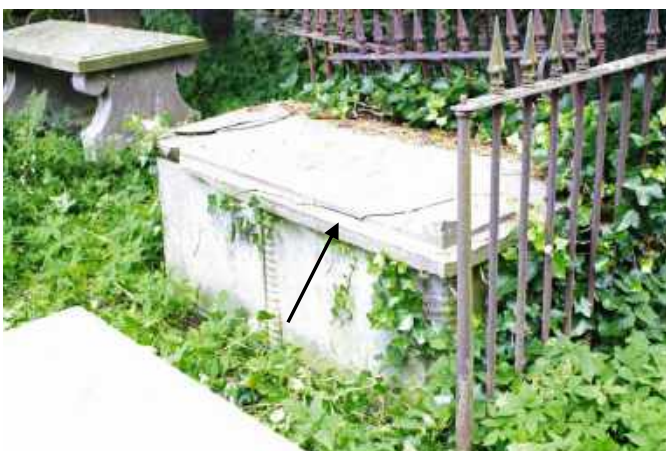
The east elevation, note the lamination in the lid, which was not caused by corroding fixings, which were in a sound condition. The lamination was caused by inherent weakness in the stone lid being exploited by weathering over a prolonged period.

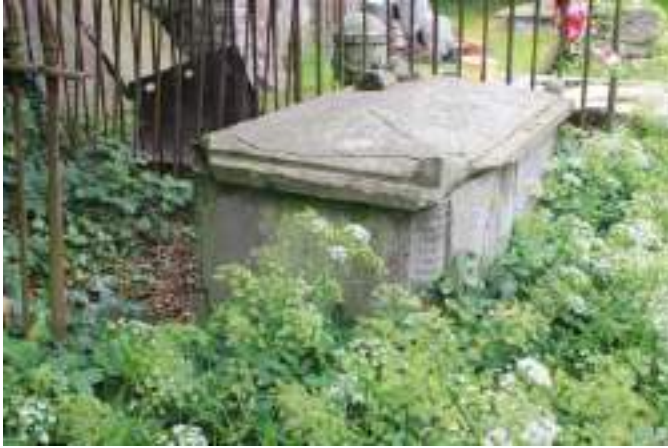
The lamination in the foreground (indicated) is where the stone has 'sprung' or deformed and is not attributable to ivy stems (of which there were none) or expanding iron fixings.

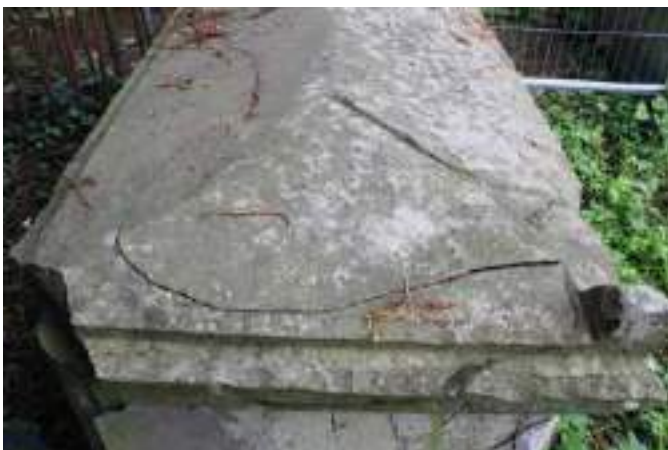
Vertical and horizontal fractures to the lid, the most significant of which follow bedding planes within the stone block. There is a shallow double-pitch to the lid meaning a lot of stone has been removed by chisel – punch, claw and flat chisels. The carving process of ‘wasting’ or removing stone will have imparted a significant amount of shock into the weak, poor-quality local material. Note how much of the outer moulding/nosing is now lost, despite searching in nearby undergrowth.

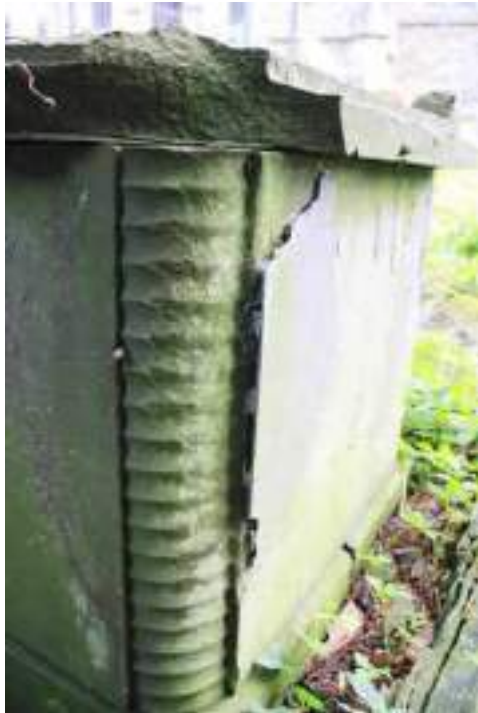
From the east elevation, the apex of the lid is more obvious. It is no coincidence that the east-end has been worked (chiselled) in two planes where the large section of stone is now detached.

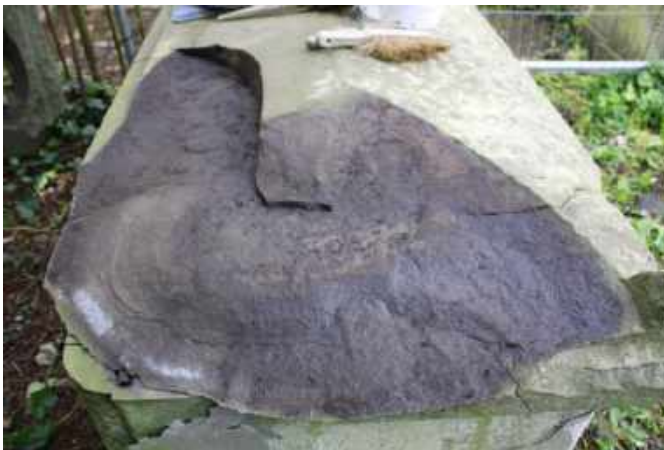
This section was loose, largely due to easy access for moisture, which exploits such laminations by repeated wetting/drying – freeze/thaw cycles. Soil debris has penetrated deep into the lamination indicating a long-standing problem for the weak building stone.

The delaminated sections were poorly bonded and therefore easily removed. All break-edges were wet-cleaned with clean water and stiff nylon bristle (nail) brushes to remove as much organic material as possible. Fragments were protected and allowed to dry thoroughly before re-bonding the extant sections.

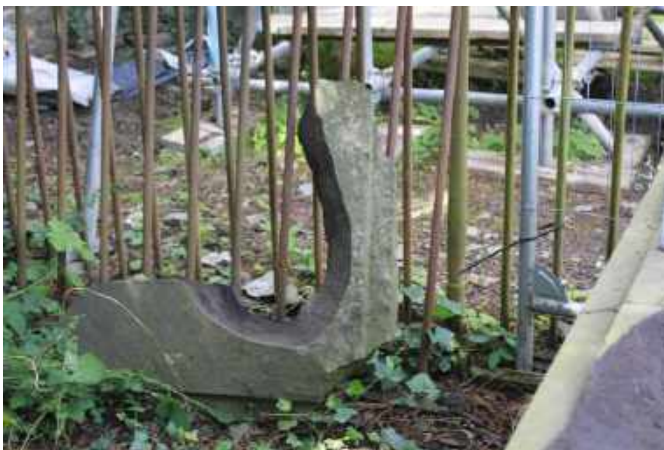
The removed fragment shows how random the delamination is in this weak material, following the bedding plane and not the worked surfaces.

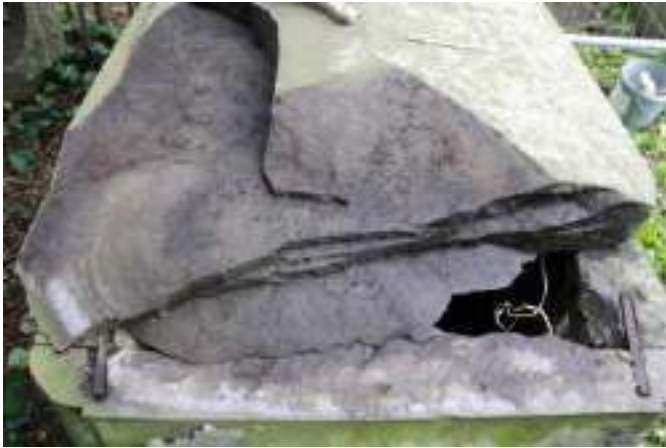
Luckily the laminations were overlapping, which makes for a much stronger long-term bond, as overlying fragments lock into place, with the aid of an external-grade resin. The hole in the bottom bed of the lid allowed sight into the core, which was largely free from plant growth and objects of any archaeological interest.

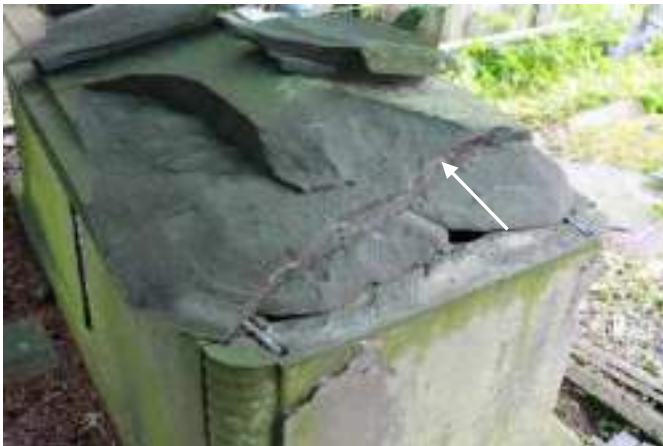
The different fragments were marked up dry and re-instated in reverse sequence to their removal. The two dog-cramps in the tomb chest beneath are just about to be secured with epoxy-resin. Note the true colour of the stone (indicated) in the parallel break edges, being a pinky-grey, not green, which is from almost complete algae colonisation.

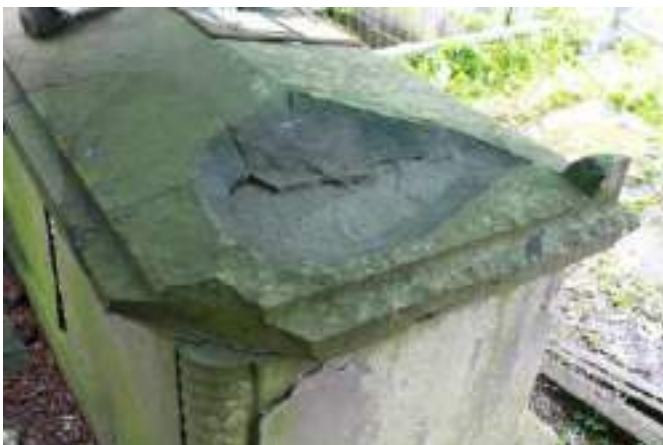
The last section of the lid about to be applied. Note the missing lower left-hand corner does not allow the lid to perform its architectural function in this area, and has been directing rainwater into the fluted corner and the adjacent section of previously loose upper surface.

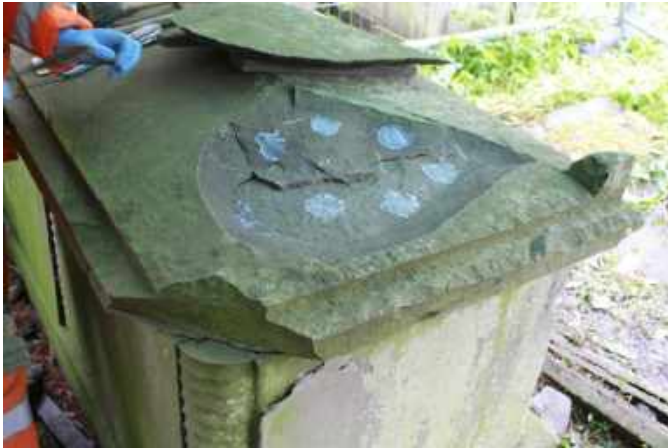
The final section about to be adhered. Again spots of resin allow the movement of moisture, which is inevitable. Despite the sections going back as well as possible there were still resultant gaps, as the breaks were old and the laminar stone had sprung.

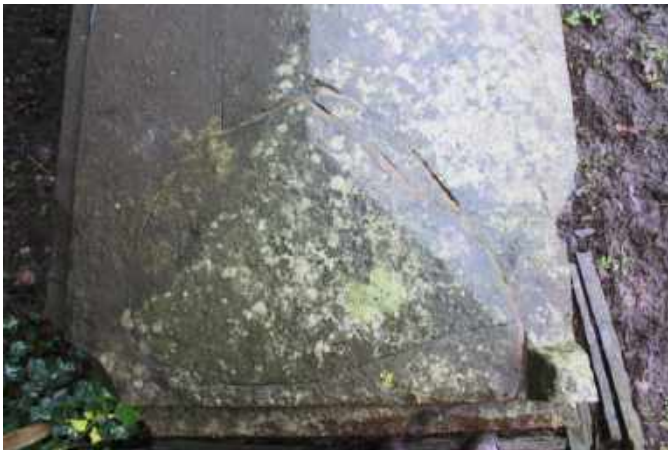
Once the resin had cured, joint lines were packed with repair mortar in small sections and allowed to harden, grout was then injected into the top of the repairs, this process was repeated until the voids were filled. This process slows-down (not prevents) the ingress of moisture, with the hard grout (liquid mortar) filling the small gaps at depth, such that rain-water cannot penetrate and freeze. The repairs were applied to prevent water pooling on their surface.

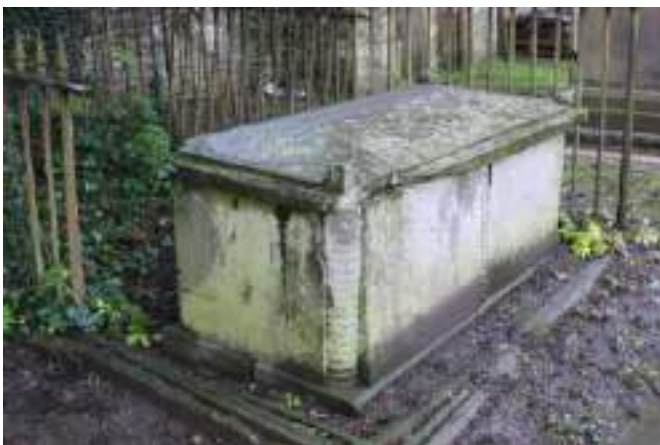
The tomb chest after all treatments. Note the kerb-set, which is the same material as the memorial and is much delaminated due to being poor-quality stone edge-bedded and expanding, corroding wrought-iron within it. Loose sections of railing had previously been removed and placed carefully within the remaining railings.

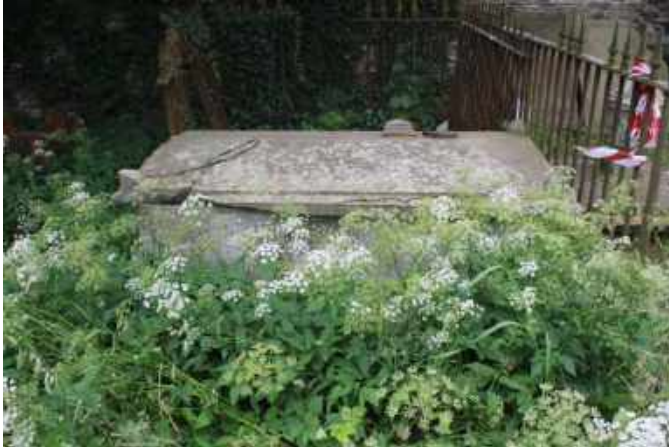
The amount of perennial growth that can occur in one growing season. This should be kept back and away from the conserved memorial. If this area has to be strimmed, it should not be against the stonework, which is vulnerable to physical damage.

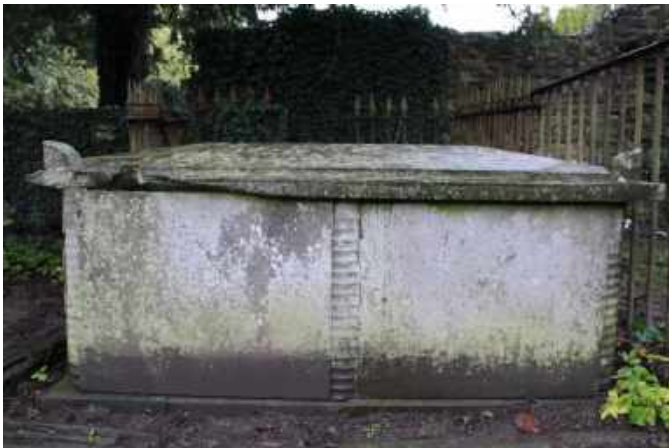
The undecorated north elevation of the tombchest covered with white/grey lichens which are particularly tenacious and difficult to remove, if you wanted to do so.

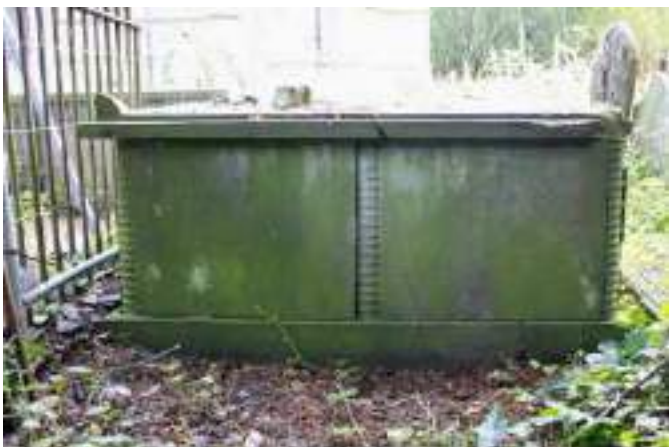
The more protected south elevation which displays the beautifully carved inscription on the viewer's left-hand panel, between the fluted colonettes. This side displays few lichens, as on the opposite elevation, but a well-established bright-green alga. This elevation was completely covered with thick ivy and bramble within the railings, keeping the little daylight available from the surface.

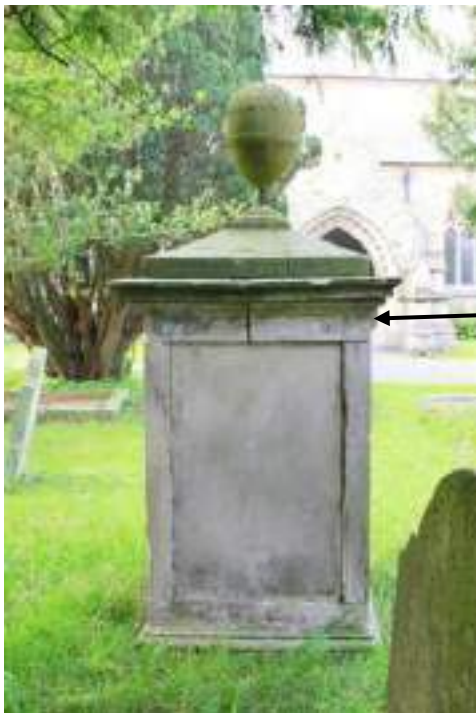
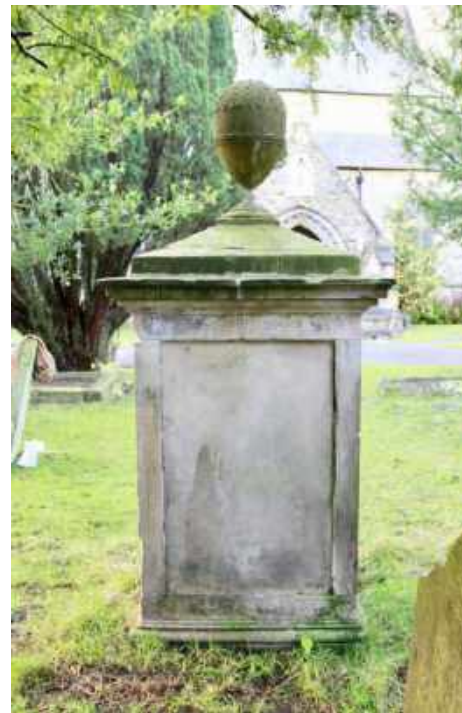
The rear, north elevation before (left) and after all treatments. Note how the moulded entablature (indicated) shows a dovetailed, vertical, central-joint, due to failed fixings - causing point-loading on the 'short' box panels beneath, at the front and back. That situation was significant on this elevation, contributing to the inside of the panel delaminating in half and being substantially weaker as a result. The resultant joints lines have all been pointed from back to front, with a fluid, gunnable mortar.

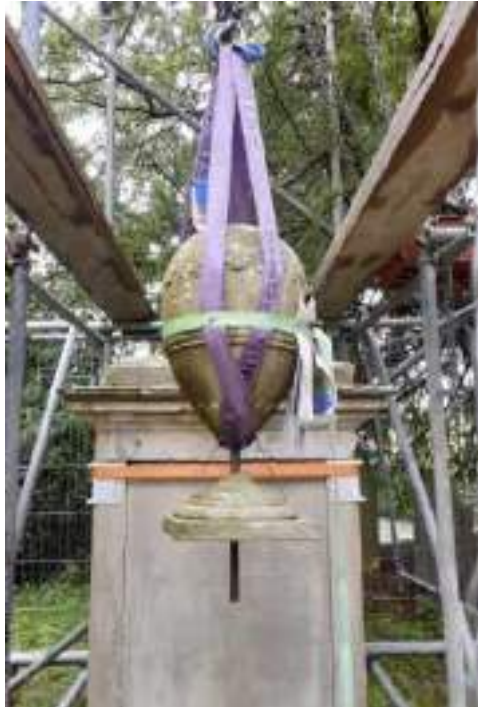
It was easier to separate the compromised sections at ground-level as well as making lifting easier. Note the section of missing neck, which was forced off at an earlier date. On the right, the underside of the expanded dowel which split the capstone. Expanding iron can exert huge forces on a strong albeit natural material.

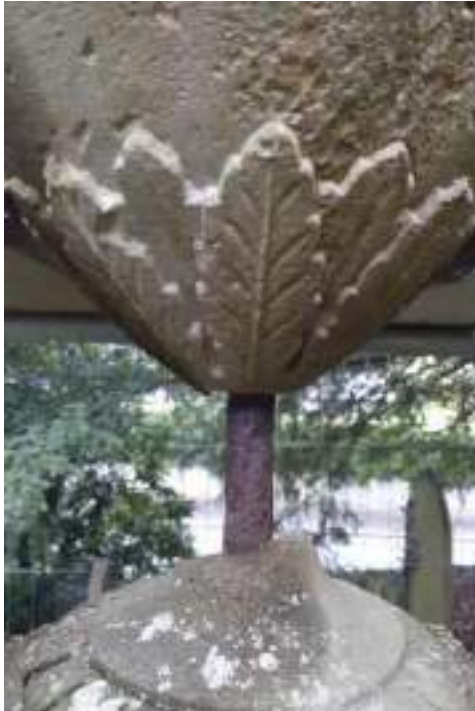
The missing section of the stone neck before dismantling. On the right, the new threaded stainless-steel dowel, secured plumb into a now deeper hole in the ball-finial with epoxy-resin. Drilling-out the corroded dowel from the ball was difficult as it had been set in with lead and there very little room between the edge of the lead and the small diameter of the carved stiff-leaf detail.

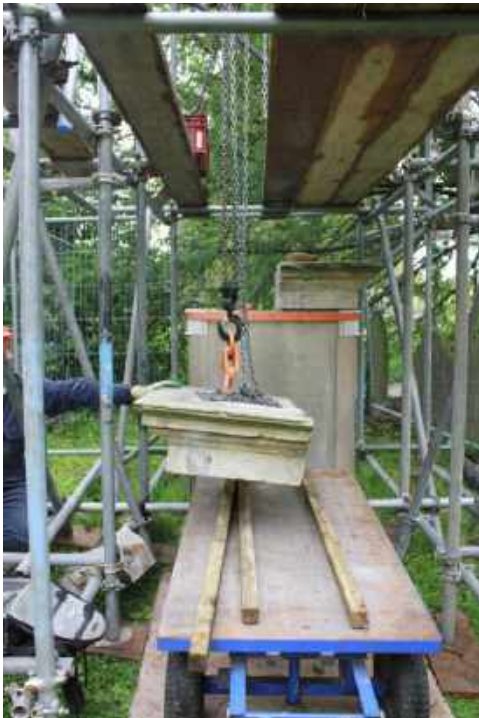
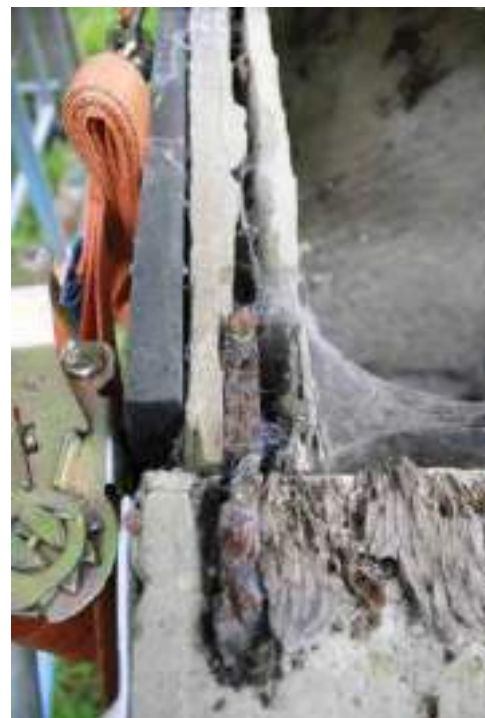
- 1.3 When the upper elements were removed for repair, the extent of jacking or movement in the corners became apparent with the 4 corner fixings extremely delaminated and now much thinner than they were originally, as the corroded material was virtually lost.

One of the heavy entablature sections being lowered down with the aid of the Lewis-pins. This made things much easier when re-building, as the heavy units could be lowered exactly into position without having to remove thick slings. On the right, one of the seriously expanded corner cramps, which had caused delamination of the already thin 'short' side-panel. The remains of several wasp nests were discovered in the by now wide joints, not in the box-tomb itself.

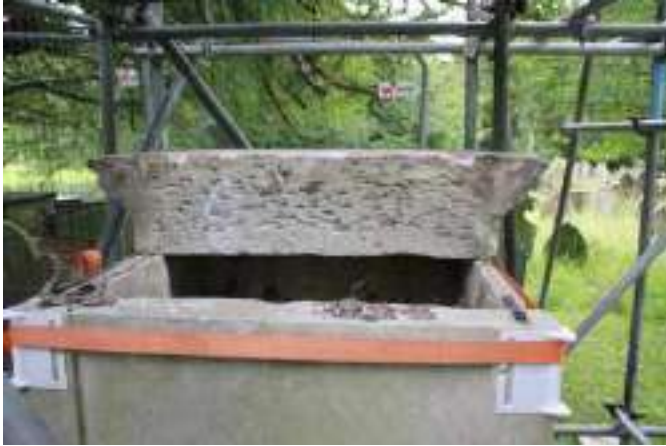
A 'punched' surface on the central joint between the two blocks. The tooling is to provide a better key for mortar, when the two blocks are butted against each other. The orange ratchet strap was necessary to prevent the 4 side panels moving once they were un-weighted as all the fixings had failed.

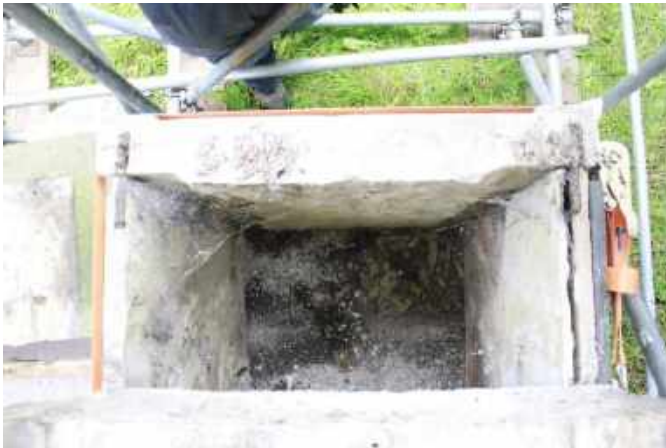
A birds-eye view inside the box-tomb. Note the north and south 'short' panels are much thinner than the thicker 'long-sides'. The lamination is in the north panel, caused by face-bedding, expanding cramp in a laminar stone and point-loading from the overlying entablature blocks.

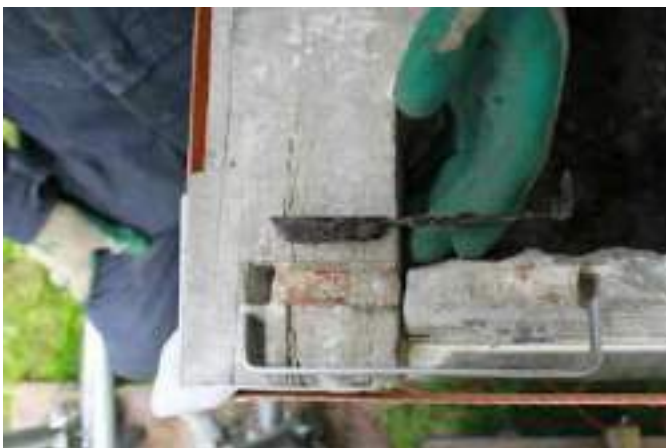
One of the corner cramps which initially had expanded, significantly - causing upward movement in the heavy entablature (jacking) and is now a thin delaminated fixing with only one, fairly useless turn-down, the other having disintegrated. The new stainless-steel cramp in the foreground. Note the laminations in the thicker stone panel follow the carved surface, with the slab being face-bedded.

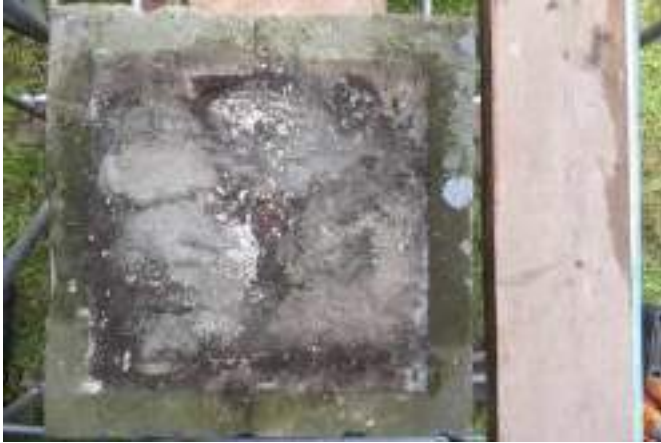
The top-bed of the entablature after removal of the capstone. Note the amount of debris in there, which is introduced by water, from defective/empty joints due to lack of maintenance.

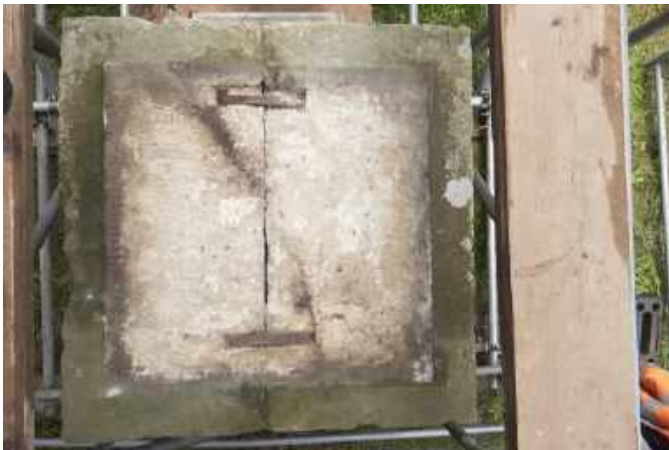
After brushing to removed defective bedding mortar and debris. The two fixings have failed, allowing the joint to collapse in on itself. It would have been better to include slate in the joint so they couldn't rotate, causing the point-loading they did, in the 'short' box-panels.

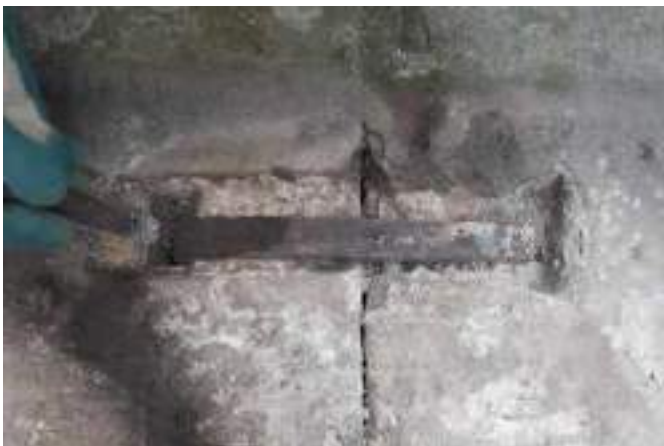
The turn-downs were filled with lime mortar, which is a soft material anyway but didn't stand a chance once excess water had got in and was allowed to sit there, due to defective pointing. The fixings were simply lifted out with a chisel. The central joint was stoned to stone and it shouldn't be. We used new stainless-steel cramps secured with epoxy-resin and lead shims in the central joint, so the blocks can't move again.

- 4.2 The two entablature sections were raised into position and wedged vertically in the centre joint, so the top-bed was flat and level again, where it had previously been forced-up at the corners, creating a large gap at the centre of the top-bed and causing point-loading on the north and south panels beneath. Lead shims (of differing stack heights) were incorporated around the top bed of the four panels to provide additional uniform support before the joint line was pointed and the mortar hardened to provide all round uniform bearing. A new pair of stainless-steel dog cramps were set-in with epoxy resin, which means the blocks can't fall inwards again, even if the lead and mortar wasn't there.

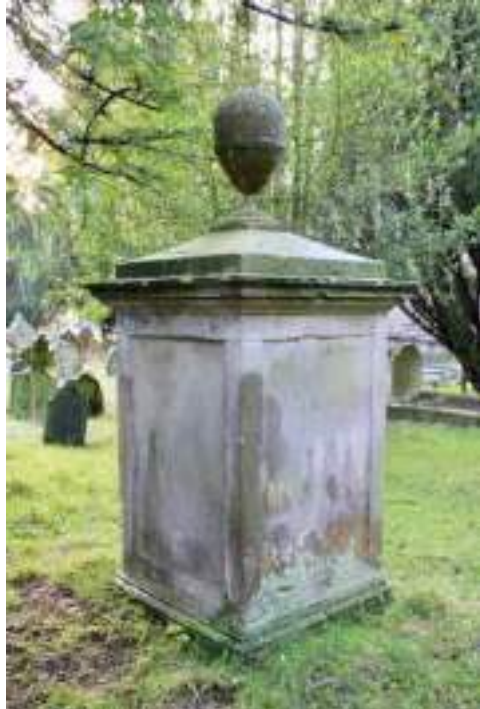
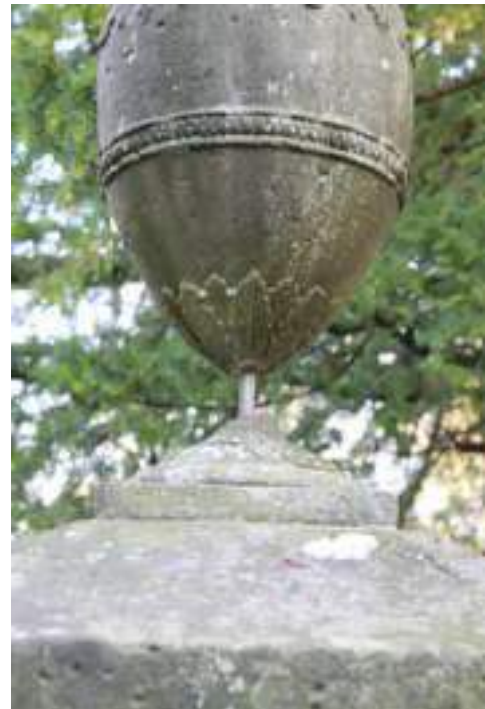
The re-built memorial after all remedial treatments. The new stainless-steel dowel was cut to give the same gap between the broken sections, as was the case before dismantling.

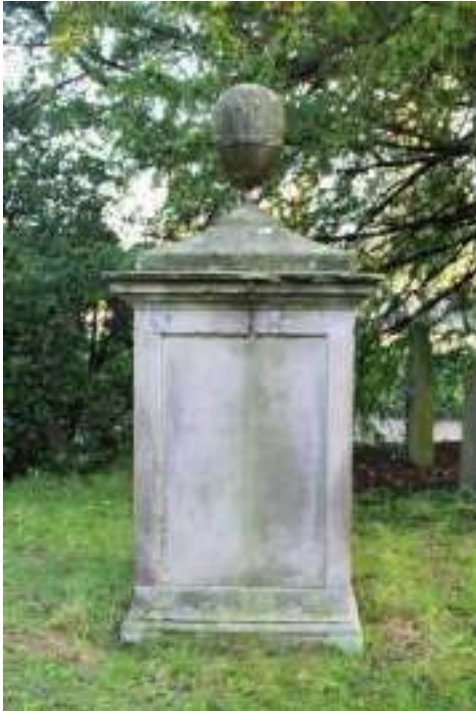
The south elevation of the memorial after all treatments and re-building has taken place. The fracture in the capstone was a natural fit and went back together tightly. Note the green colonisation already in a matter of months, on the new vertical joint in the entablature.

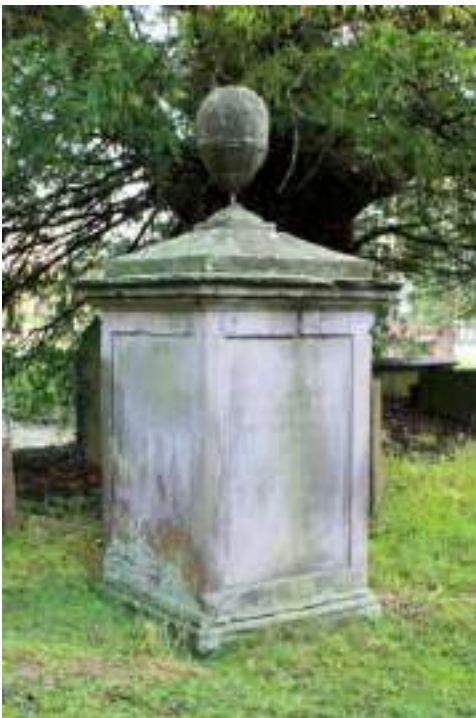
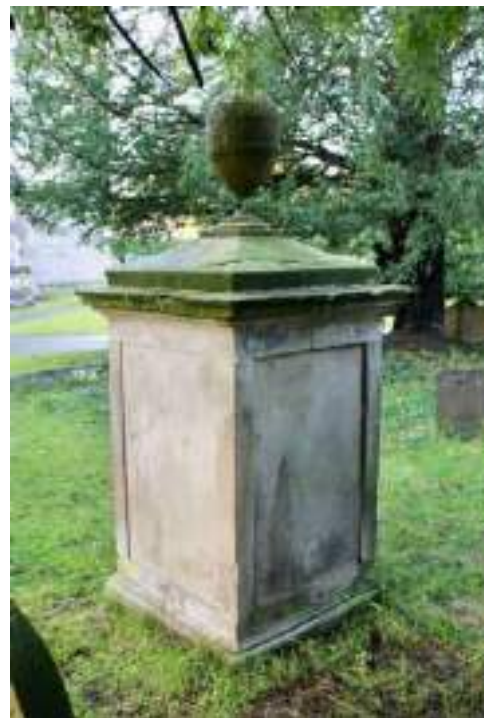
On the left, a three-quarter view of the south-west corner, looking like nothing has happened, except all the horizontal joints are now parallel and you couldn't push it over. On the right, the north-east corner shows the nearly white, new mortar (the same colour as the original mortar) is already colonised and doesn't stand out, due to the location of the memorial beneath trees and that it wasn't cleaned.

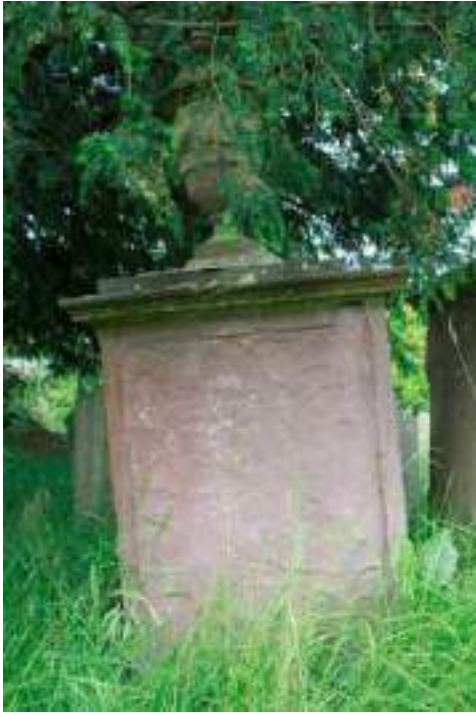
- 1.7 The composite urn on this memorial had suffered differently to that of its neighbours, with branches physically touching the upper elements of the urn-lid, which were found to be off-set and actively loose on top of the draped-urn section as a result.

The memorial before any treatments, note on the left the branches are actually touching the upper sections of the urn. This shouldn't have been happening to a listed memorial. The left image highlights the angle of subsidence, whilst the right shows the amount of the moulded plinth that is now below ground level.

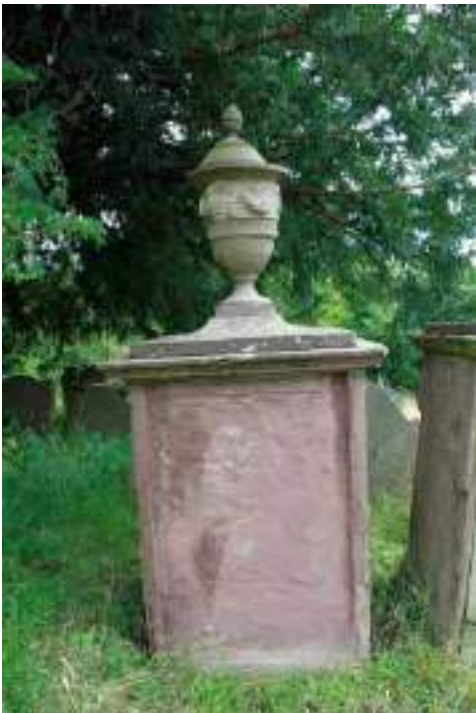
After our initial removal of over-hanging branches, showing the now off-set positioning of the upper urn sections, which were loose and could have been dislodged/damaged during high winds, with the tree moving enough. Despite the perhaps alarming stance of the memorial, the joints are parallel and tight with no signs of separation. The bed joint beneath the capstone was in a relatively sound condition.

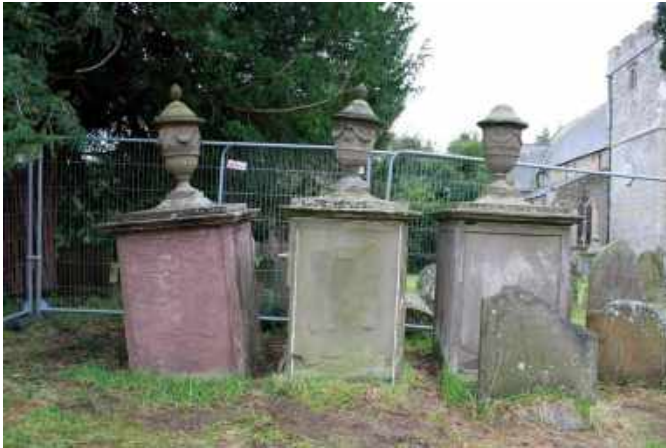
The three strikingly similar box-tombs next to one another. Note how vividly red the sandstone panels are to the Home memorial. All three memorials have been completed in this image.

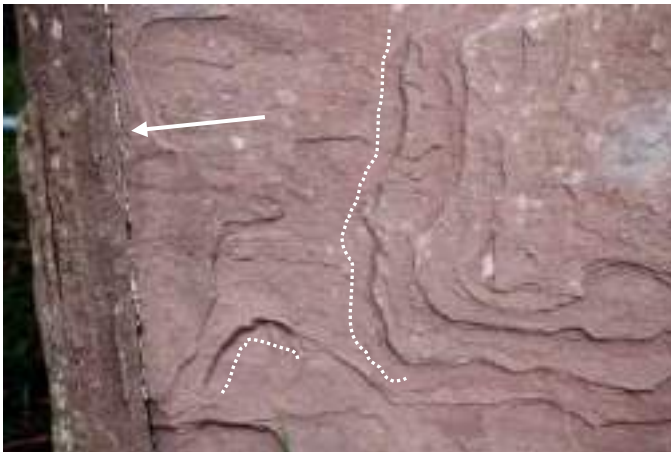
- 6.1 The stone of the side-panels in particular have suffered from extensive delamination and surface scaling/flaking. The substrate was rationalised hard previously by us to remove loose, degraded substrate beyond practicable repair, prior to emergency consolidation in the form of tacking with spots of resin. Much of the weakened flaking stone that retained moisture has been removed. The decay mechanisms present are progressive, due to the local conditions and the stone being poor-quality to start with, very little can be done to slow it down, without isolating it from its surroundings. If it were a museum object, it would have been completely dismantled, then dried and delaminating side panels deep-consolidated, to restore physical cohesion.

Classic contour scaling/delamination on one of the elevations to the memorial. The panels were all rationalised to remove loose, de-laminating areas of substrate (not upper carved surface) beyond practicable repair. Getting back to sound stone, but delamination is progressive. Note coloured support fillings applied into vulnerable edges (some indicated). And the fine, vertical, white, fat-lime joint between the adjacent 'long' panel.

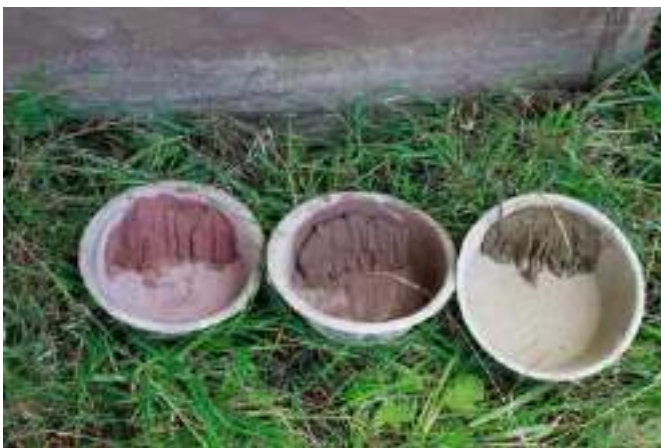
Three of the coloured Lithomix repair mortars used for support fillings, to slow-down the ingress of moisture into areas of weakness.

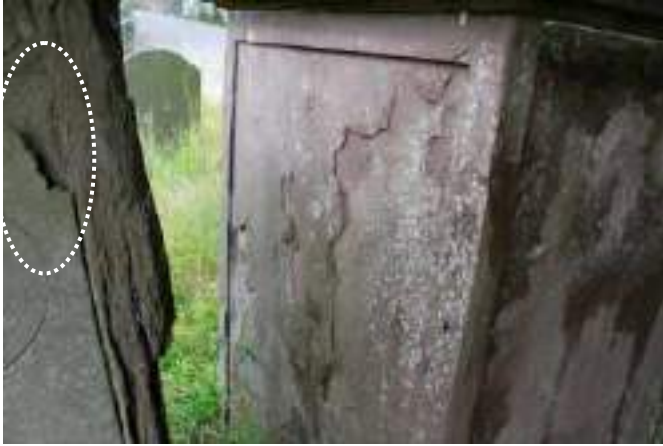
Support fillings being inserted/packed into laminating areas. The stone was so delaminated it was difficult to know where to stop. The area indicated was grouted because it can cause more damage trying to pack in repair mortar to deep voids. The corner on this memorial has suffered particularly badly as corners are points of greatest evaporation, taking harmful minerals and soluble-salts in and out of solution.

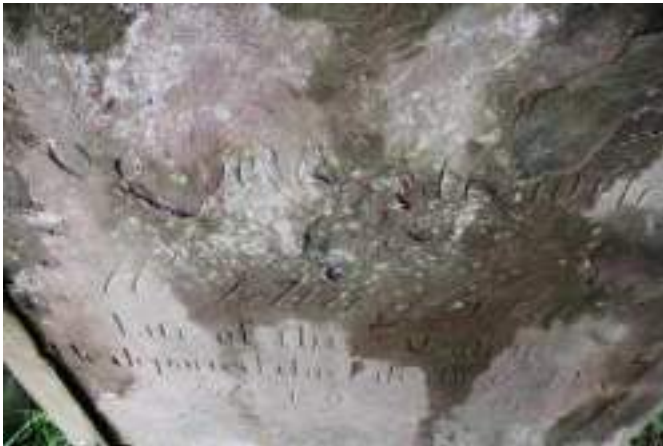
The laminations are pre-damped with water applied by brush, such that the dry stone doesn't pull the moisture from the repair mortar, which makes for a weaker eventual repair.

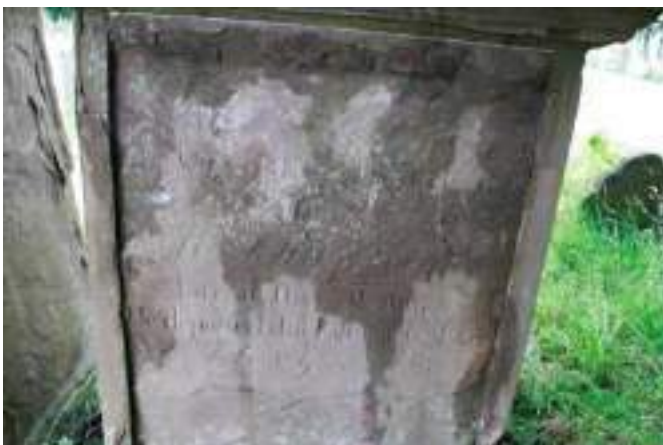
After application of the support fillings, which have to be particularly discreet visually so as not to distract from the carved decoration/dedication. This upper carved stone containing the historical information is of utmost importance culturally, but treated in the same way as the delaminating substrate.

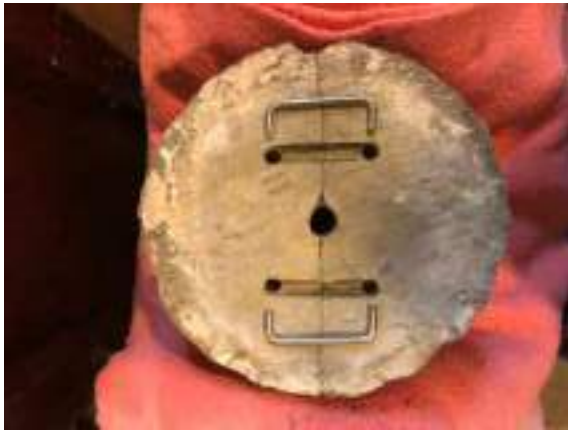
- 1.8 The diminishing fluted urn-base beneath the draped section had fractured in two, due to the expanding internal, iron-dowel. Luckily the delicately proportioned diminishing neck was intact (which could act as template in the future for the crudely repaired neighbour) despite a heavily expanded dowel passing through it and on downwards, beyond the bottom-bed of the capstone such was the length of the dowel.

The diminishing base to the urn after being re-joined and before the new cramps are secured into position, to strengthen the bond further.

- 2.4 The fractured lower section had the break edges wet-cleaned with nail-brushes and clean water and was allowed to dry inside the church over the course of a weekend. It was a tight natural fit and bonded together using Akepox 5010 an external grade epoxy-resin without aggregate extenders, which enables very thin layers to be made. When this was fully cured after 24 hours a pair of parallel holes were drilled of suitable depth and channel cut with a Dremel between the holes. A pair of 6mm diameter stainless-steel dog-cramps were fabricated and set into the slots so the fixings and resin were below the top plane of the stone. This ensured the fracture was bonded as well as possible, as it bears a large amount of combined weight.

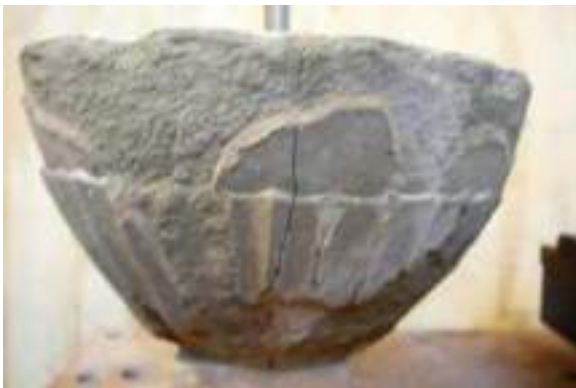
Coloured support fillings were inserted into vulnerable delaminating areas to slow down the previous rates of deterioration. The vertical break-edge on this side was not filled, as fills so thin never penetrate the break edge, and are doomed to failure as there is too little body of repair binding medium.

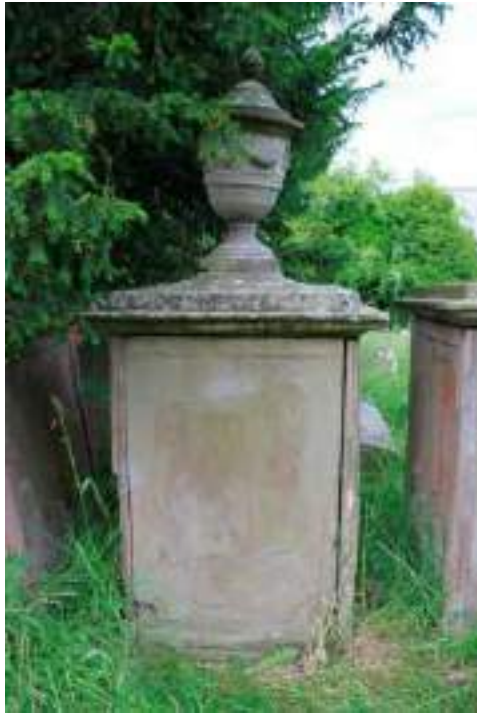
The memorial to Mary Hughes before and after all treatments. On the left, the Yew tree branches brushing the urn, prior to being pruned back. The box panel on this elevation was actively loose when the capstone and urn were lifted off. The new pointing mortar is the same colour as the original fat-lime mix.

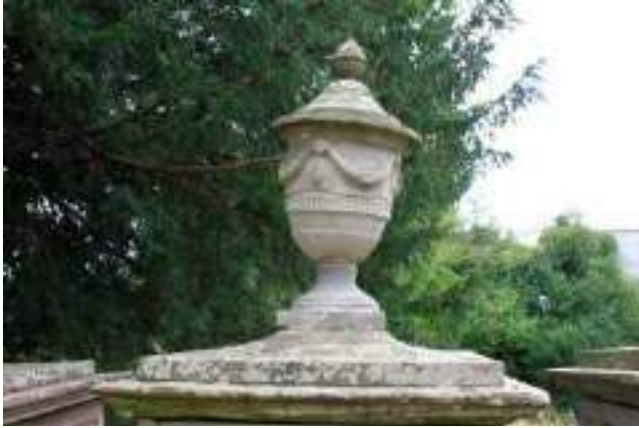
- 1.5 The composite urn on top of the capstone has suffered more than its neighbours, judging by the crude historic repair to the urn-base and neck. The base has obviously been fractured into four pieces and displays wide joints on all four elevations, leaving the urn-base sitting beyond the stooling beneath, when it should be stepped-in to form a neat rebate. The round moulding and neck have been crudely repaired with a cementitious mortar. Despite it looking unattractive and been in a material now deemed inappropriate (due to it being too hard) there were no signs of material or structural breakdown, or staining from the likely still ferrous dowelling within.

The square base and diminishing neck look nice from far but are far from nice. The base sits over the underlying stooling, where there should be a rebate in the other direction. From the lid upwards was dismantled, so these elements weren't damaged during the lifting process.

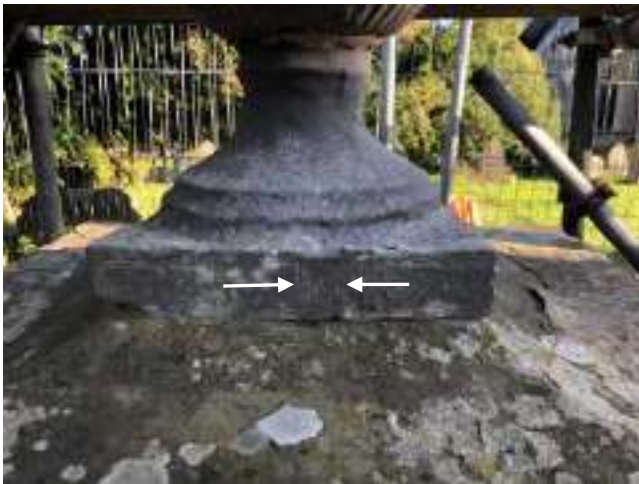
A detail of the crude cementitious repair, with a wide joint on each elevation of the base (indicated) where there should be no joint. Despite looking ugly, the repair shows no signs of iron-staining or any structural breakdown. A unanimous decision was taken in consultation with members of the DAC, not to dismantle this section and monitor its condition going forward. Note the extent of biological colonisation on the repair medium, indicating it has been there for a long time.

- 1.6 We deemed it would cause avoidable damage to the historically, repaired surfaces if we sought to remove and replace the likely iron fixing, especially in light of our experiences with the urn on the neighbouring box-tomb to William & Ann Hughes, where the dowel was nearly 400mm long. The decision to leave the urn alone was at odds with our initial assessment at time of tender, which was conveyed to the Project Manager (Mrs Harriet Carty). The PM convened a meeting with the DAC secretary and its Architectural and Archaeological Consultants - Mr Andrew Arrol and Mr Andrew Pike respectively. The issue and options raised were discussed on-site between all parties involved and the unanimous decision was taken to leave the urn un-molested and monitor its condition.

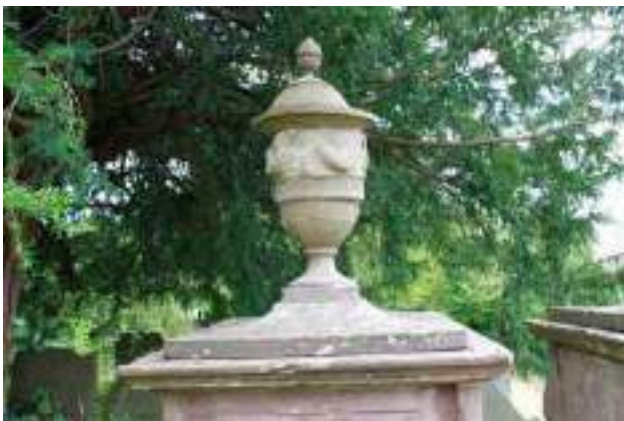
The same detail as above but stone, from the neighbouring Home memorial, which is intact despite of corroding iron. See how the square base sits within the stooling beneath.

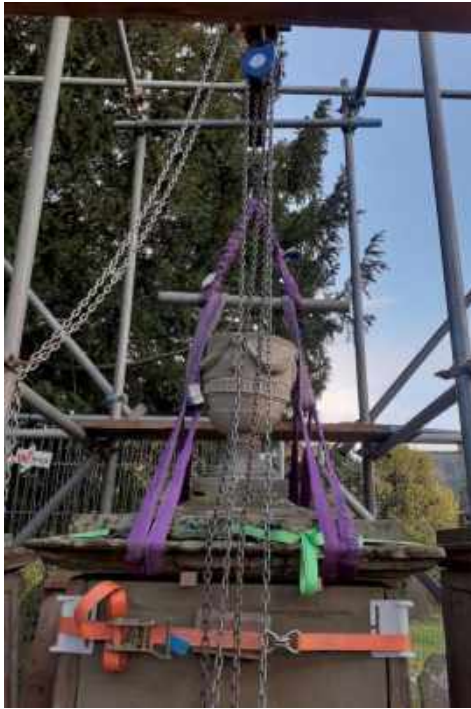
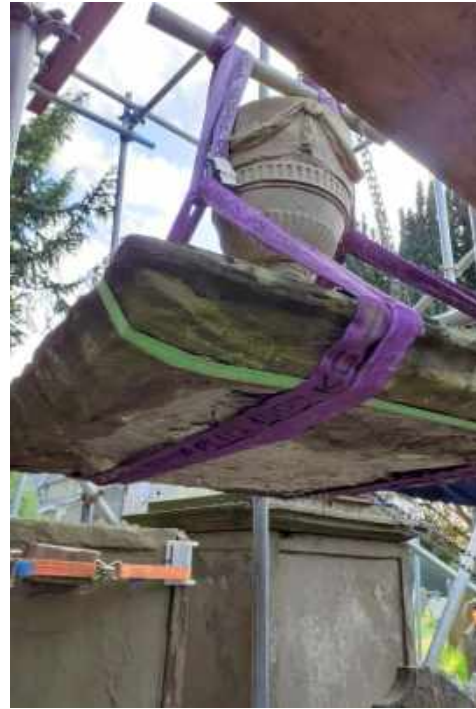
On the left, the urn-lid having been removed. A spreader bar was still required to prevent the slings pinching the weak, carved swag details. The lift was difficult as the weight of the whole urn was focused on a small footprint at the centre of the wider capstone, meaning the slings had to move inwards to overcome this. Note the rough-nature of the bottom-bed of the capstone when in mid-air.

- 2.2 The upper two sections of urn-lid were noted as being loose, due to degraded mortar and were removed and set aside safely for later re-fixing. This was fortuitous as the angle of the lifting slings (with the urn still in place) would have caused point-loading on the outer rim, even with a spreader-bar. The lift was complicated by the urn remaining insitu, creating a considerable weight focused in the centre of the square-section capstone, which could exploit any unseen/heard weaknesses, due to the lifting slings having to be positioned in, a particular distance from the outer edges to ensure a strong lift. The lift was carefully planned and executed without any surprises.
