Final Conservation Report for Churchyard Memorials

St John the Baptist Church - Bishops Castle - Shropshire

The Diocese of Hereford

Elliott Ryder Conservation

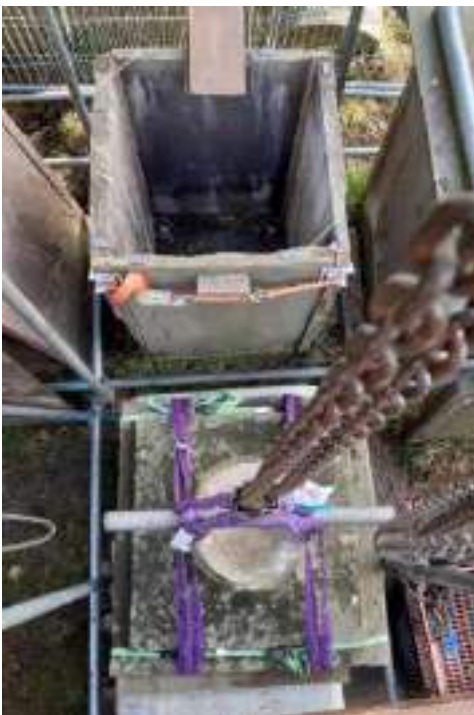
- 2.4 After removal of the capstone it became clear the four iron-cramps at the corners were providing no restraint, as they had either failed or were delaminated. Despite the restraining ratchet strap the west elevation panel was actively loose. The fixings were easily removed with chisels and the sockets removed of dead-metal whilst deepened to provide additional support. Fortunately there were no side studs in the centres of the panels, which we had been expecting after the previous memorial. The sockets and channels were enlarged to receive new stainless-steel fixings which were fabricated next to the memorial.

When the capstone was removed the stone panel in the foreground, closest to the chain, moved forward against the ratchet-strap. If the strap hadn't been there it would likely have fallen against the capstone being lowered. On the right, the inside of the box-tomb after the internal mitres have been removed of defective mortar and new mortar packed in, to increase rigidity and prevent moisture entering the structure. There was no plant-growth of any kind in either of the partially dismantled box-chests.

- 3.3 Once the box-tomb was secure with the new fixings, the internal mitres inside the box were removed of old, degraded mortar. The vertical joints were then dampened with water and coarse bedding-mortar packed deep into the wide joints to give more rigidity, provide something against which to point against from the front and ensure a water-proof joint at depth.

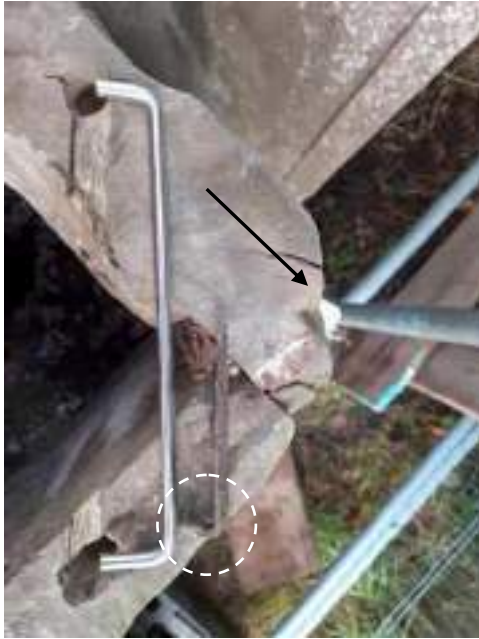
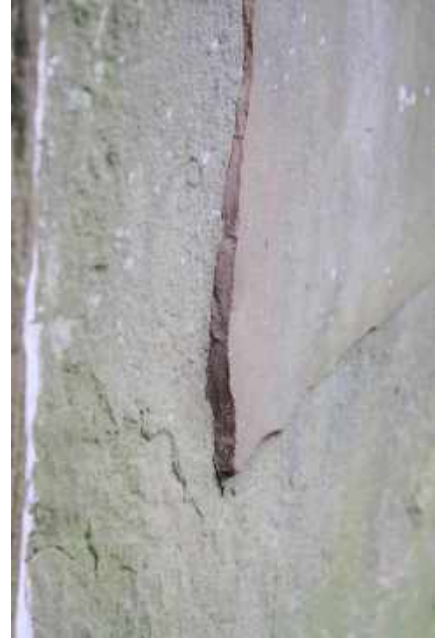
On the left, the remains of a laminated iron-cramp. One of the turn-downs is now missing but had forced off the outer corner due to its expansion. Note how small the remaining turn-down is (indicated) and the depth of the new stainless-steel turn-downs, with holes drilled deeper. As the corner was lost a new socket was created diagonally across the mitre, so that the cramp wouldn't be seen. On the right, one of the laminations filled partially with a coloured support filling then grouted before more filling, protecting the smooth, carved upper-surface to the right.

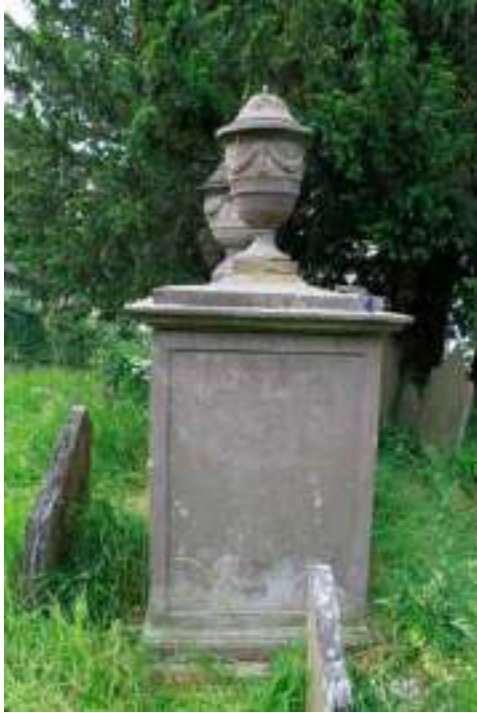
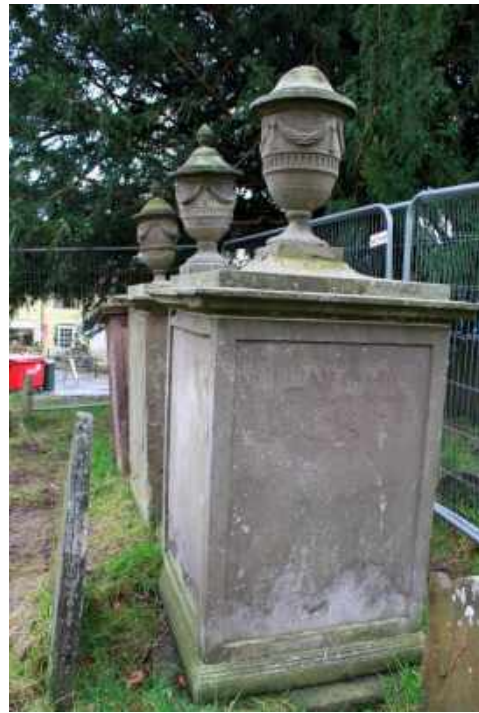
The south elevation of the memorial to William & Ann Hughes before and after all treatments. Note the parallel joint between the capstone and the box-panels, pointed on the right image. The shallow, moulded plinth and sub-base is just visible through the grass on this elevation.

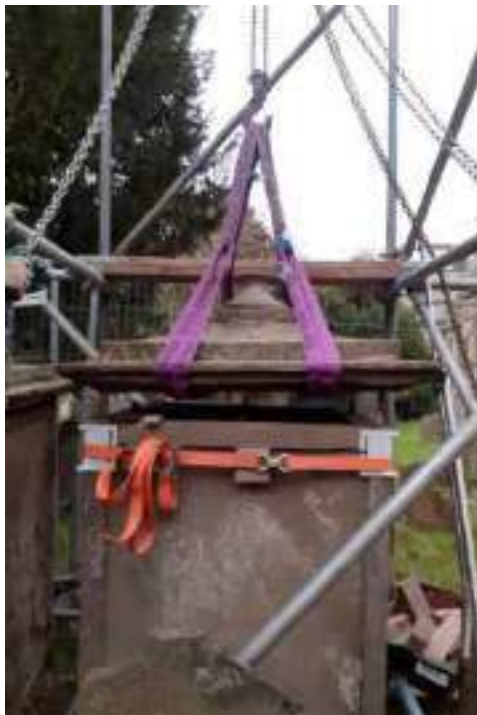
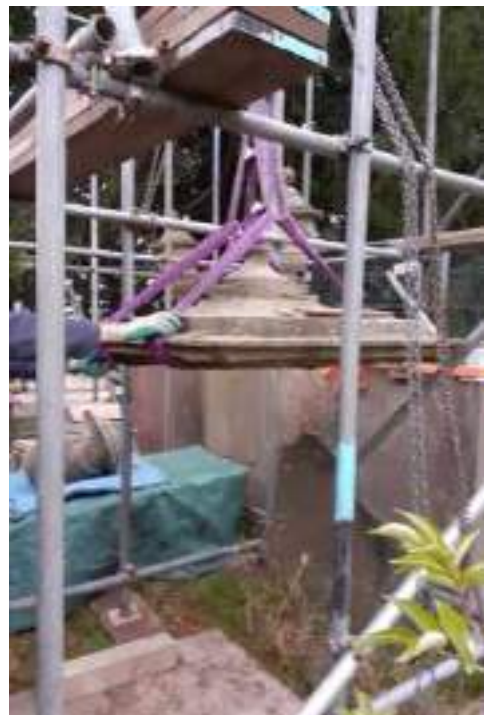
- 4.1 During dismantling, the bottom-bed of the capstone was observed not to be flat side to side, with only the outer edges or margins worked flat and a raised, 'punched' surface in between. Stacks of lead shims were applied on the top-bed of the side-panels to the required joint thickness. A layer of coarse bedding mortar was applied at the pre-dampened rear of the panels, to the same approximate height as the lead.

Once the urn was removed, which was also lifted using the block and tackle given its combined weight, the capstone and urn-base was raised slightly, moved horizontally on the girder-trolley before lowering onto the turn-table truck below and away from the area of work. Note the very uneven nature of the bottom-bed of the capstone, with the surface having a rough 'punched' finish from the workshop.

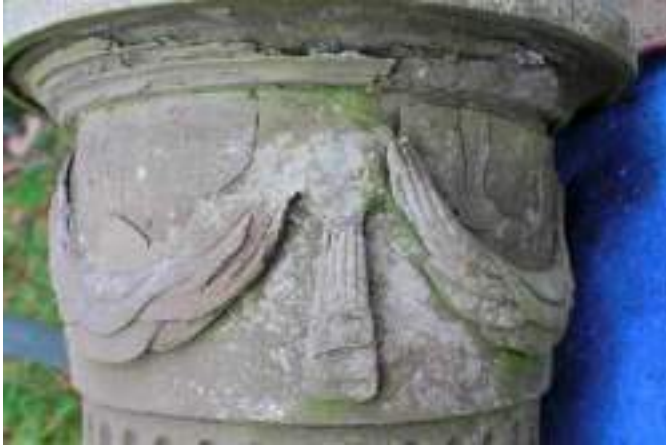
The poor condition of the urn showing laminations concentrated around the moulded and high-relief carved areas. The stone obviously takes carving well given the sharp detail, but weathers poorly, something the masons of that period were probably unaware of. Note the resin behind the laminations carried out as part of the emergency consolidation, in advance of surface filling.

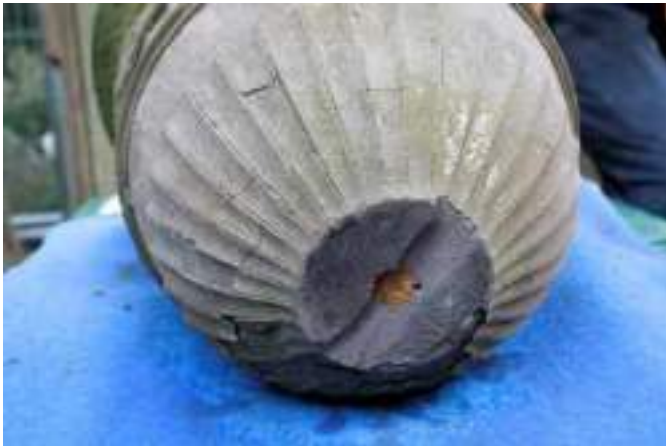
The dowel in the bottom bed of the urn, which had expanded to fill the hole and fortunately was not that deep. We lengthened the hole to give deeper embedment for the new stainless-steel fixing. Note the laminations (following sedimentary bedding planes) horizontally through the fluted decoration.

- 2.4 The dowel in the urn had been set-in with molten lead and luckily wasn't drilled that deep into the urn-base. This was eventually released by drilling around the perimeter of the fixing. As there was very little embedment, the hole was deepened to receive the new, threaded stainless-steel dowel and ensure a stronger long-term fixing.

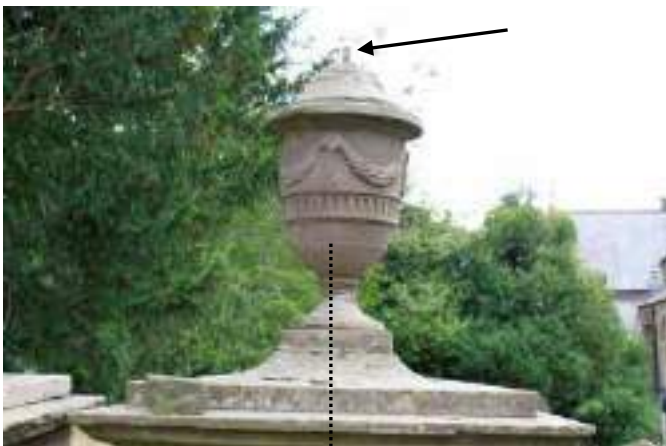
- 2.3 The dowel had to be removed from the stone urn-neck, by drilling around the perimeter of the expanded iron. The dowel extended vertically all the way through the neck, on past the bottom-bed of the capstone. This required our longest, small diameter drill-bit, to drill around half the perimeter of the dowel before it was released. The iron had expanded into the historic drill-hole, but luckily hadn't fractured the urn-neck or capstone as witnessed on other memorials.

The urn before its removal. Note the thin, stone neck remained intact despite having to drill a series of holes around the perimeter of the embedded iron dowel to release it, which was over 50cm long. The hole in the urn was extended to below the horizontal fluted decoration, to make it more solid. The iron dowel from the lid (indicated) was removed and resultant void filled with repair mortar.

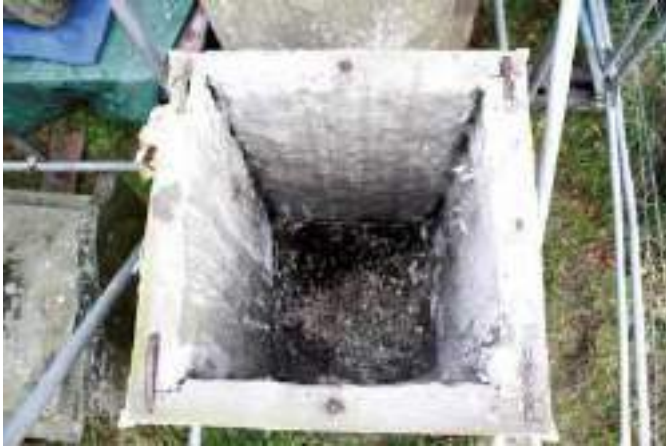
The top-bed of the box-tomb, showing the much more substantial fixings at the corners. Threaded locating studs lead into position were also incorporated in the top bed, making this memorial seem much more sturdy – that is until the iron starts delaminating and expanding, causing structural issues. There were no plant growths inside this box-tomb.

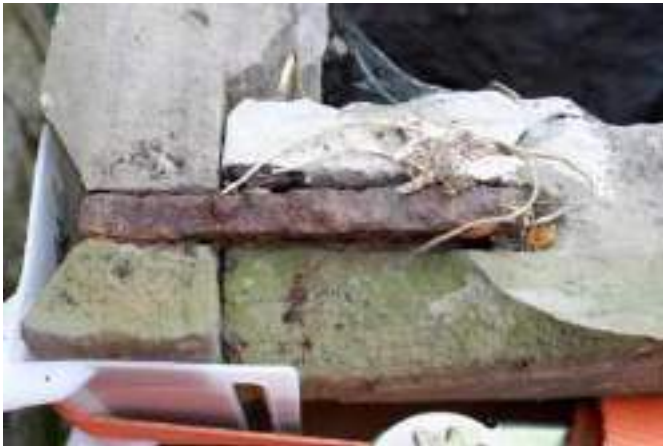
This cramp from above, has forced off stone on two elevations and raised upwards, forcing the capstone up. The broken stone has been long gone judging by the biological growths on the break edge, in the foreground.

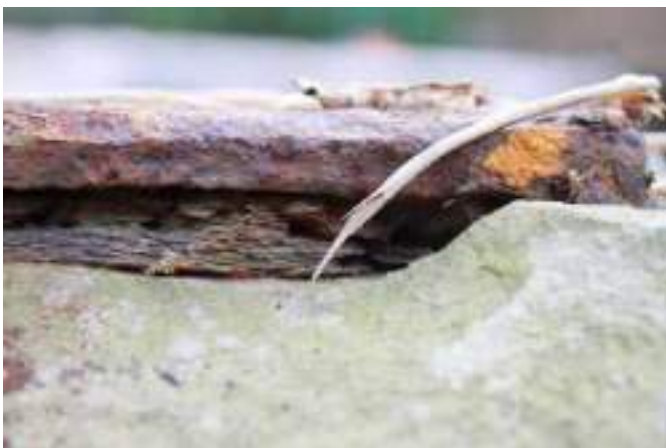
The same iron-cramp from the front. As the corrosion product slowly formed the large increase in volume has raised the fixing upwards. The smoother surfaces would have had the same flaky appearance but have detached once exposed to the elements, when the stone was forced off.

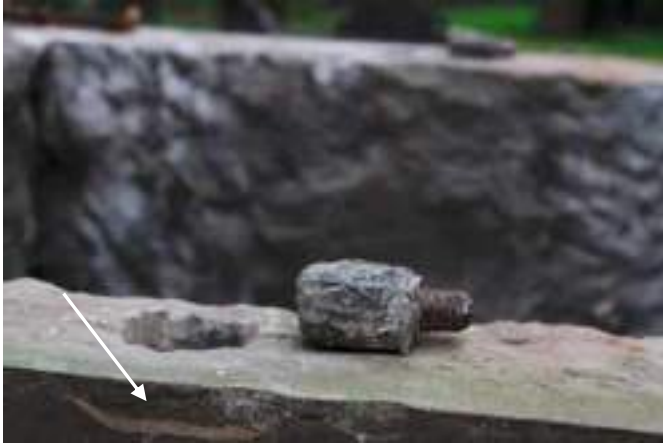
One of the threaded iron locating lugs, which we didn't see in any of the other memorials dismantled. There was one in the centre of each elevation and weren't replaced, as there was no need for them. A support filling can just be seen beneath the hole for the stud (indicated).

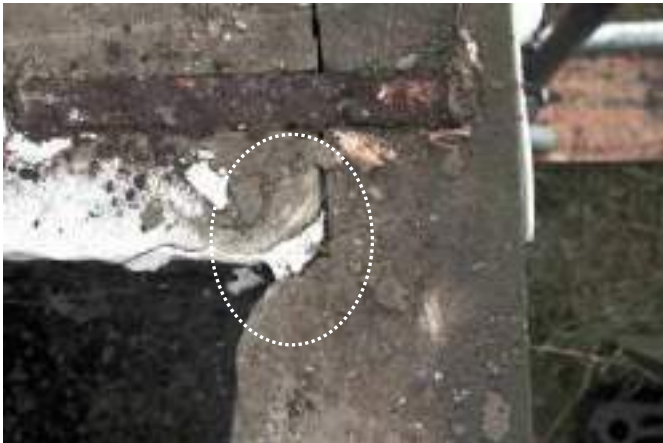
Another corroding fixing that has corroded to fill the sockets and joining channel, with corrosion product on its top surface. All the fixings were set in with mortar. Note the internal mitres have been filled (indicated) with the same fat-lime, pointing mortar. This was all removed and replaced with new mortar to provide additional support.

- 3.3 Once the box-tomb was secure the internal mitres inside the box were removed of old, degraded mortar. The vertical joints were then dampened with water and coarse bedding-mortar packed deep into the wide joints to give more rigidity, provide something against which to point against from the front and ensure a water-proof joint at depth.

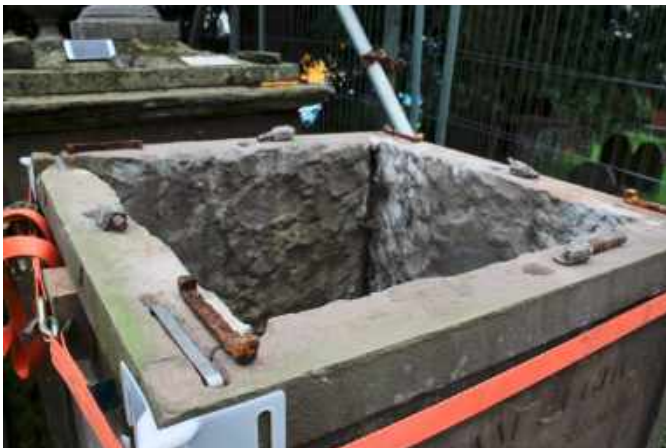
The top bed of the box-tomb showing all the iron fixings and locating bolts removed and new stainless-steel cramps about to be secured into position with epoxy-resin. This box was of much sturdier construction compared the memorial to Mary Hughes. The four slabs were much thicker and the fixings of a bigger scale to start with.

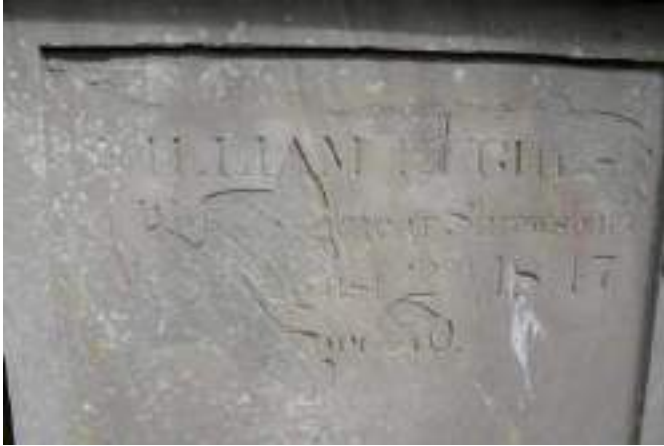
The dedication to William Hughes on the south elevation prior to any treatments. The stone is face-bedded and delaminating and risks losing even more carved detail. The sinking which is beneath the now raised border has undergone additional tooling to make it flat, then smooth and then the surface is lettered with the dedication. All these processes impart significant percussive-shock, creating micro-fissures in this poor quality stone.

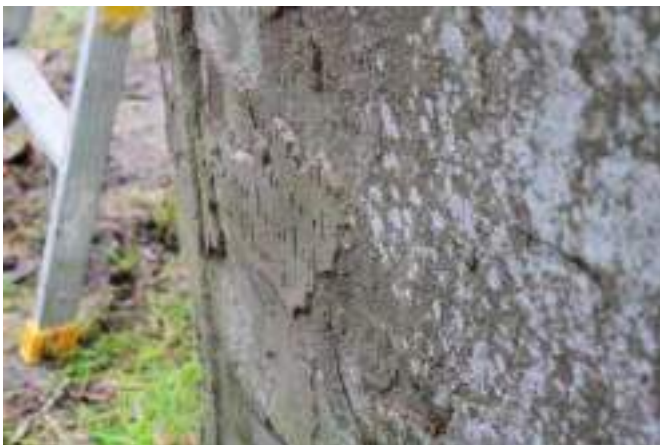
An island of surviving upper carved detail which was filled and grouted to prevent entry points for water and slow down the rate of deterioration. The stone on this elevation is so weak due to its lithology. You can see the depth of the substrate that has been lost, making the island of surviving stone all the more remarkable. Note the extent of white lichens to the right of the surviving inscription.

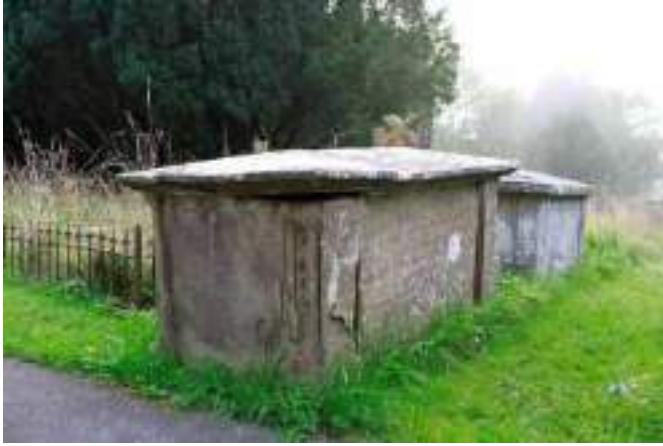
- 1.1 The tomb-chest was in an extremely unstable condition having sunk into the ground at an alarming angle at the west elevation closest to the path. The stone of this memorial, is the same poor-quality, laminar stone type to the majority in this project. Stone elements displayed significant delamination and loss of material, with individual blocks much thinner in scale and the lid being too thin for its length again.

The memorial to William Powell before any treatments. Note the plinths proximity to the path, the degree of subsidence in the foreground, disruption/misalignment of the lid corner and delamination in the pilaster beneath that corner.

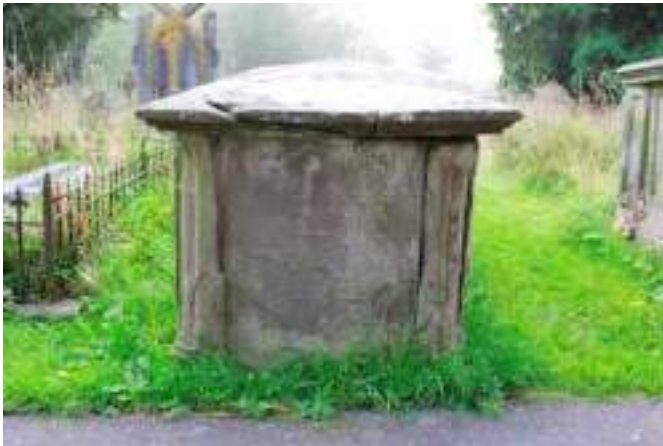
The west elevation of the memorial, highlighting subsidence in two planes east – west and north – south. The laminations in the lid can be seen more clearly in this image, largely attributable to the level of deformation witnessed in the underlying tomb chest.

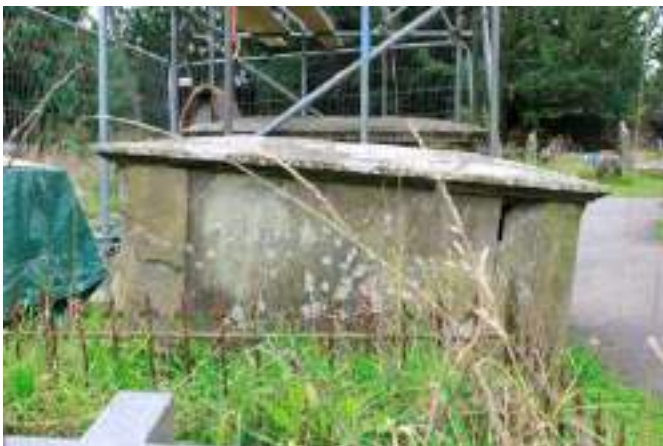
The north elevation of the memorial highlighting the extent of subsidence and the proximity of the path. The iron railings in the foreground are more or less level across their top.

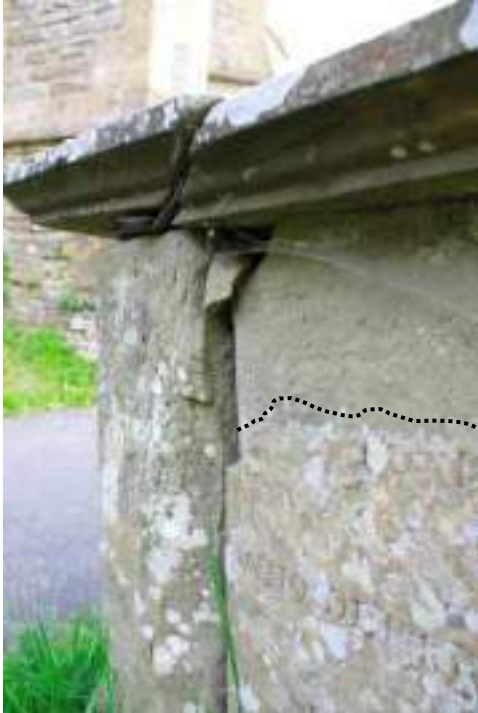
On the left, the south-west corner shows a transverse fracture through the lid and the extent of material loss to the main dedication panel, with the top quarter now lost horizontally, the exposed substrate is very fragile and displays extensive flaking. On the right, the north-east corner, carved detail is completely lost from the curved corner block.

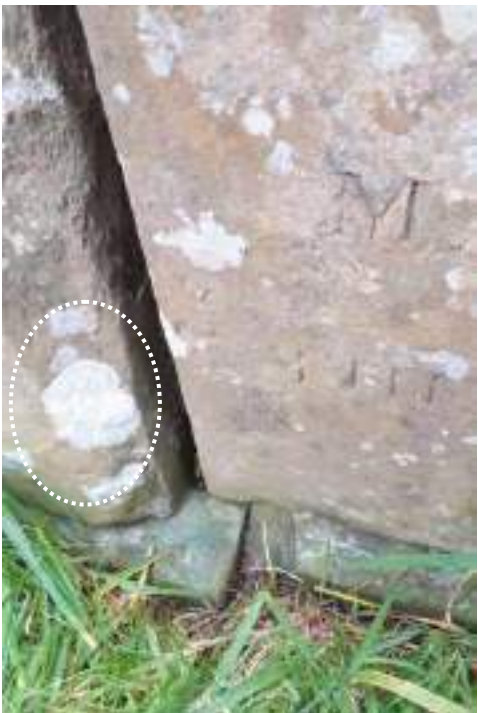
The south-west corner on the left isn't just a wide joint. The left-hand corner block should have a rebate which sits over the dedication panel, but is long-gone. The island of aged, white lichen where the carved detail has been lost and rounded stone indicates this has been missing for a long time. The right image highlights the extent of delamination and flaking to this poor-quality, laminar stone.

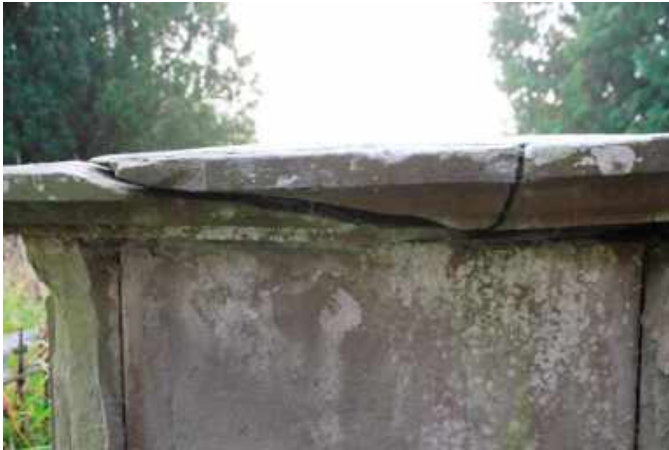
The transverse fracture is inherent within the laminar stone; the vertical fracture is a result of point-loading. Note the vertical joints in the tomb chest are still largely parallel, indicating the tomb chest is subsiding as a whole.

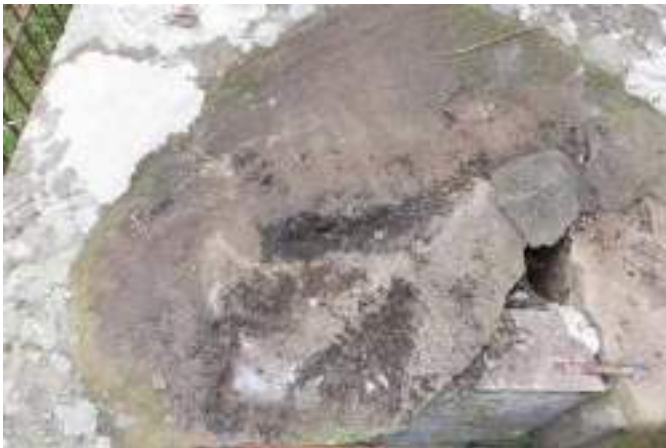
The remains of debris from within the lamination, indicating it has been allowing the ingress of moisture for a prolonged period. Fortunately the different layers are overlapping making for a stronger bond, when adhering the fragments in stages.

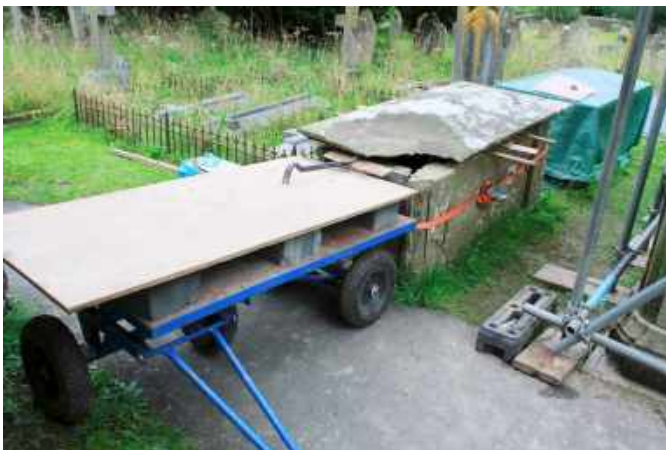
The remains of the lid being rolled off the tomb chest, after the fragments have been moved for storage. Because of other inherent weaknesses still in the slab it was not up to lifting, which risked pulling it apart. The slab was successfully moved off and back on without compromising the existing geological faults.

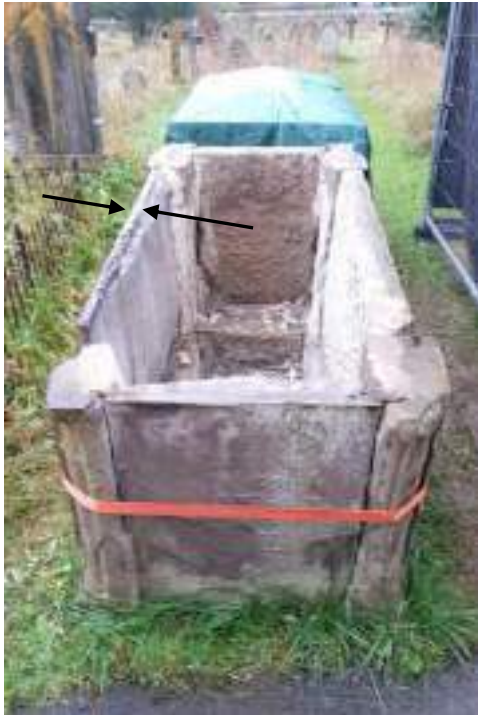
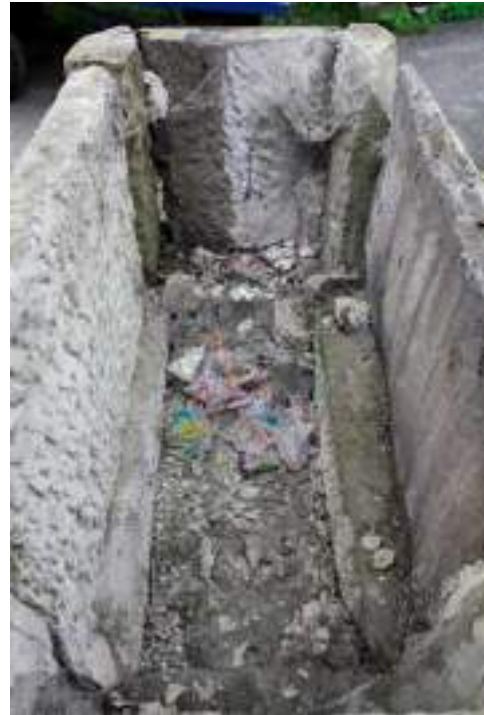
The tomb chest once the lid was removed. On the left, note the thin nature of the bedding surface (indicated) the rear of which slopes away, leaving only 10-15mm of bearing. On the right, detritus on the inside of the chest. The west elevation, 'short' side shows where (white) liquid plaster has been poured in historically, in a vain attempt at consolidation.

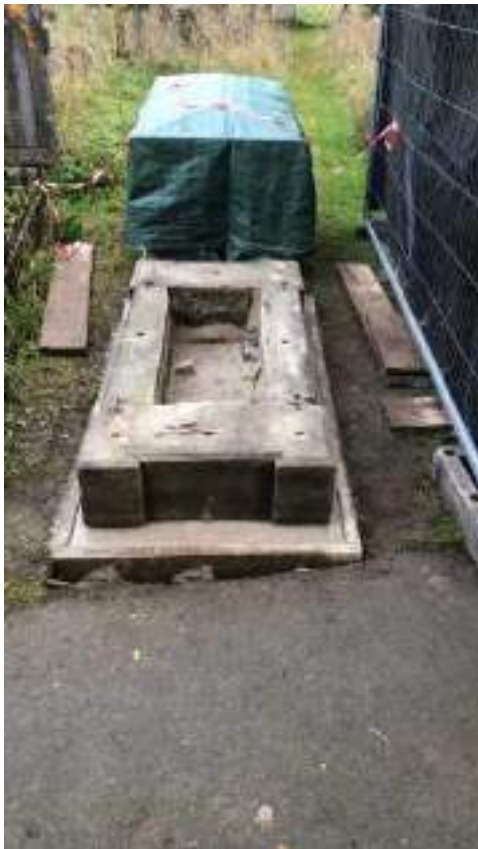
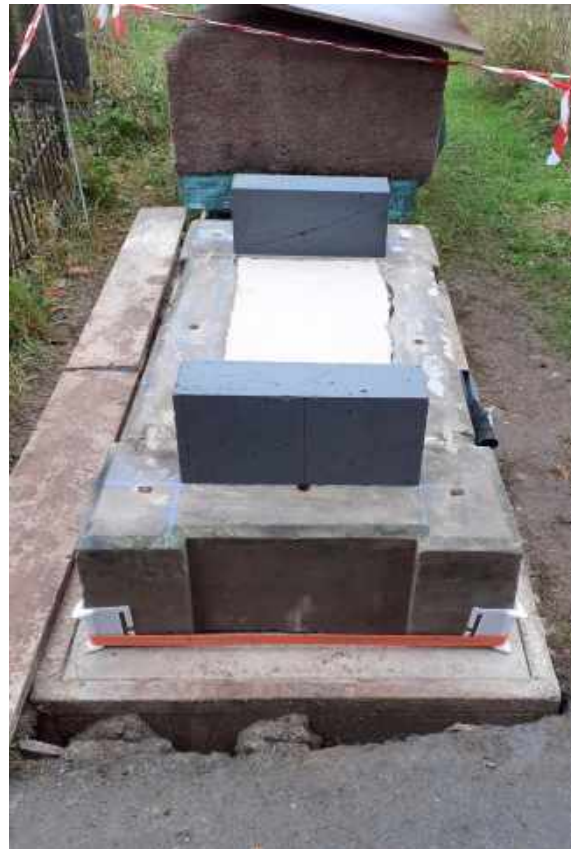
On the left the new re-enforced sub-base in position with the plinth blocks having been bedded into position. On the right, the void within the plinth has been filled with Limecrete, on top of a Visqueen DPM/separation layer. Celcon blocks being laid to create a supporting internal core.

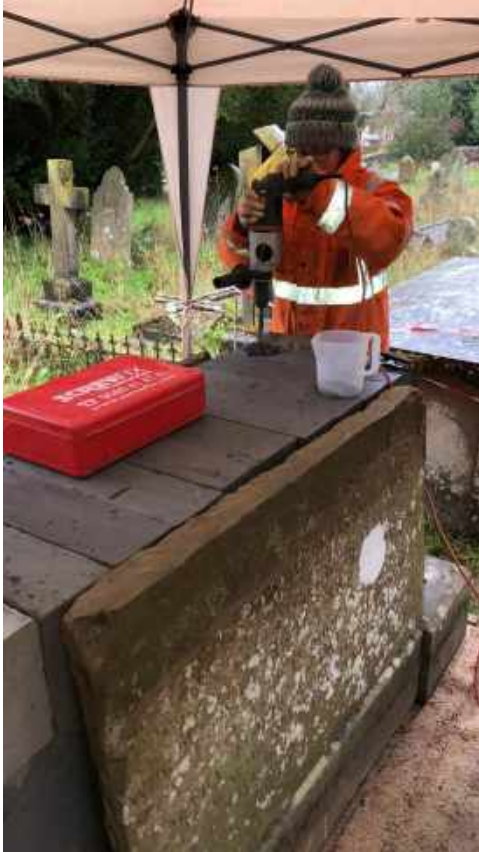
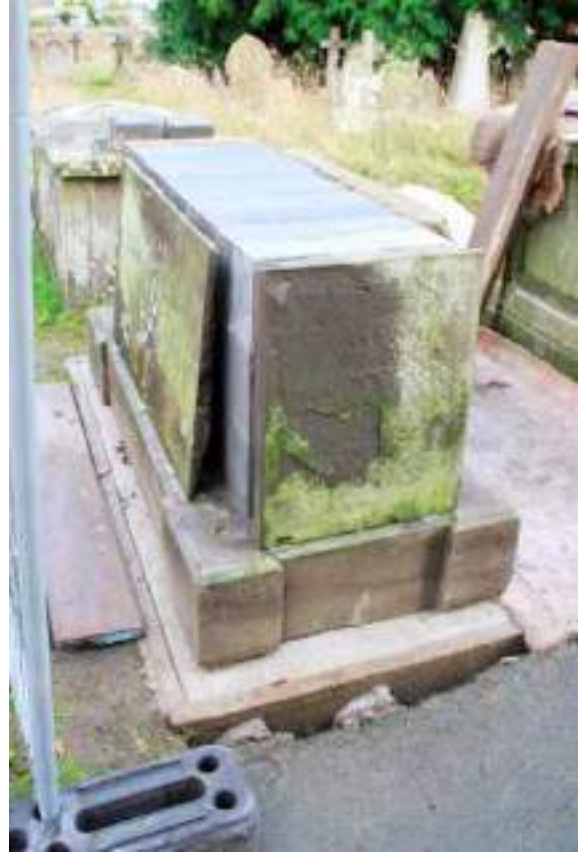
The top outer blocks at either end, had long dowels secured with gunnable epoxy-resin, deep into the course beneath, such that the two opposing blocks could not be pulled outwards by the slabs being restrained. The central fixings on the long panels were in the same block, so were pulling against one another. On the left, the top quarter of the panel has been lost through delamination, with an angled support filling inserted along the length of the vulnerable edge.

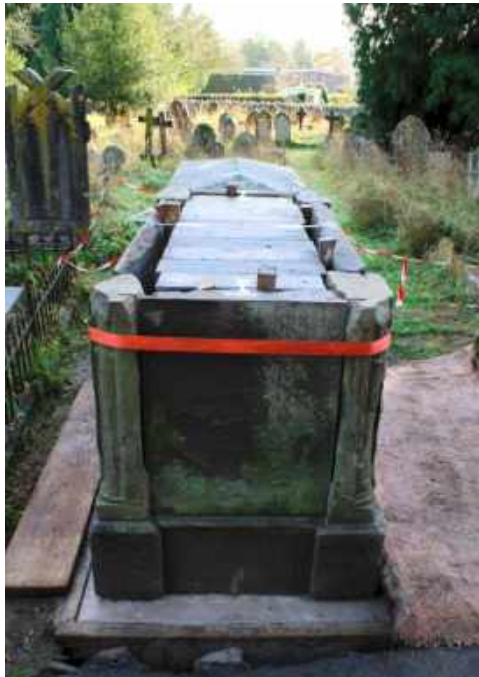
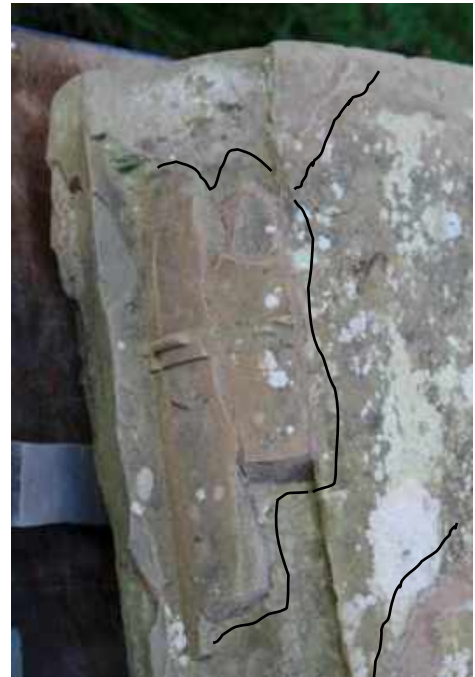
On the left, all restraint fixings are in place and stone elements are kept plumb with wedges and a ratchet-strap, whilst the epoxy-resin cures. On the right, one of the corner blocks displaying the extent of loss of carved detail and coloured support fillings to protect edges, previously tacked with epoxy-resin (by us) to prevent further loss.

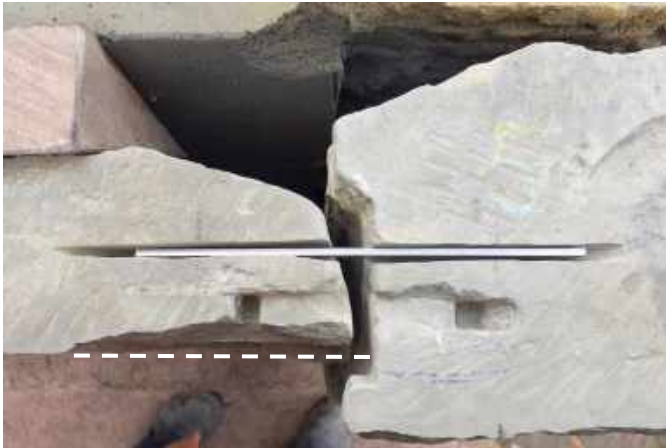
A new stainless-steel fixing to replace the thin-section clamp, which would have been visible due to the loss of material (indicated). These were all secured with an external-grade epoxy-resin.

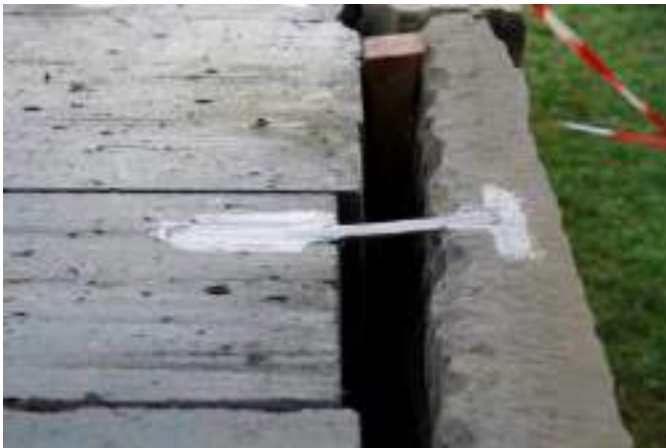
A restraint fixing in one of the 'long' panels. The core was built slightly higher than the tombchest panels, such that it bore the weight of the restored lid and not the fragile side panels. A thin layer of mortar was applied to the top-bed of the panels at their rear, so there was something to point against, with the gunnable pointing mortar.

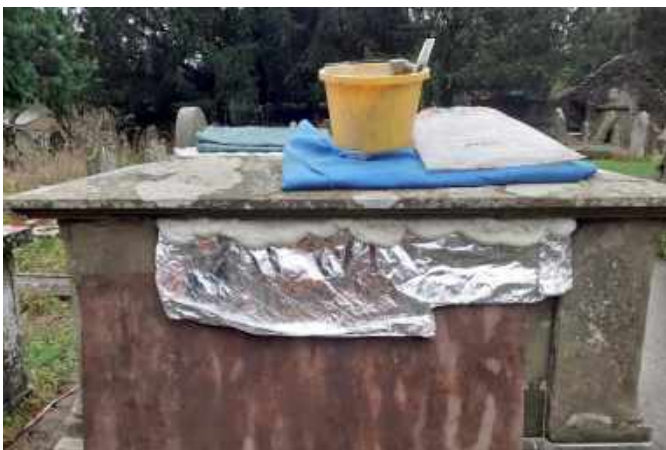
On the north elevation the 'long' panel was so thin on the top bed, with a void behind back to the core. Because of this there was nothing to point against and so a pocket was created using expanding epoxy foam. The tin-foil and timber is to stop any foam coming into contact with the stone. When it had cured it was cut back to create a solid backing against which to apply the initially fluid pointing mortar.

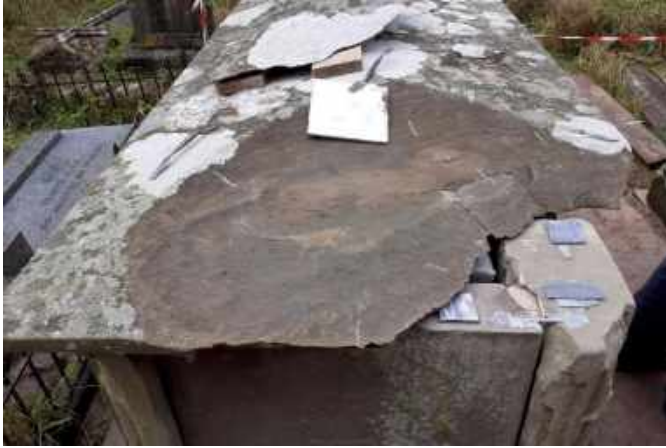
The cleaned lid, marked out dry where sections would sit and where to apply spots of epoxy to ensure the strongest bond. Note stacks of lead-shims on the tomb chest panels, which was easier than applying mortar and taking the sections on and off, which could have been messy and caused lime-staining.

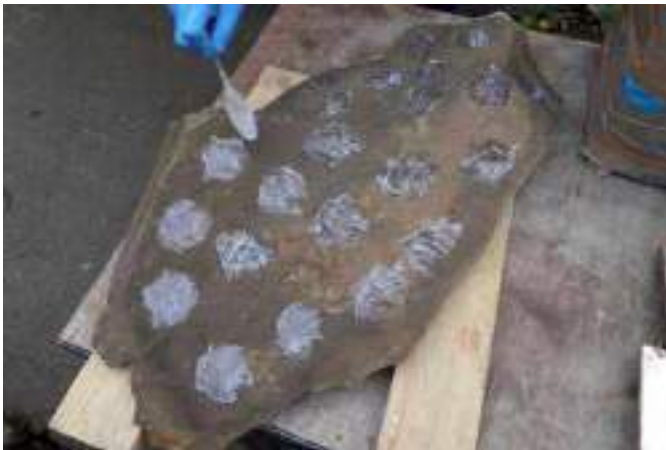
Resin is applied one side, the fragment applied to see where the corresponding spots will be on the lid, then the fragment is removed, with resin applied evenly to both faces. This gives a much stronger long-term bond than merely applying resin to one face only. Note resin is kept well back from break-edges.

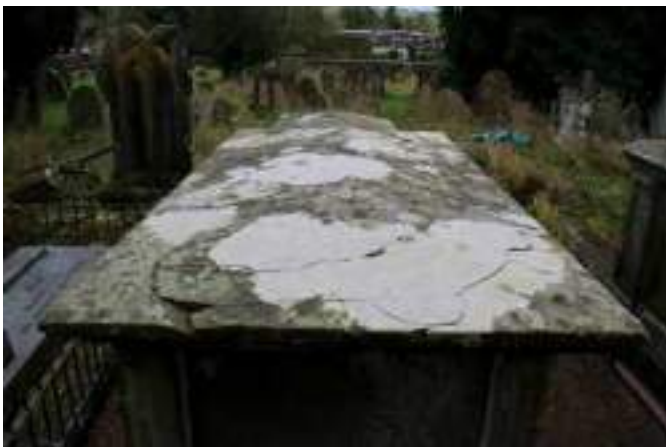
The fragments locked together in a natural, tight-fit after they had been removed of all organic material. It is hoped the extensive, aged white lichen will cover over the laminations eventually, sealing the moisture entry points. These lines were not filled as they are doomed to failure in such proximity to thick lichens, which secrete weak organic acid.

- 6.11 Spots of resin were used to secure the fragments and produce a strong long-term bond. The large island of thick white lichen precluded the use of a support filling which would have failed, as repair mortar does not bond to lichen material and the poly-saccharides from the lichen at such close quarters would weaken it almost immediately. Free-flowing liquid grout was introduced into the very fine joint lines which had minimal penetration, indicating the join is very tight and water percolation won't be such an issue. The joint lines that are there are diagonal, meaning any water that does penetrate will migrate through the lamination. Using spots of resin as opposed to a solid layer ensures moisture in gas, liquid, vapour phases can move freely through the porous stone. The hydrophobic lichen is likely to grow over the surface fissure and prevent the ingress of moisture in the short-medium term.

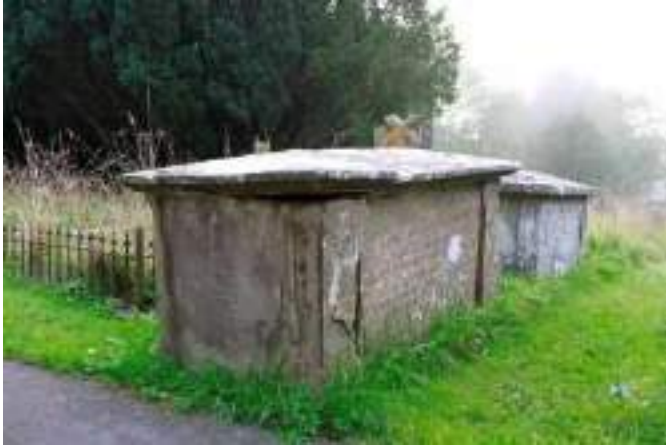
The Powell memorial before any treatments. Note the proximity of the grass around its perimeter, which obscures the plinth. In this image water would be running down the path and transferred into the plinth, which was saturated, being below ground-level.

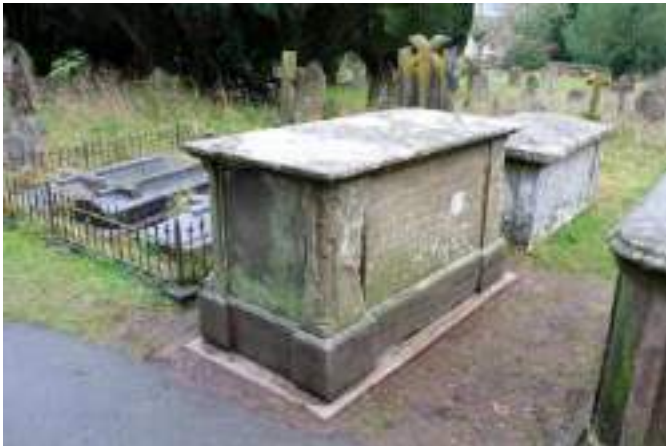
The memorial after nearly all treatments. The joint between the concrete sub-base and bottom bed of the plinth has yet to be pointed with a traditional mortar, such is the level of undulation, due to roughly shaped not worked blocks, which would have contributed initially to less than perfect transfer of weight. The plinth is well-bedded just not surface pointed.

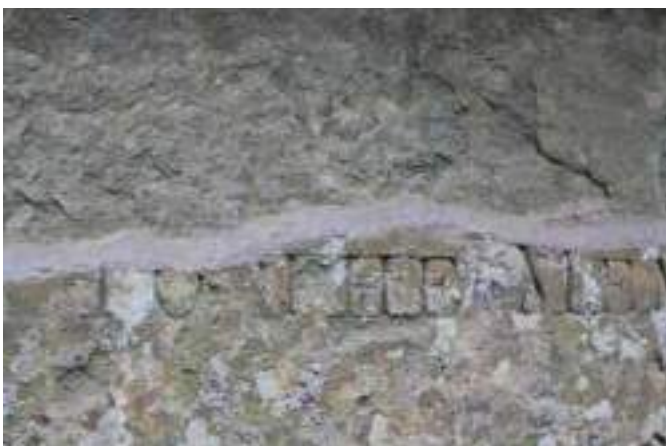
The coloured support filling (that is dry due to being covered) which ran nearly the entire length of the south long panel, to protect the carved upper-surface below, which contained the dedication. Note the poor condition of the flaking substrate above, the loosest stone and other areas beyond practicable repair were rationalised to prevent loss and retention of excess water.

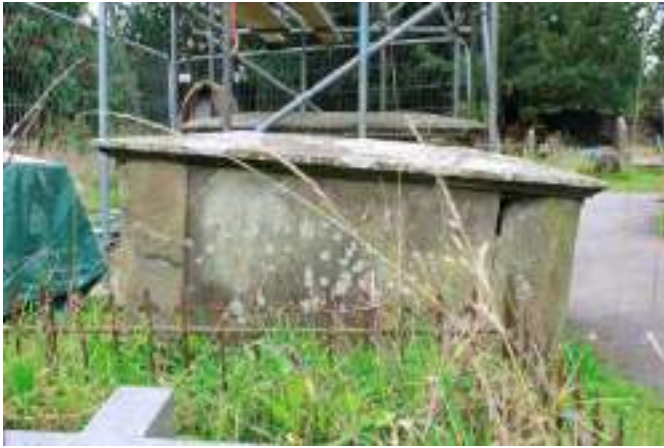
The extent of subsidence prior to dismantling. Note again the proximity of the nearby path and adjacent railings.

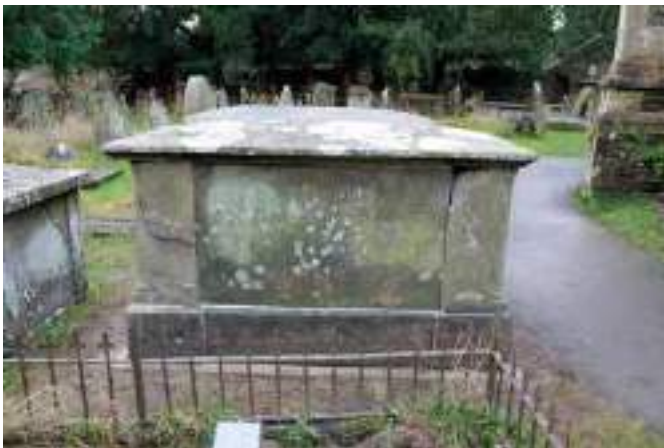
The memorial after nearly all treatments. Note the concrete sub-base is just below ground level and the path but the void between both is filled with free-draining aggregate, which will prevent water pooling in this location. The plinth will dry slowly in time, having been below ground-level for so long.

- 9.2 The tarmac path will continue to direct rainwater toward the west elevation of the plinth. The aggregate spanning between the path and the plinth should be monitored to see if it gets silted-up in the medium-term. If it does it should be replaced with something similarly free-draining such that saturated soil does not sit against the stone of the plinth and cause damage from frost. That situation is likely to be a long way off.
- 9.3 Elliott Ryder Conservation will monitor the condition of the memorial (free of charge) and the appearance of any ivy near the plinth after twelve months, as part of our on-going maintenance commitment, and report back to the PCC with any findings.

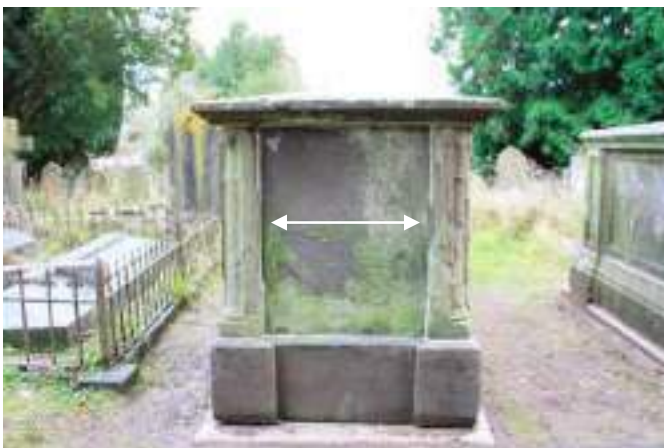
The west elevation of the memorial showing the relation between the neighbouring kerb set/railings and Griffiths memorial to the right. The gap between the two memorials is a mown path and we didn't want to create a trip-hazard on the corners of either sub-base. Note the inner mouldings or rebates on the two, rounded corner-blocks (indicated) is largely missing and why the joints look so wide.

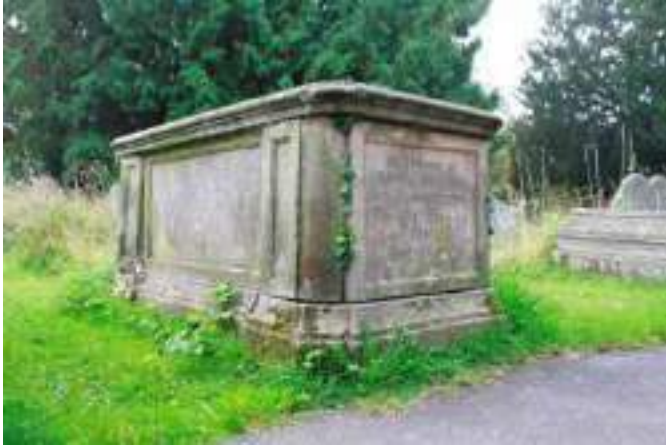
The memorial prior to any treatments, note the proximity of the tarmac path in the foreground, which gives no sense of the camber of the path, directing water into the plinth block. Work was done by us to remove as much of the ivy growth as possible in the winter of 2019. New growth can be seen issuing from the joints of the memorial.

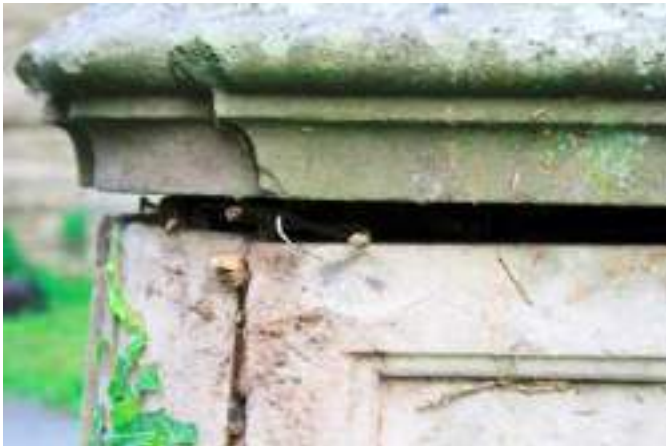
- 1.4 The double-pitched tomb chest lid has very little overhang and was observed to direct water onto the plinth beneath during heavy rain, surely an architectural oversight. Despite this anomaly, the lower elements are in a relatively good state of preservation, which is fortunate given the soaking this plinth must endure at times.

The compromised bed-joint between the tombchest and heavy lid, raised-up due to active, internal ivy growth. Note the poor architectural detailing of the lid with only a small bull-nose drip, effectively directing rainwater round onto underlying elements, instead of shedding water from the pitched lid, away from the memorial. Note also the tomb chest panel to the left is well out of alignment.

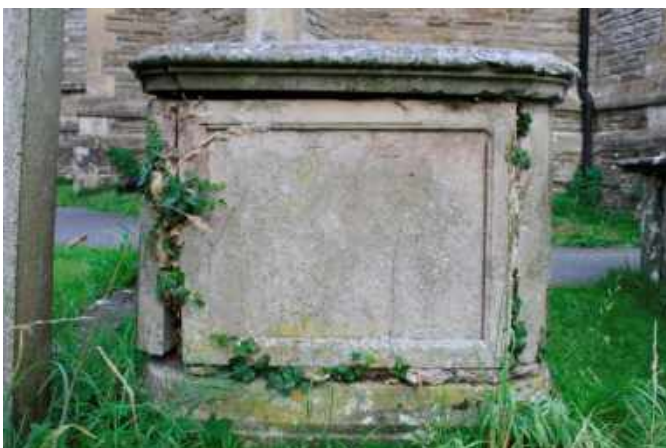
- 1.5 Ivy was seen to have grown through vertical joints in the tombchest, forcing some of the corners out of alignment by nearly 125mm. Because the lid was so thick, luckily this point-loading did not cause any further issues as witnessed on the Woolacott Memorial where differential loading led to delamination of the much thinner slab.

The extent of internal growth issuing from vertical and horizontal joints at the east elevation. Note the left-hand corner block has been forced-out beyond the plinth and the angle of the lid, raised at the left-hand (south) elevation, causing point-loading on the north 'long' panel and flanking corner blocks.

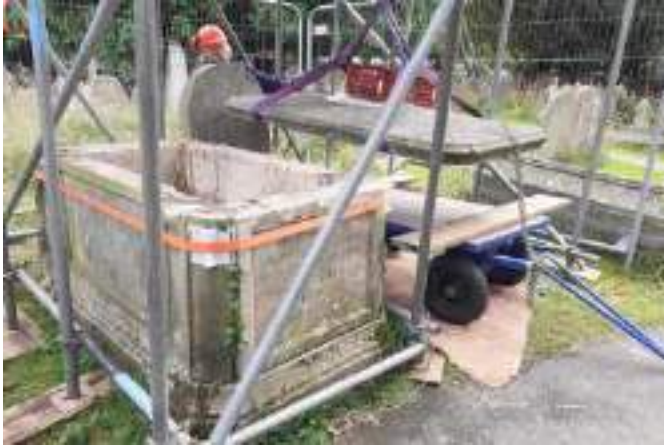
Lifting the heavy lid away from the tomb chest. We were able to lift the lid as the stone was assessed visually and 'rung' (assessed audibly) to determine any fractures or geological faults. The stone of this memorial is different to the majority of the other memorials and is stronger for it. There was no delamination despite the extent of deformation witnessed, just some isolated 'scalloping' (scallop shaped areas of loss) due to point-loading.

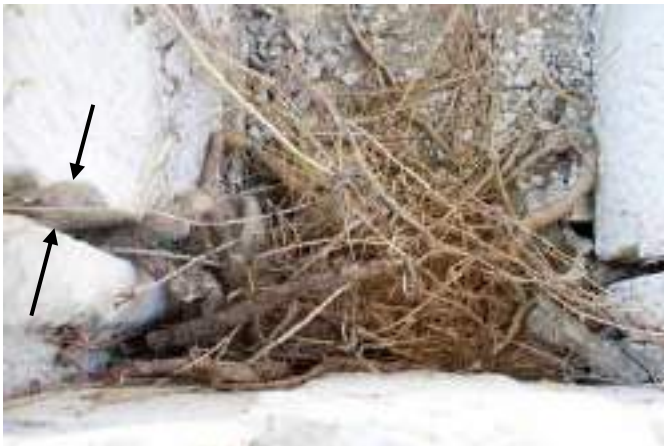
The mass of ivy stems visible in the south-east corner. Note the internal mitres (indicated) are empty of mortar, which would have prevented ivy from penetrating the joints and moving outwards, seeking daylight.

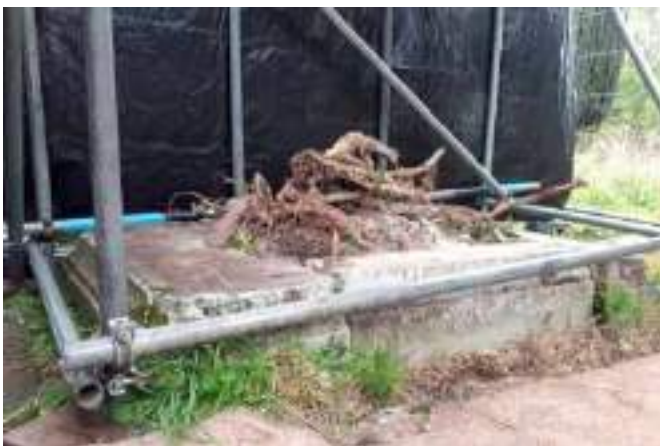
The thick woody stems visible after removal of all tomb chest elements and which carried on down below ground-level. The scaffolding was tight to the plinth due to the weight involved in lifting and lowering the lid which was calculated as weighing nearly $\frac{3}{4}$ ton, plus the requirement to keep both paths open, for movement around the churchyard by visitors.
