Final Conservation Report for Churchyard Memorials

St John the Baptist Church - Bishops Castle - Shropshire

The Diocese of Hereford

Elliott Ryder Conservation

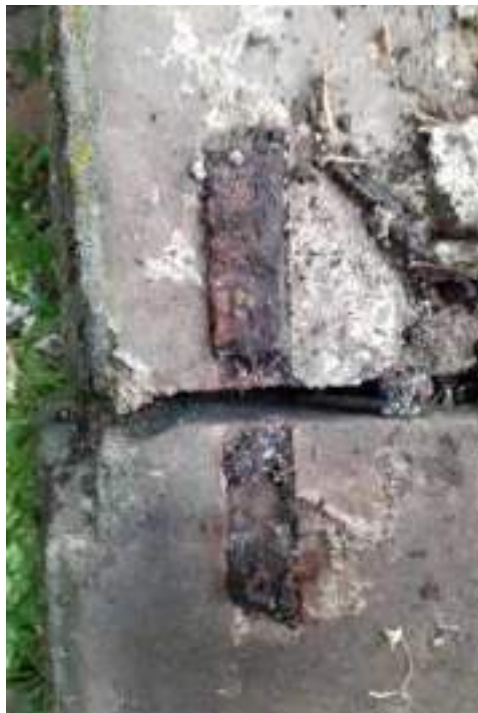
Corroded iron fixings which have delaminated to now flaky metal, serving no useful purpose. Luckily there was no iron-staining to speak of, despite there being easy access for excess moisture, with which to initiate the process. On the right, ivy stems grow easily beneath the fixing, ready to force this one apart.

- 5.1 The corroded iron fixings in this memorial were of the right size for the scale of the component elements. Many fixings had expanded or ivy growth had moved blocks so much that the turn-downs were not engaged and so providing no restraint/support. All corroded iron was removed with original fixing holes deepened to accommodate new stainless-steel fixings, which were made on-site.
- 5.2 No attempt was made to clean the outer exposed surfaces which are all well colonised with biological growths, giving the memorial a pleasing patina. Only the break edges and fixing sockets were cleaned.

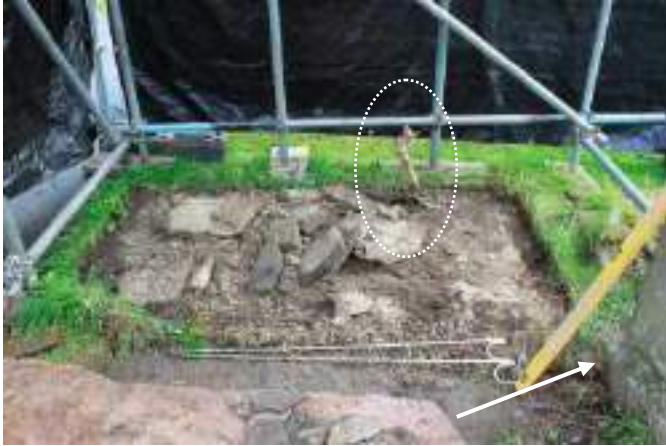
After removal of all plinth elements. The loose slabs are what the sub-base was made from, loosely arranged on top of one another with very little mortar. Note the ivy stem protruding from the ground (indicated) that was pulled outwards beyond the footprint and cut off. Note the proximity of the headstone plinth in the foreground which hampered the width of the new concrete pad.

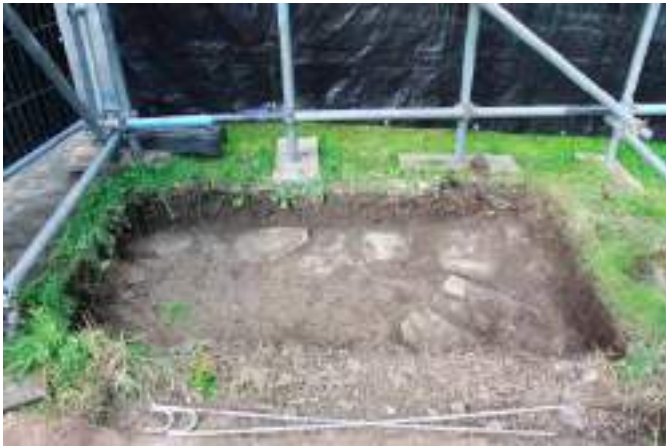
During removal of the stone sub-base to get sufficient level and depth for the new concrete pad.

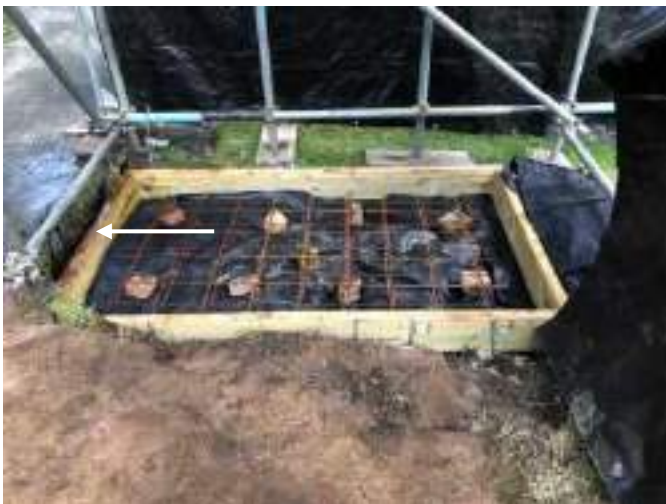
The shuttering and re-enforcing mesh in place, prior to application of the concrete. Note the top-bed of the shuttering and ultimately the concrete pad is lower than the height of the tarmac (indicated). The gap between the two was packed with free-draining washed, clean aggregate. If the pad had been higher than the path, there would have been a huge expanse of concrete at the east (right) elevation, which would have looked unsightly.

- 4.1 As the ground was not level in this location a larger rectangular aperture was cut in the ground to receive timber shuttering for a new concrete pad of the correct proportions for the sub-base, the top bed of which finished below ground level to the west (the tarmac path). Visqueen heavy-duty polythene (DPM) was placed at the bottom of the shuttering to ensure moisture-retention in the concrete and aid workability. Re-enforcing mesh cut to size so as 100mm back from the eventual edge of the concrete was placed on bricks to ensure it was midway vertically in the concrete. Concrete was poured and tamped with smooth edges applied around the perimeter. After several weeks the shuttering was removed and the strips where the timber was, backfilled and tamped with spoil on three elevations and clean, washed aggregate on the elevation closest to the path.

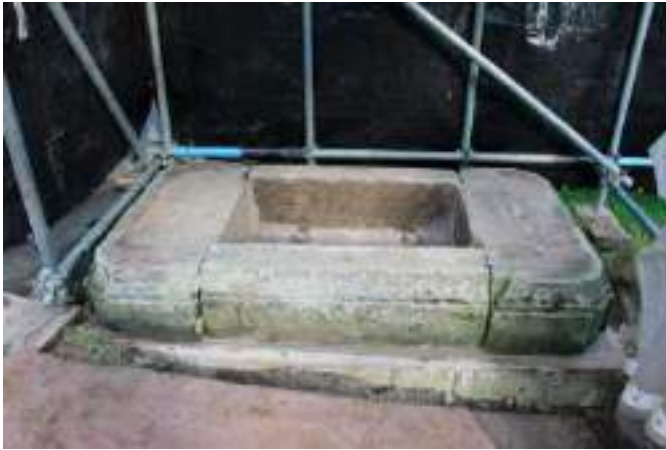
The cured concrete within the shuttering and the four plinth blocks now in place. The rear of the joints was packed with coarse bedding mortar to provide additional support/rigidity. The bottom beds of the different blocks had been worked to varying degrees, with some relatively flat and others requiring more bedding mortar to make them level in both planes on the top-bed.

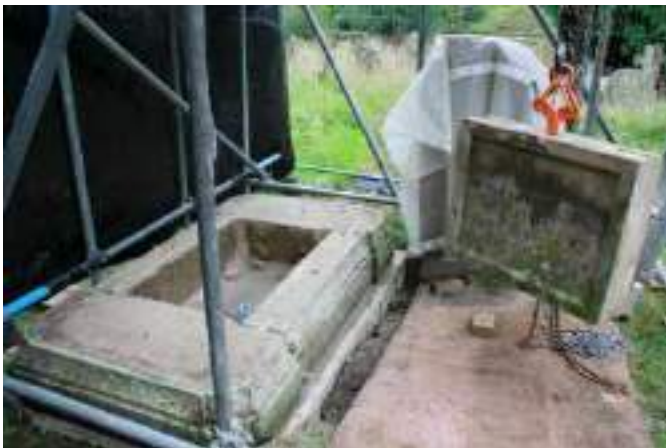
The west elevation 'short' panel being hoisted into position. The Lewis-pins enable blocks to be lowered into position precisely, without the need for removing straps. As none of the blocks were the same height or level on the top-beds, all eight had to be placed on the plinth dry, to see which was the highest and fix them around that block. This process was made much easier with Lewis-pins.

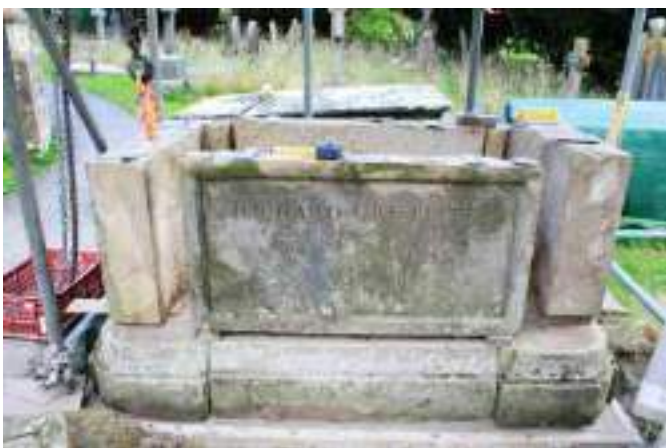
The last of the four main panels being lowered into position. The four corner blocks (which were just manageable by-hand) all fitted differently, with different masons interpretation of the 'bed-moulds' when carving the blocks obvious, during our fixing. Note the joints appear cleaner, having been jet-washed. No cleaning was carried-out on the outer faces.

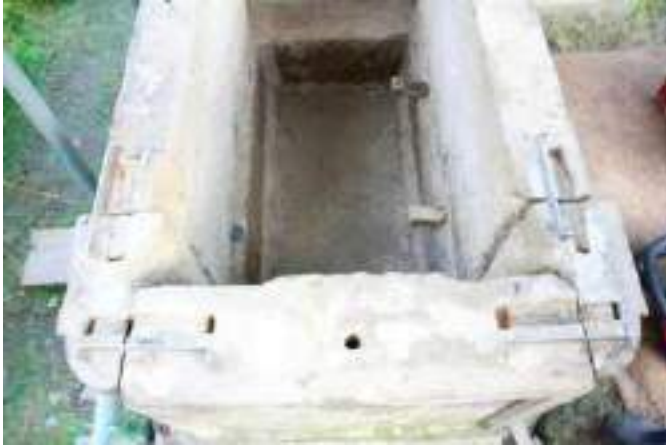
The tomb chest panels were so wide and in sound condition, there was no need for an internal supporting core. Note the new stainless-steel dog-cramps before being secured into holes/slots originally cut by hand, which we deepened by us in the same manner, them being rectangular. Not one of the cramps was the same length.

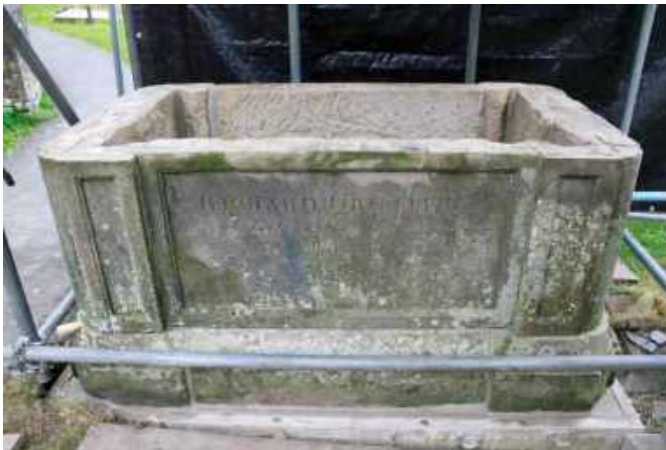
The tomb chest constructed with all bespoke cramps secured into position with epoxy-resin. There was a good deal of compromise when fixing the corner blocks, to ensure there were consistent parallel joints from top to bottom. If using the original slots and dimensions there would have been numerous ugly, dovetailed joints.

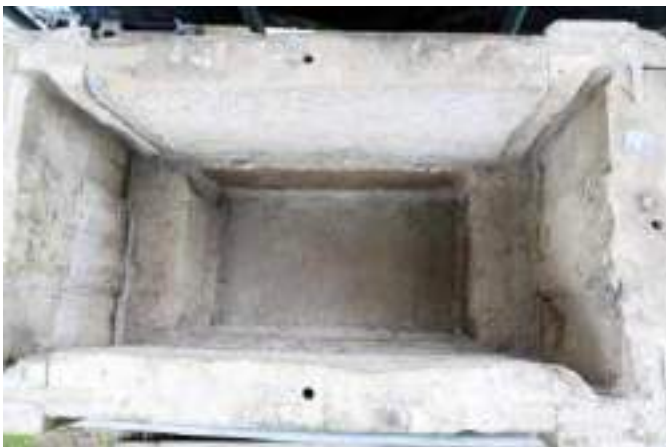
The inside of the memorial showing the massive footprint of the plinth and the thick tomb chest panels. All internal mitres were packed with mortar and the gunnable mortar used initially where joints were tight at the rear. This adds extra rigidity and strength to the already sturdy new fixings as well as ensuring moisture cannot penetrate.

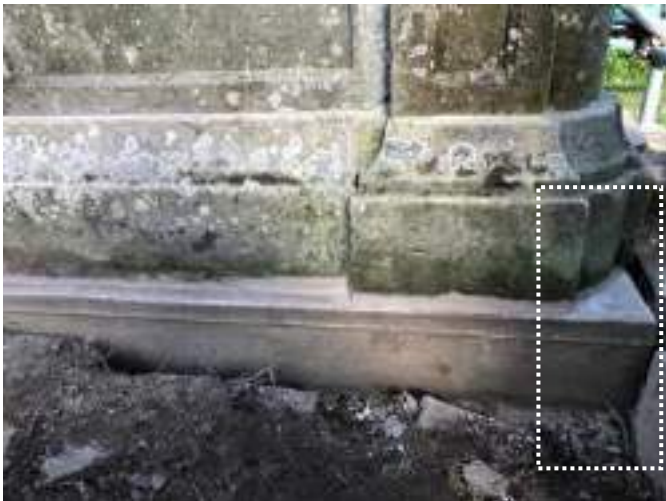
Detail of the concrete pad after the shuttering is removed. A coffin-shaped grave-slab is pushed tight against the plinth on this elevation. Note the tight, uniform joint between the plinth and the overlying tomb chest blocks. The joint between the concrete pad and bottom bed of the plinth blocks undulates significantly to ensure the top-bed of the plinth is flat for the next course and ultimately the lid. Note the proximity of the two plinths to adjacent headstones (indicated) which hampered the size of the new concrete pad.

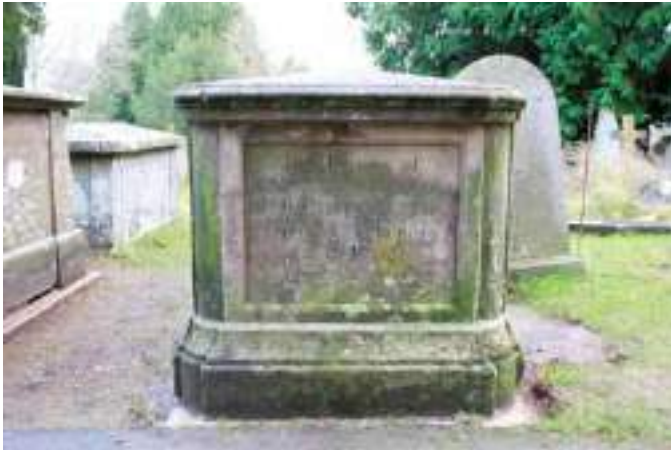
The west elevation of the memorial after all treatments. Note the uniformity of the joints and the small amount of overhang from the lid, which is rounded and therefore largely ineffective. The step down between the tarmac path in the foreground and the new cast slab is packed with free-draining aggregate. The biological growths on the upstand of the plinth should diminish in time, given it will no longer be saturated.

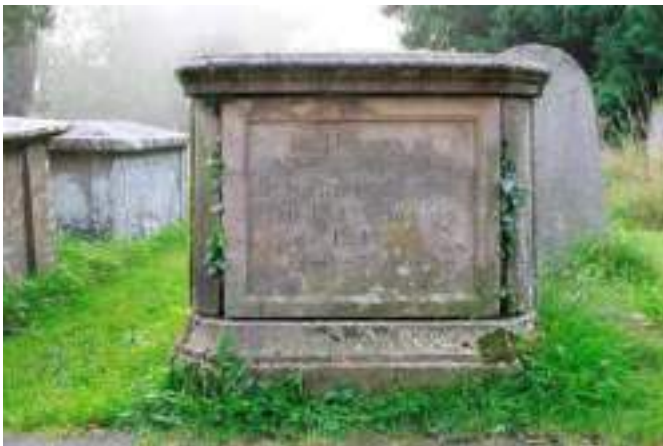
The memorial before dismantling showing an array of uneven, dovetailed joints caused by poor construction and the effects of ivy, forcing the memorial apart from the inside.

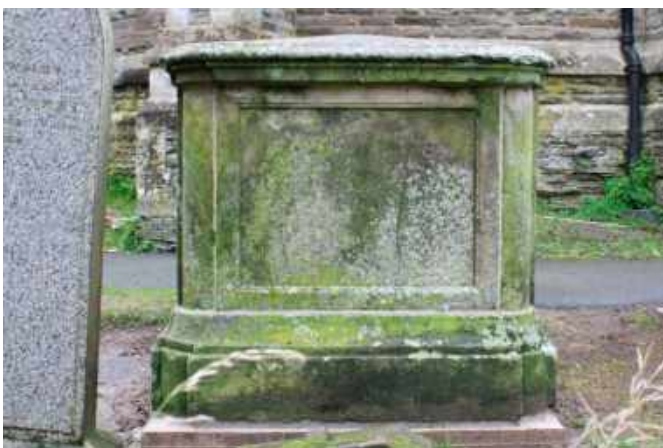
The east elevation after all treatments, note the dark-green biological growths on the plinth should also diminish in this location, however tall grasses were seen to grow against the memorial, before conservation. Note the concrete would have been even thicker at this elevation, had the pad been at the same height or above the tarmac at the opposite elevation.

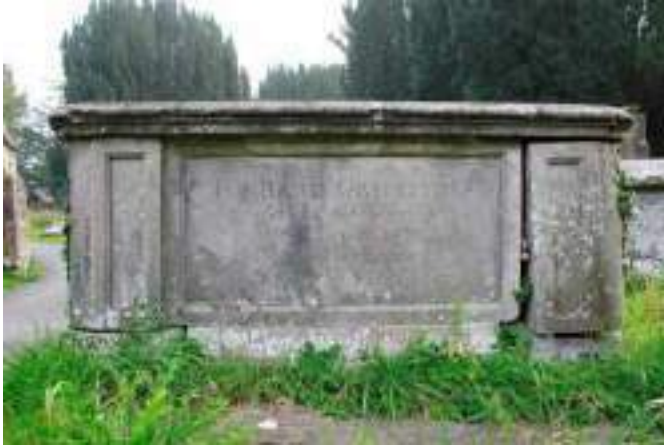
The south elevation of the memorial before any treatments. Note the amount of deformation to the south-east corner in particular. Note the coffin-shaped grave-slab in the grass in the foreground.

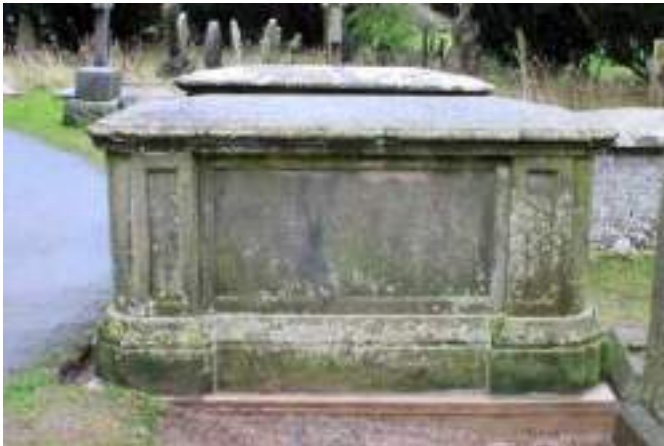
The south elevation after completion of re-building, with soil due to be packed down into where the timber shuttering was for the concrete pad. The coffin-shaped slab will also cover the concrete on this elevation where the ground drops away to a far-greater extent. The downward sweep of the tarmac path can be seen to the left.

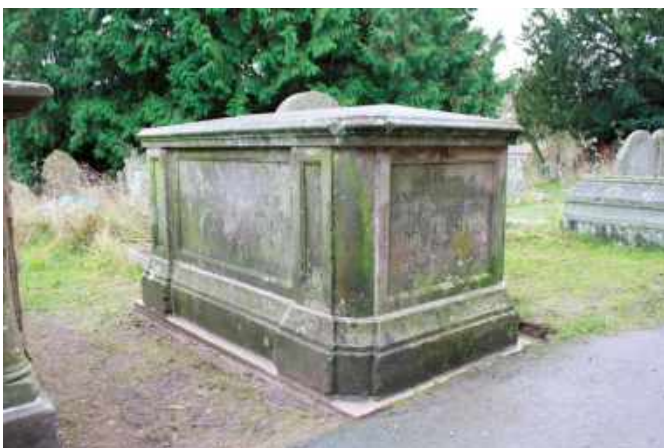
A three-quarter view of the completed tomb chest. Note the concrete pad could not be moved over any closer to the William Powell monument, which itself couldn't move any further to the north because of a granite kerb set to an adjacent family plot. The gap between the Griffithes and Powell memorials is a footpath, so it was important to maintain the existing dimension between both.
