Final Conservation Report for Churchyard Memorials

St John the Baptist Church - Bishops Castle - Shropshire

The Diocese of Hereford

Elliott Ryder Conservation

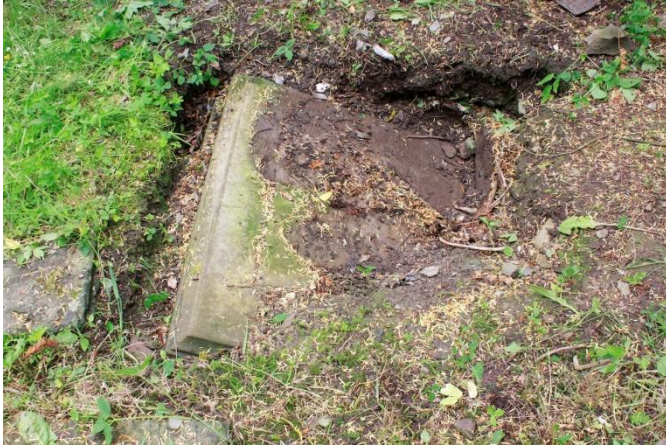
The top of the moulded plinth once all the side elements were removed. It was not apparent at this stage the presence of a rough (uneven) sub-base beneath that.

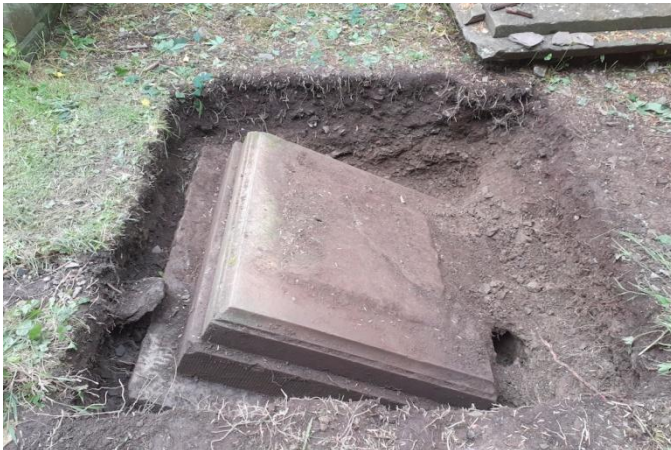
Carefully excavating the moulded plinth and sub-base, note the remains of an animal hole/tunnel at the bottom right-hand corner.

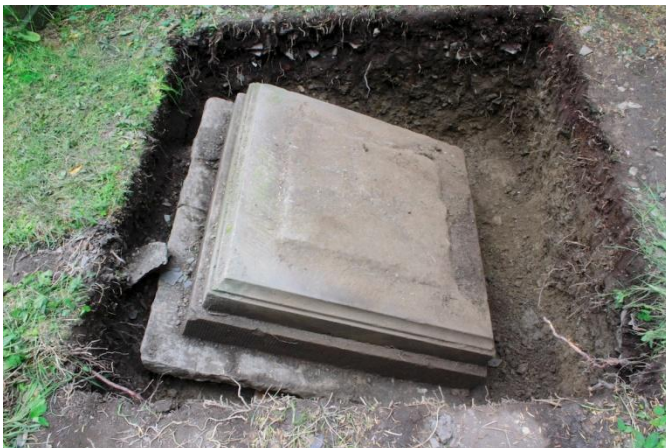
Three sides have been excavated to allow lifting slings to be wrapped around the west and east elevations, to give an even, albeit angled lift. The bottom bed of the angled corner (lowest in the ground) is very close to the internment beneath, so this area was not excavated further.

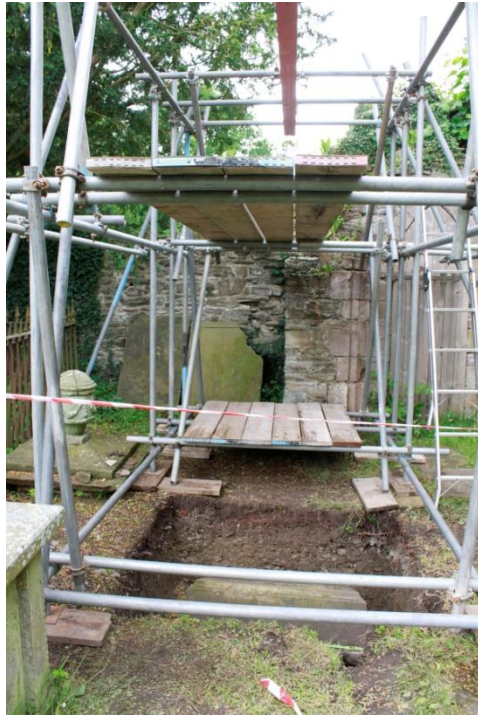
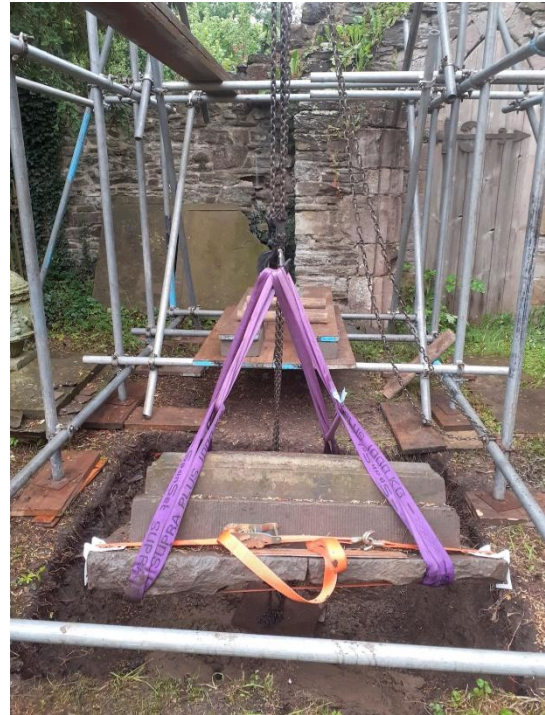
The sub-base and plinth before and during lifting/manoeuvring. Note the front of the sub-base which is in two pieces was secured with a ratchet-strap horizontally prior to lifting, to prevent either side moving during the lifting process. Note also the uneven thickness of the sub-base which would simply have been laid directly on the ground. This unevenness likely contributed to the instability of the 'whole'.

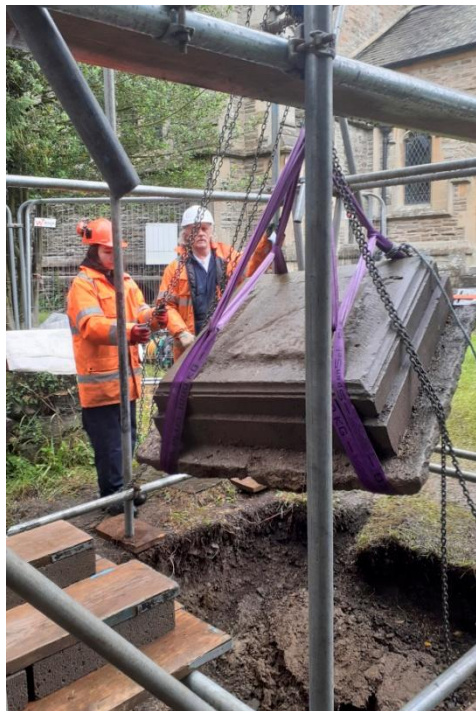
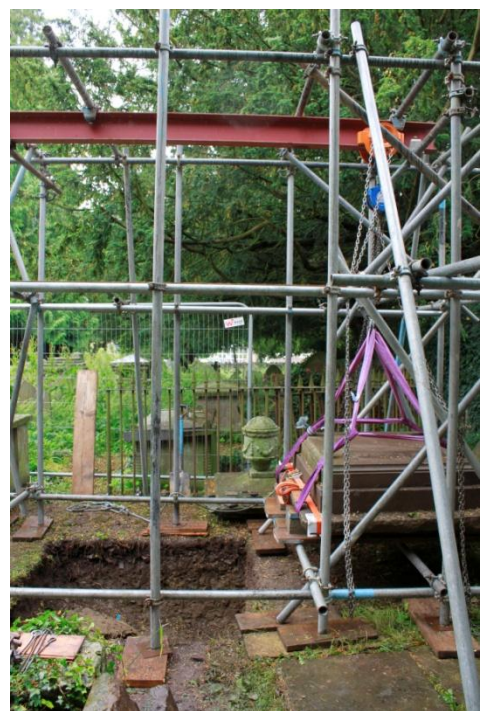
It was not safe to attach a ratchet-strap (as applied to the front) to the rear edge, lowest in the ground, before or during the lift, which had to be done quickly and smoothly. The mass had to be lifted at an angle before being lowered onto thick rollers onto the boarded platform and into a horizontal position, safer for re-lifting into its final position. The red 'I' beam with girder-trolley was used for smoothly manoeuvring the total mass horizontally, which weighed in excess of 850kg.

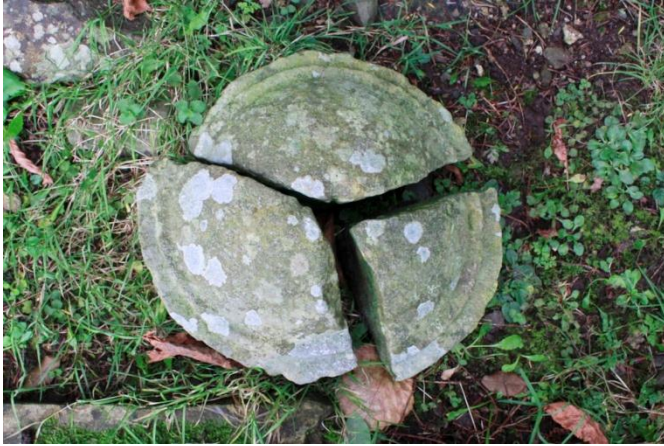
The urn-lid which was fractured by the corroded, internal iron-dowel. Given the level of erosion to the arrisses and biological growths on the break-edges, this is judged to be a very old fracture.

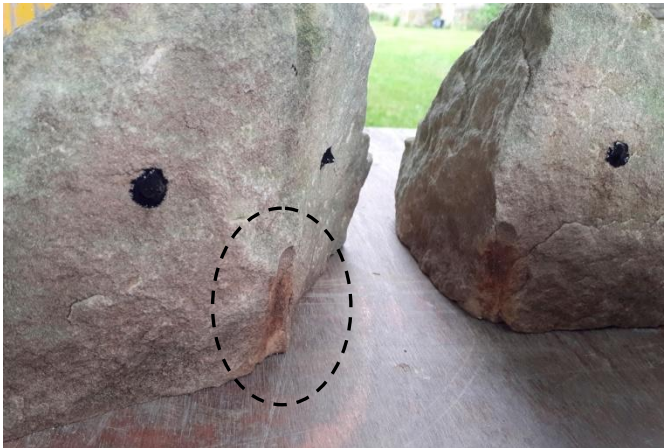
Corresponding spots of paint indicating where stainless-steel dowels were to be inserted. Note the corresponding iron staining (indicated) where the expanded vertical iron-dowel has forced the stone apart.

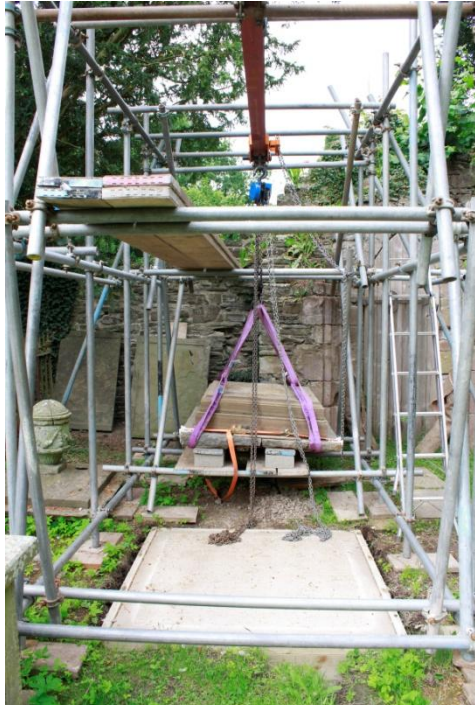
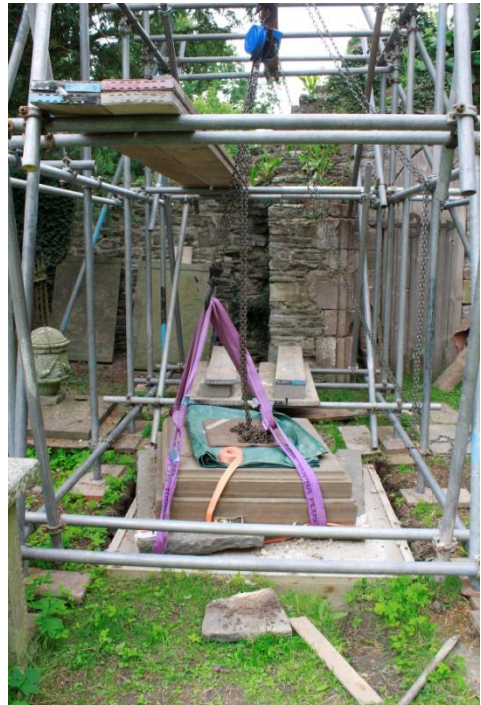
Once the concrete padstone had reached compressive-strength, the sub-base and plinth were moved horizontally and lowered into position. Unfortunately whilst lowering the 'whole', the right-hand half of the sub-base fractured and detached from the moulded plinth, with only mortar between the two courses and no fixings.

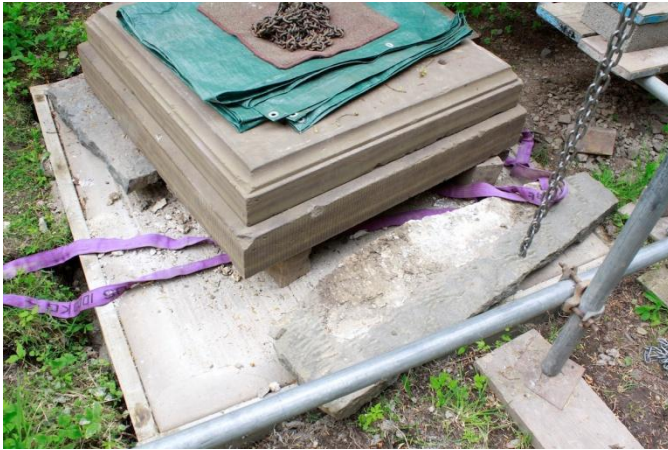
Fortuitously the fracture allowed us to reduce the very uneven nature of the bottom bed, which had a keel like protrusion and would have produced an ugly, wide joint with the concrete pad.

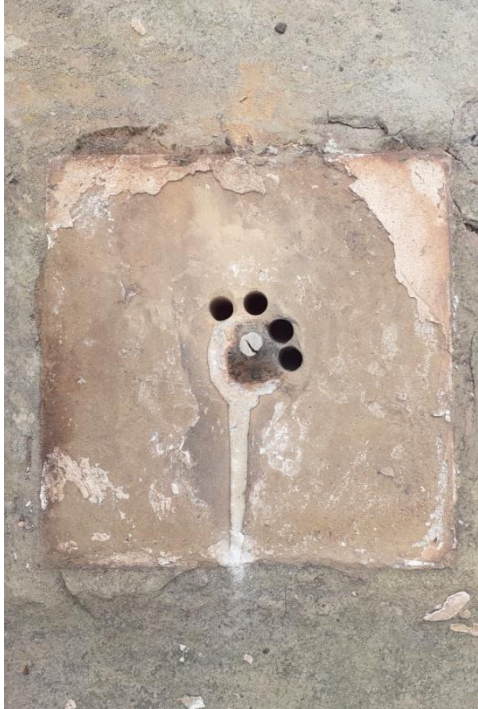
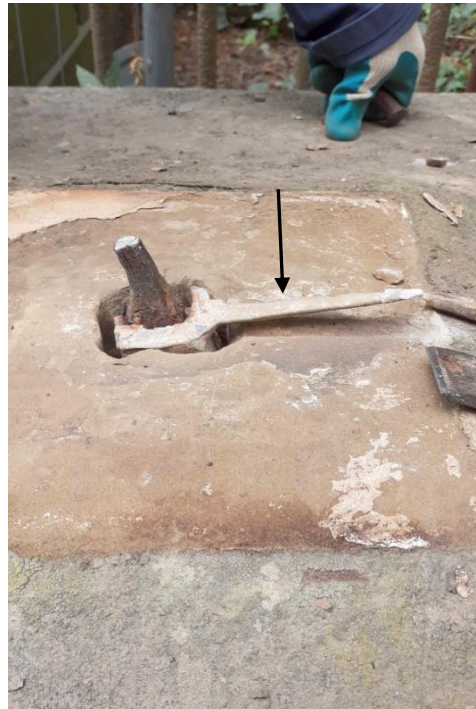
Drilling around the lead 'encased' iron-dowel to release it, which was completely ineffective and didn't prevent delamination of the ferrous metal. Note the route of the molten lead (indicated) introduced into an oversize vertical hole, but ineffective once excess moisture gets into the joint, when pointing fails. Original holes were re-used where appropriate, often needing to make them deeper, to accommodate longer stainless-steel dowels which will not corrode.

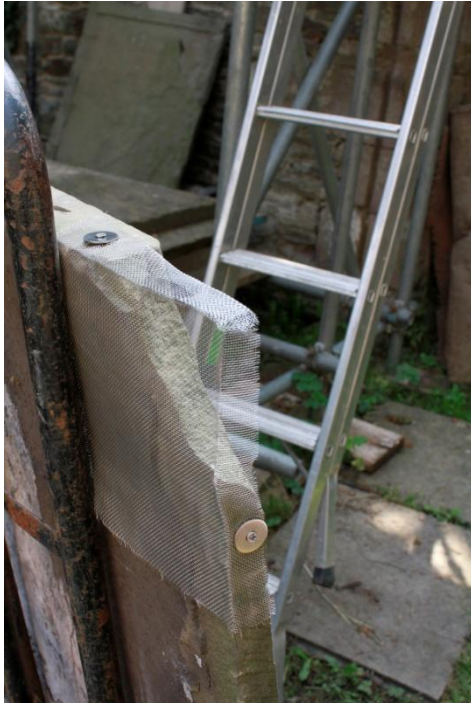
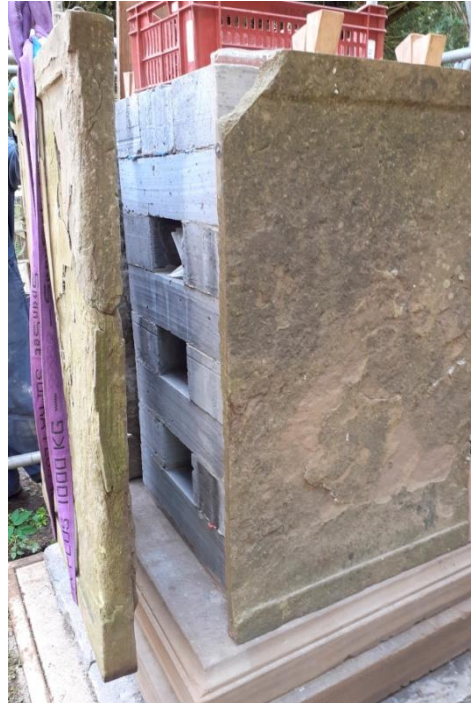
The corner of this block was missing, indenting new stone would have necessitated removing even more sound stone, therefore discreet stainless-steel mesh was secured on two elevations to prevent entry for birds or other mammals. The heavy fractured and repaired slabs were moved as little as possible to save the repaired joins from unnecessary stresses.

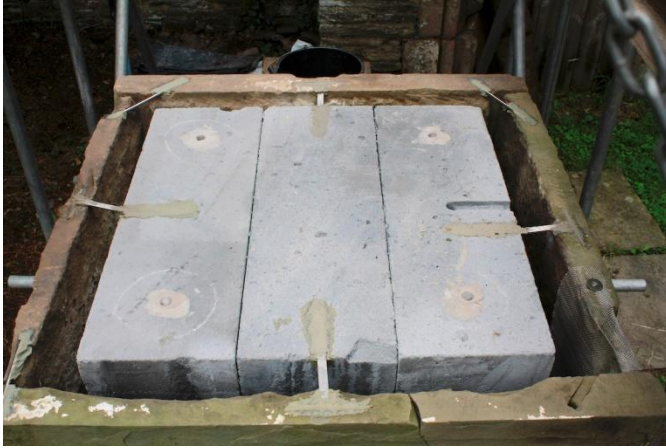
Three of the original corner fixings were re-used after enlarging the holes. The bottom right-hand corner was missing. The outer top light-weight blocks had vertical fixings securing them deep into the course below. All four panels were secured to the core to give far greater structural stability.

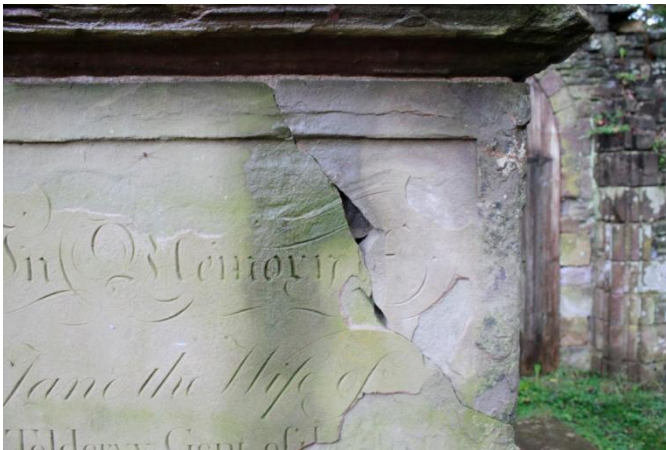
The joint between the capstone and front inscription panel. The areas of loss from the break edge were not filled as it would have been visually jarring. Coloured mortar within the void was angled such that rain on this surface would flow downwards and not into the core. The much eroded nosing of the overlying capstone is designed to shed water away from the four side panels, but does that far less effectively now given the levels of erosion and deterioration witnessed.

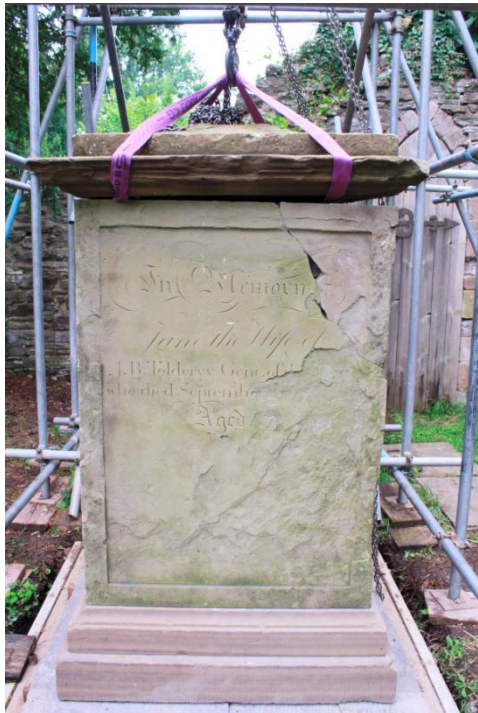
The capstone being lowered into position. Slate shims were required on the top-bed of the core to make it level, as the bottom-bed of the capstone was so uneven. The right-hand image shows mortar repairs (indicated) inserted into vulnerable areas previously tacked with epoxy-resin spots to prevent further damage/loss. Much of the original carved surface has been lost from this very laminar local sandstone.

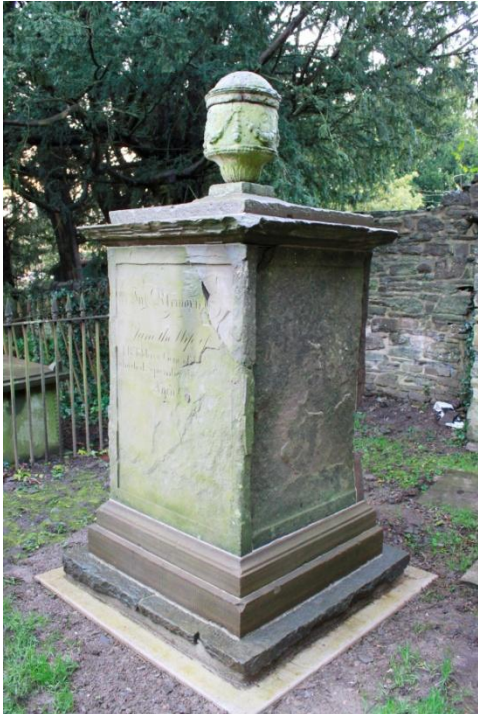
- 6.2 It is also worth noting that the outer nosing or extremity of the capstone is much eroded and had suffered some isolated physical damage during dismantling and stacking of the stone elements. As such the capstone is not shedding rainwater away from elements below as designed to do and is actually directing rainwater onto the aged stone in some areas. This was witnessed during/after several heavy rain-showers. That said the memorial as a whole is in a much better state of preservation than it was - stacked badly on an uneven surface and its re-erection/conservation has ensured its long-term future.

The re-built box-tomb on its new concrete pad. Note the eroded and physically damaged nosing (outer edge) of the capstone which casts biological rich water directly onto the moulded stone plinth beneath. Despite the architectural detailing and proximity of the over-hanging tree, the long-term integrity of this beautifully proportioned and decorated memorial is now assured.

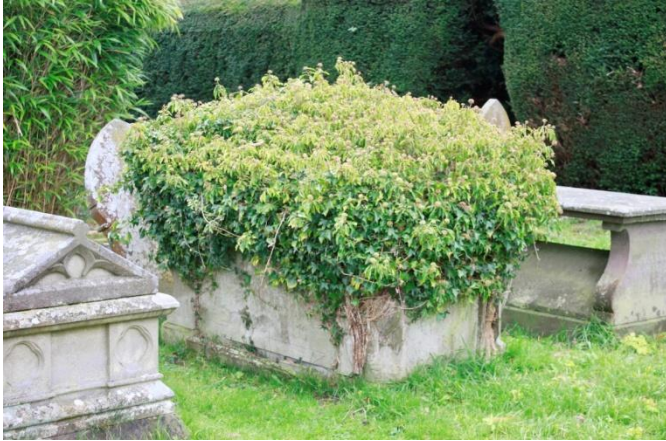
- 1.4 The ivy was seen to have grown through vertical joints in the tombchest, forcing some of the corners out of alignment by nearly 100mm. The main roots/tendrils had exploited weaknesses in the delaminating stone slab and completely forced their way through a weak area to the west of the lid. Smaller tendrils had grown through horizontal bedding planes to such an extent that the stone would not have provided an effective lid/covering for the tomb-chest beneath and would have let water in through multiple repairs, requiring resin, fixings and mortar. The relatively poor-quality, local, laminar stone slab, was too thin and long to perform its architectural function in the long-term.

A general view of the memorial before any treatments. Note thankfully none of the neighbouring memorials are afflicted in the same way with the insidious effects of ivy growth.

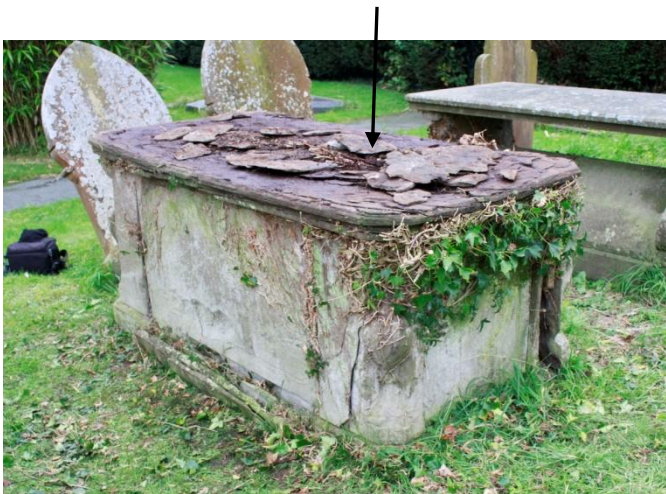
The much de-laminated upper surface of the tomb chest lid, which the ivy stems had exploited, puncturing through the weakened sandstone in the area indicated. Growths can clearly be seen issuing from the horizontal and vertical joints.

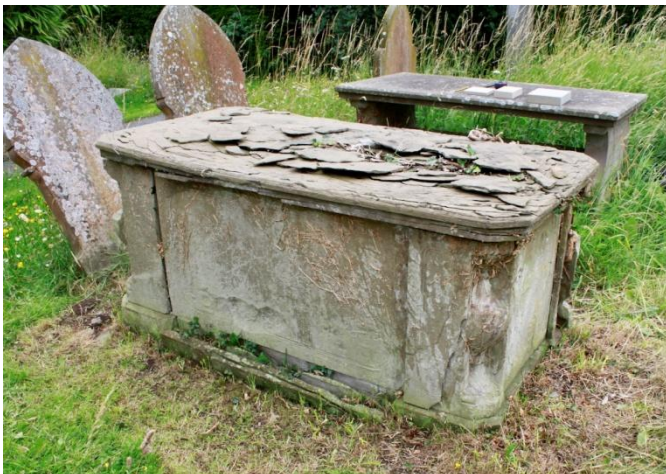
The tomb chest after being rain-washed clean over the course of a winter. Despite the level of disruption witnessed, the memorial plinth blocks are still largely level, which was a factor in determining not to dismantle the sub-base, which is always a last resort.

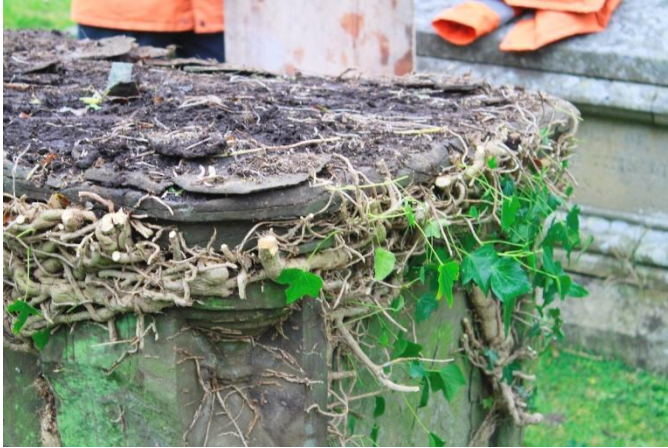
During removal of ivy growths, which couldn't be removed properly until the tomb chest was dismantled fully. Note the extent of soil debris on the top-bed of the slab from the breakdown of ivy-leaves over many years.

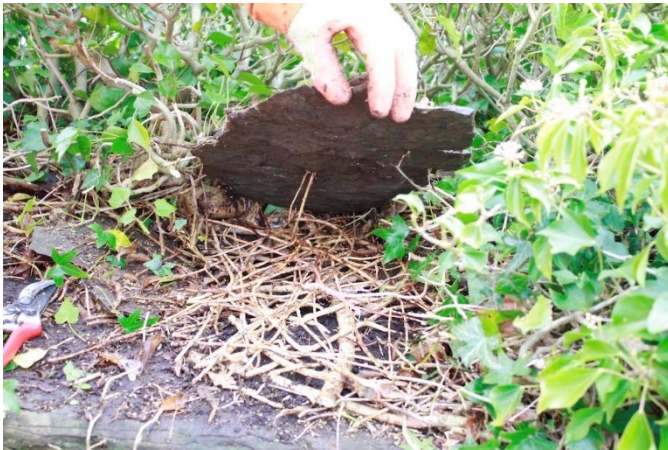
The ivy tendrils had exploited the laminations of this weak laminar stone, growing along bedding planes and forcing layers apart.

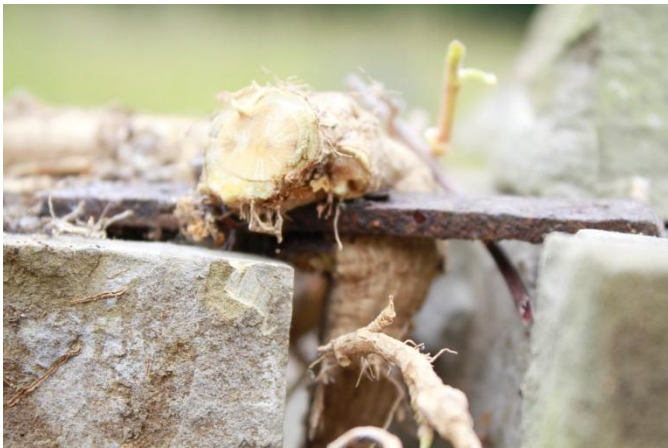
The ivy roots had forced apart many large, heavy sections but kept this dog-cramp (double turn-down) in place, by growth around it. The thick stems had forced these large stone blocks apart horizontally.

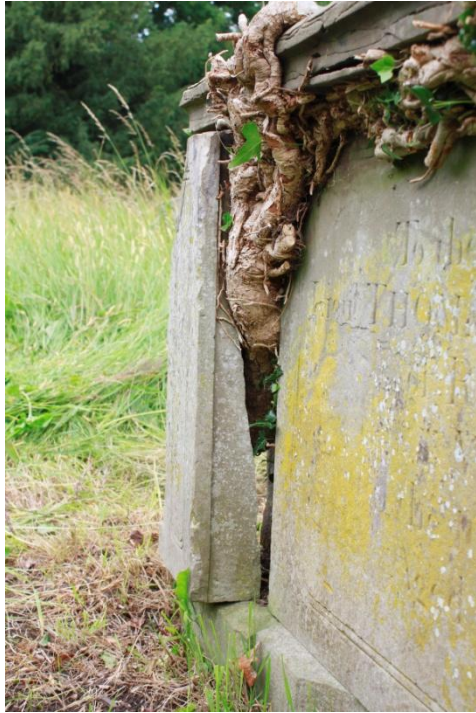
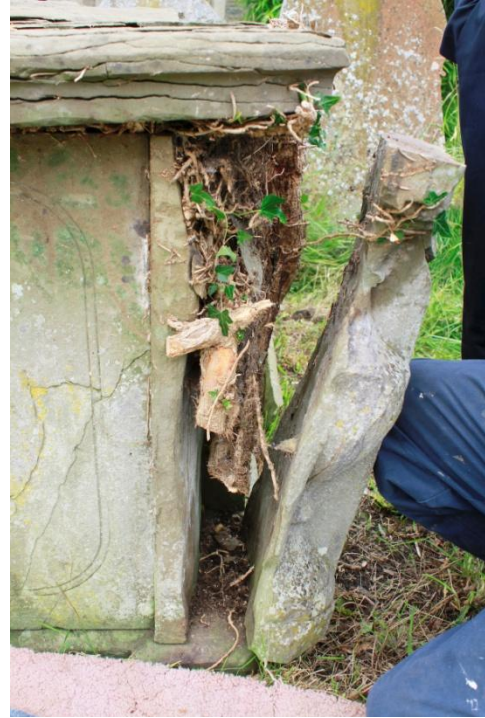
The extent of the stem expansion, compromising the load-bearing capacity of the tomb chest itself. The right-hand image highlights the weak, laminar nature of this local building stone, when looking at the moulded corner detail of the slab. Note no attempt was made to clean the memorial with the yellow, green and white lichens providing a visually pleasing patina of age.

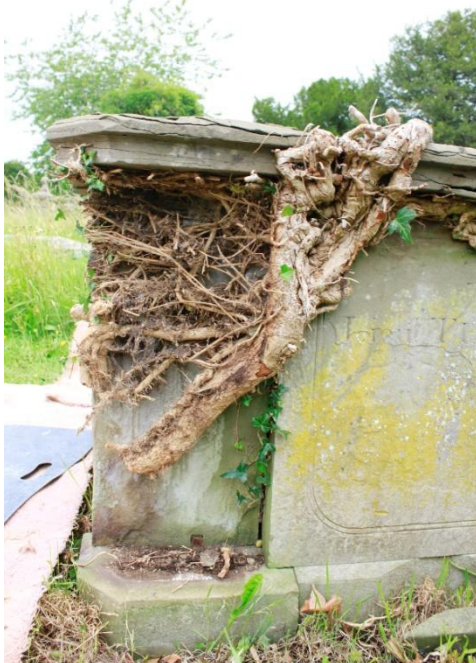
On the left, the south-west corner block having been forced off, on the right, vertical fractures through one of the plinth blocks. The ivy had grown the same width as the joint before widening back out within the tomb chest.

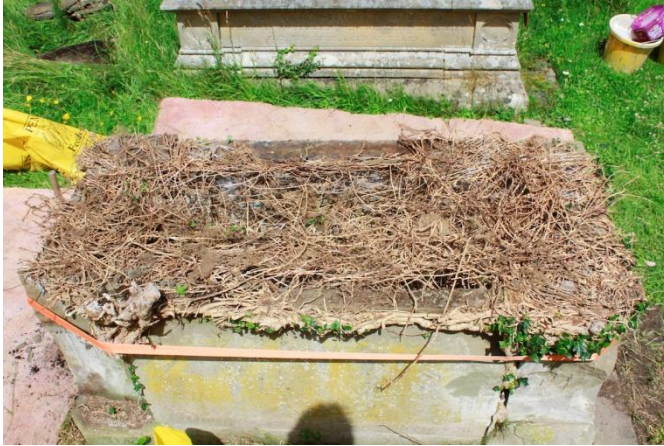
The maze of ivy growths within the tomb chest, once the lid was removed in sections. Much of the growth was dead but some was still healthy. Note the new green leaves in the foreground, even after removing the majority of the growth on top of the lid.

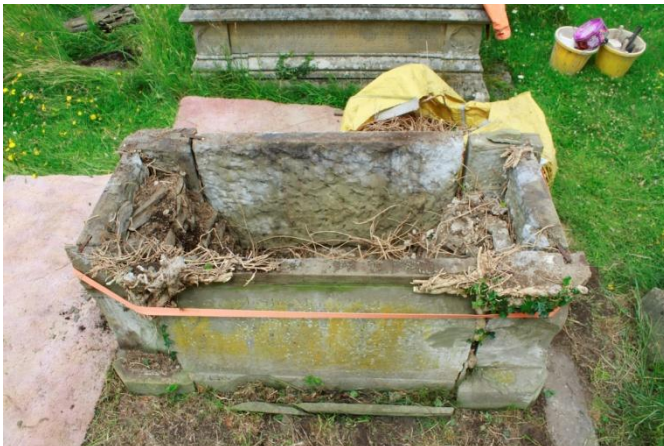
Having cut back much of the growths where possible. The stems were within the supporting sections of walling and would have to be removed once these sections were dismantled. Once the lid was removed several of the smaller side elements became unstable, as all the fixings had failed, which required the use of a ratchet strap to keep other sections in place.

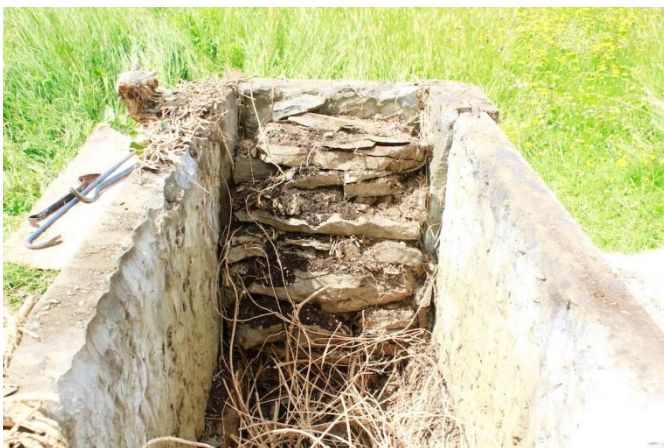
The rear of the west elevation and the random nature of the initially supporting core. Once the fixings are compromised it creates instability, with an angled mass leaning against the short panels. Built with thick mortar, both cores had absorbed and retained moisture from the compromised, much wider open joints, with easy access for rainwater and all its associated problems.

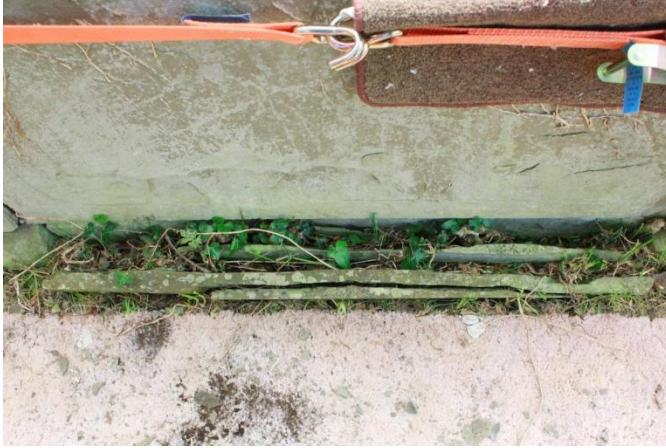
The extent of delamination in the plinth block, which has obviously been an historic problem judging by the extent of established plant growths within the laminations. The stone is edge bedded, that is rotated 90 degrees from its original sedimentary bedding plane, with weather better able to exploit the weak laminar stone.

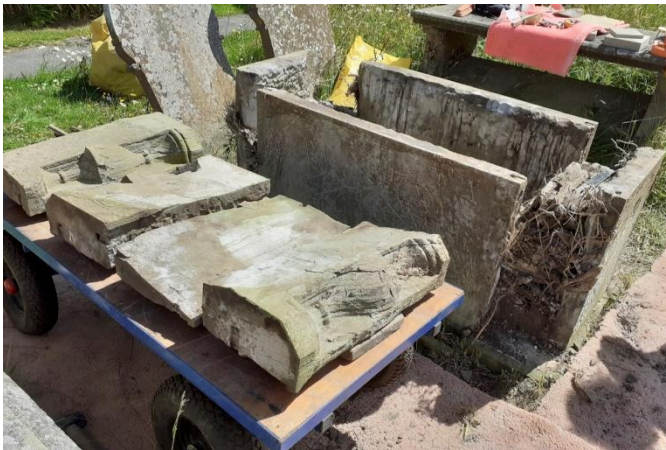
The smaller, carved corner blocks which join the short and long sides together. Note the three right-hand blocks and how severely delaminated they are, with the middle of the three having lost all carved detail.

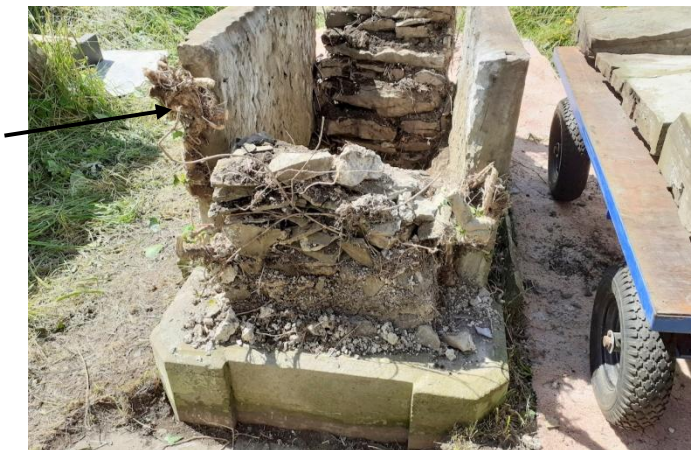
The east elevation after removal of the short panel, highlighting the extensive roots within the core structure and the small mass of roots within the joint between the north long panel and where the corner block was (indicated). The chamfered plinth (short) block in the foreground is in its natural bedding plane and is in a much better state of preservation as a result, bedding planes constantly in compression therefore unable to be exploited.

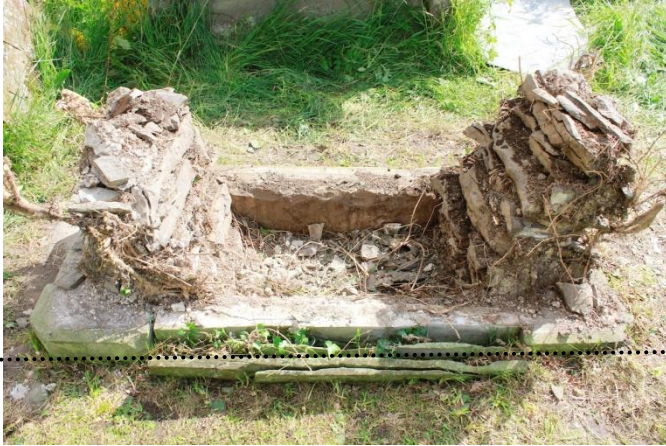
All of the side panels removed leaving the angled 'supporting' core and ivy stems, which appear to have grown out of the corners, most likely the points of least resistance. The front plane of the long (south) plinth block, should be behind the outer edge of the short blocks (indicated) but has delaminated/moved to such an extent.

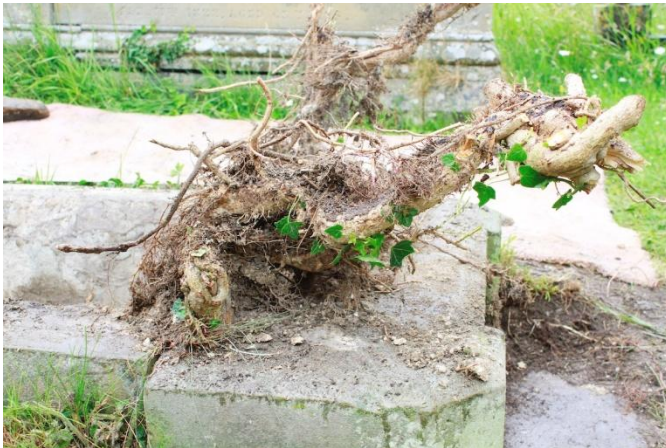
The extent of aged ivy roots at the south-east corner, showing some small healthy leaves, indicating the plant stem was alive.

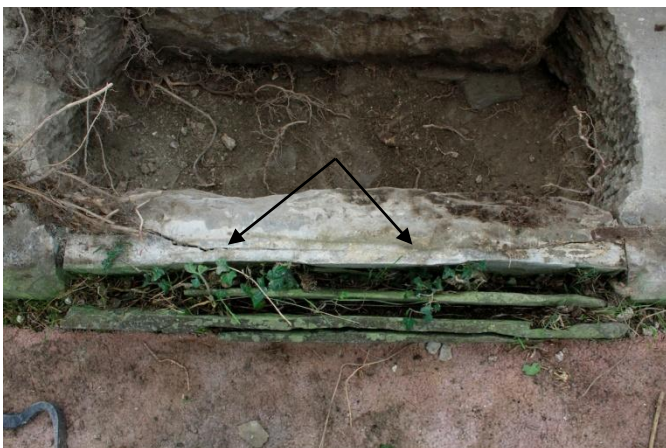
The plant stems removed as far as possible before removing three of the four plinth blocks. The opposite (north) plinth block showing an equal amount of disruption, with an inherent delamination about to be exploited (indicated).

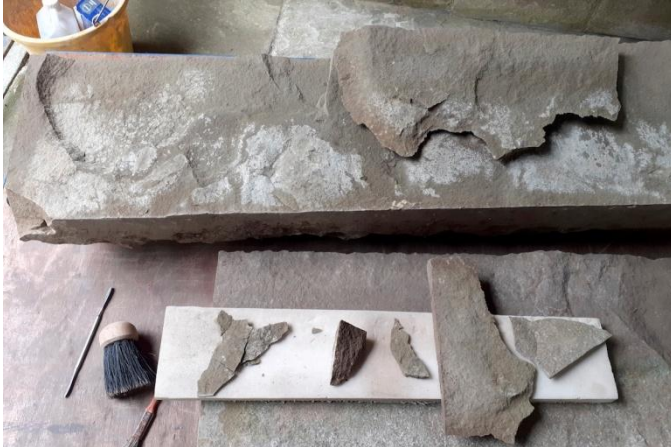
The extant sections were wet-cleaned and allowed to dry before being re-joined. The white accretion on the surfaces is efflorescence from soluble salts, caused by soil and organic materials.

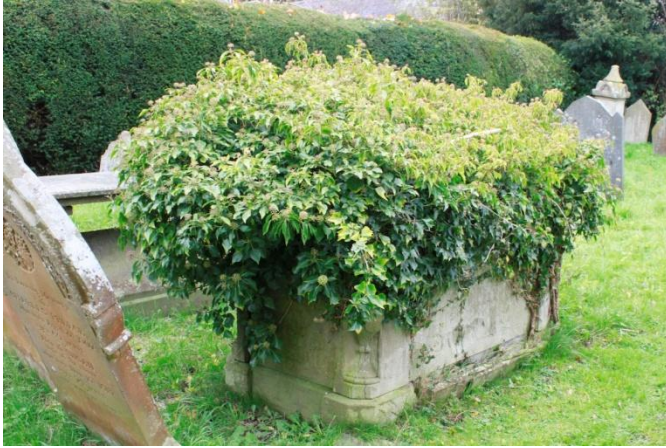
The tomb chest before any treatments, highlighting the extent of well-established ivy growth, which disguises the extent of structural damage to the memorial.

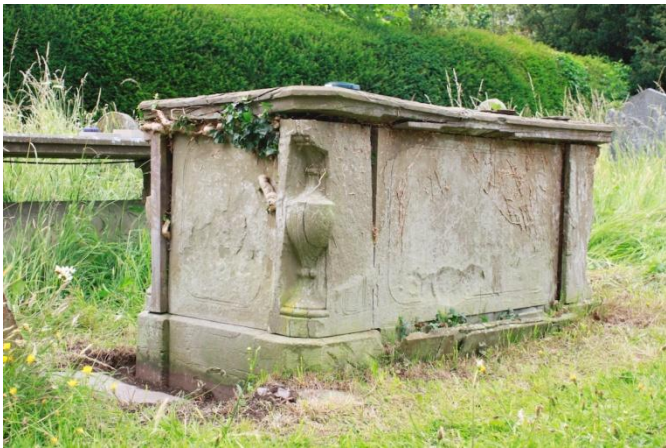
After removal of the surface growths, with stems still growing through the joints. Note the upward plane of the tomb chest lid in the foreground and the horizontal fracture through the slab as a result.

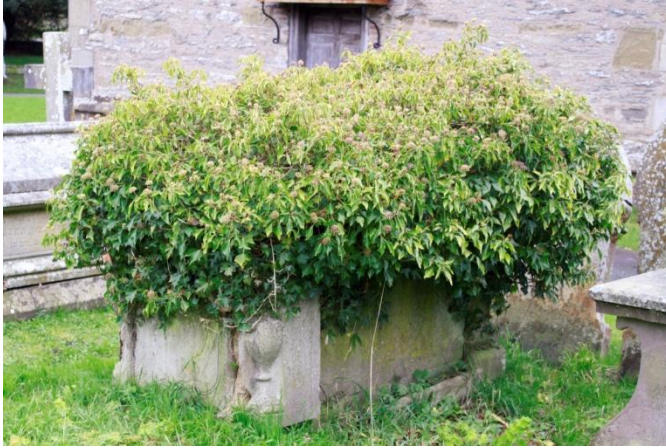
Another view of the tomb chest prior to any treatments. Ivy is well-established and a memorial enjoying a Grade 2 listing for so long, should not have been allowed to reach such a perilous condition.

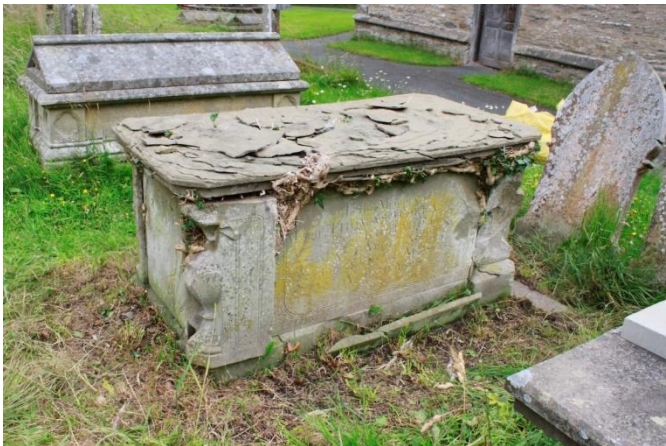
The majority of the ivy growths removed and the lid having been left to be rain-washed over the course of a winter. The full extent of disruption and delamination, now apparent over the whole tomb chest lid.

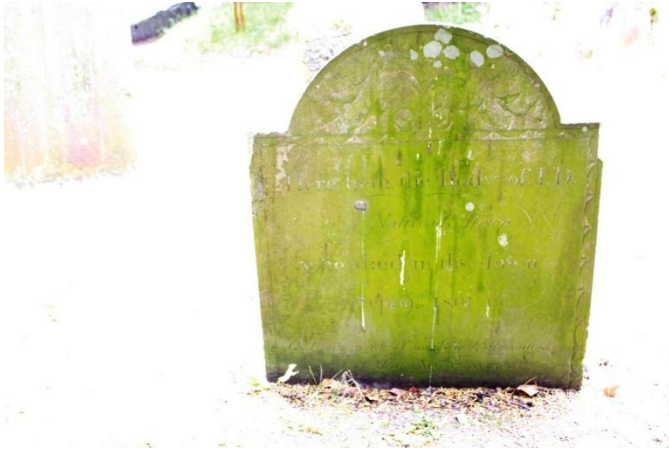
The over-exposed grave-slab before any treatments. This front surface is completely colonised with bright-green algae, with a small amount of light-grey lichen at the top. Bird guano was visible down the centre of this face. Note how the extent of finely carved, low-relief detail is lost visually on the semi-circular head.

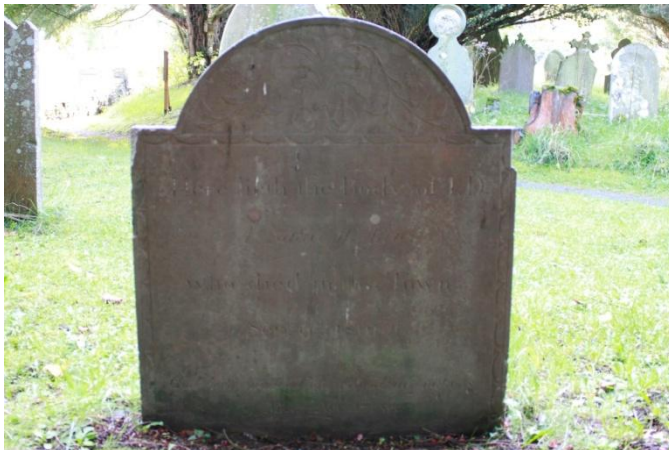
The front elevation after cleaning. Disfiguring biological growths were pre-softened with paper-towelling compresses and a weak surfactant solution, before being reduced with soft bristle-brushes and changing clean-water. This is the most gentle form of wet-cleaning and could not be taken any further, as particles of stone were observed in the beakers. Cleaning stopped after two cycles of this method.

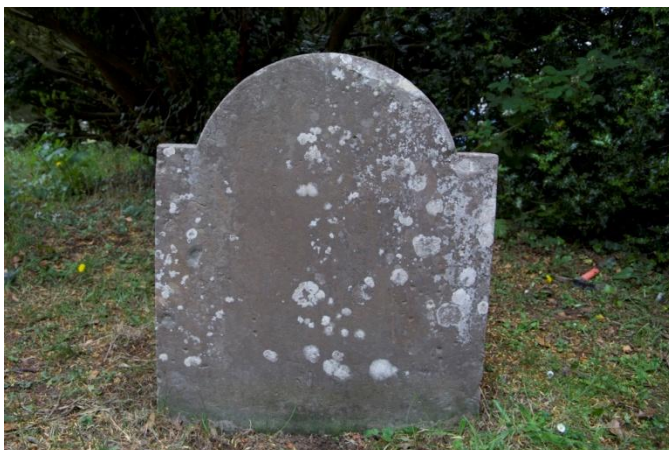
The rear surface of the graveslab seen from the adjacent path and grassed area. You have to stand beneath the tree to see the dedication and carved detail. Note the greater levels of white/grey lichens, due to greater in-direct light-levels. This surface is protected somewhat from direct sun-light, due to numerous mature trees in the foreground, but must receive weaker sunlight earlier in the morning.

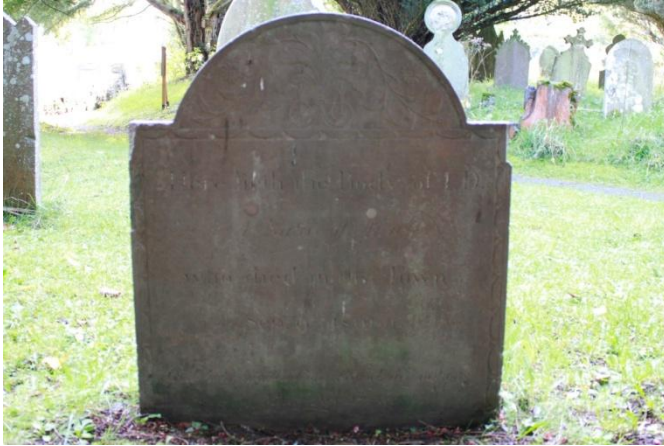
The warm colour and carved detail at the head of the slab, much more apparent after cleaning. More tenacious green algae at the intersection with the ground could not be removed further due to disaggregation of the stone in this area. This deterioration is not serious enough to warrant consolidation yet, which would be problematic, as the object cannot be isolated from moisture. Removing it from the ground for treatment would present ethical conservation issues.

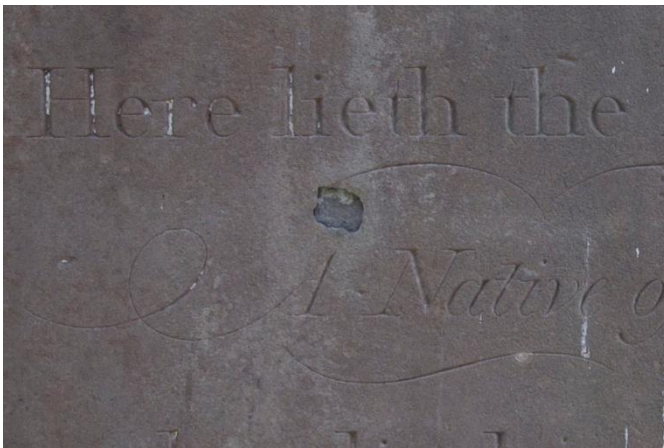
Detail of the quality of setting-out/lettering and the only blister on the carved surface. A large area around it (above and below) sounded hollow when tapped, caused by delamination of the now face-bedded slab. A fine, free-flowing liquid grout was injected behind the pre-wetted substrate in two cycles and surprisingly little was absorbed, indicating the lamination is not as bad as first thought.

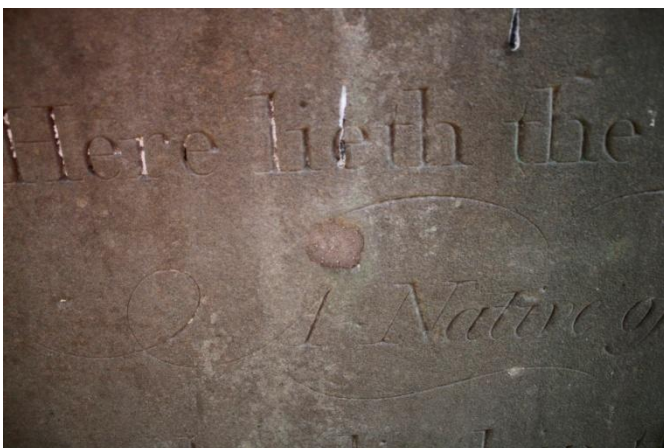
Once the grout had settled and hardened a coloured repair-mortar was carefully packed into and around the diameter of the blister with a small spatula, before building up from the substrate to the upper carved-surface. The void was over-filled, left for several hours to go leather-hard then pared back with a busk, to give the desired final texture. The mortar is designed to be softer than the host stone.

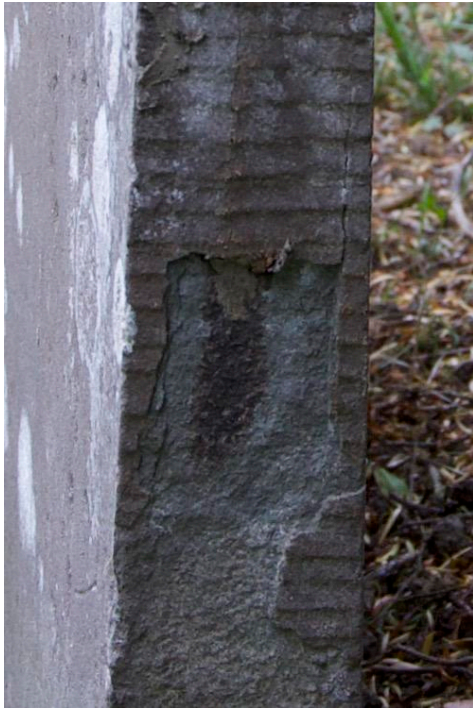
The north side of the slab before and after treatment, the stone is spalling not delaminating, as it is at 90 degrees to the bedding-plane partly as a result of the force/shock required to produce the tooled or 'batted' surface on the edge of the slab. The darker area on the now exposed substrate is an inherent ferrous mineral, which is another point of weakness and reason for localised failure. Coloured repair mortar was packed up into the vulnerable edge as far as possible.

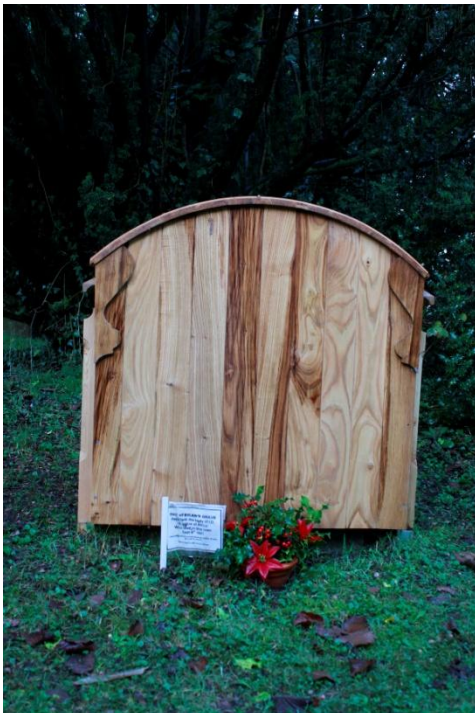
The Chestnut (hard-wood) protective covering, which is designed to shed rain-water, is clear of the stone inside and well-ventilated. All factors that will ensure the long-term preservation of this important Grade 2 listed memorial.

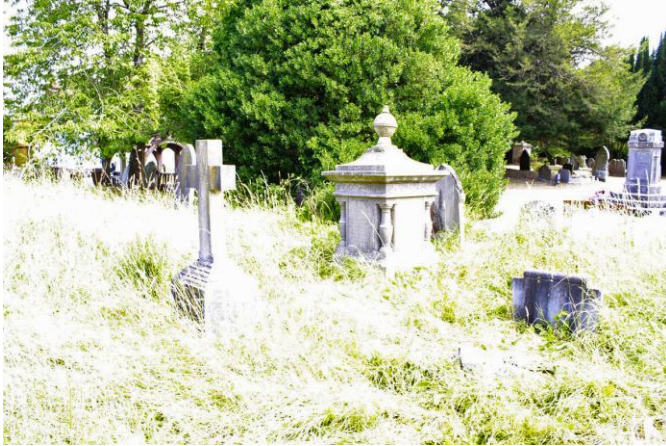
The Thomas memorial in the centre of the image, with a protective tree in the background, to the north-east. Note the extent of grass growth around the memorial with the moulded plinth all but obscured.

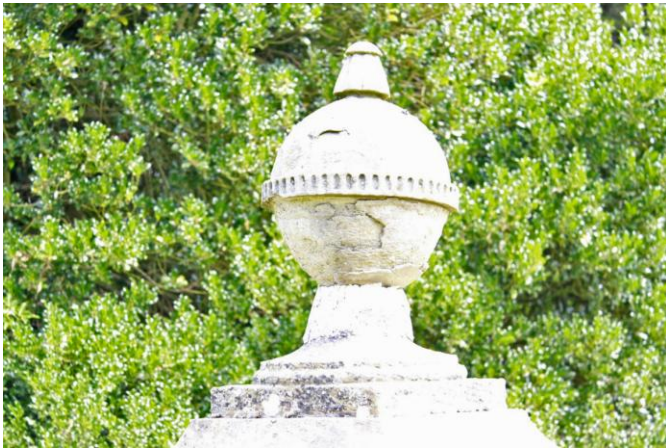
- 2.2 The ball-finial has been re-fixed badly in the past and is now at a jaunty angle. Although the cementitious repair would now be deemed inappropriate material, the crude and ugly repair to the diminishing urn-neck showing no signs of breakdown, or splitting and is colonised with well-established lichens and algae, indicating it is an old repair.

The ball-finial with crude cementitious repair around its diminishing neck. The ball is carved in one piece, which is made more difficult given the raised fluting around the centre, requiring the use of two reverse templates instead of one. Perhaps unsurprising the ball is so deteriorated given the amount of chiselling required for the numerous, decreasing chamfers, to create the curve – semi-spheres.

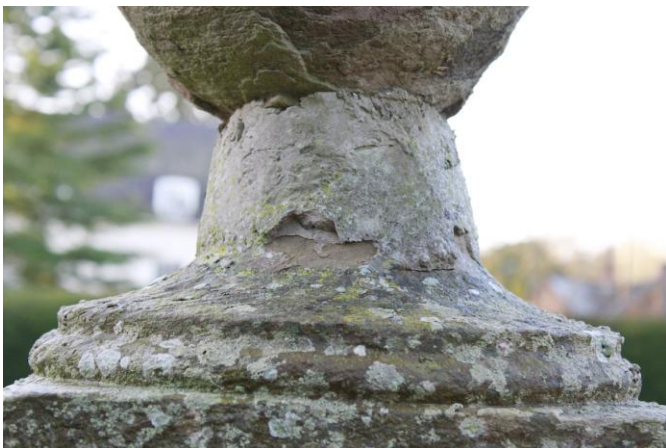
- 2.3 Cementitious mortar has been smeared over the stone beneath and is well-bonded. Its removal, no matter how careful would pull off weaker, underlying stone, causing avoidable damage and it is for that reason, with no evidence of structural breakdown that the decision was taken to leave the urn for the future.

A detail of the crude repair to the neck. It is so big and clumsy, most likely to replace missing detail and create a sound base/stooling for the stone-ball which is significantly weighty. Note how the cementitious mortar (more alkaline than the sandstone) has colonised with the same lichens, indicating it is an old repair. As the repair was sound, the decision was taken to leave it unmolested.

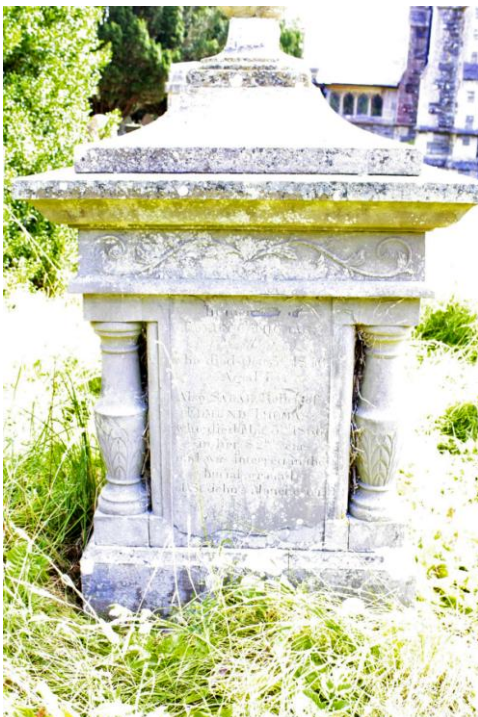
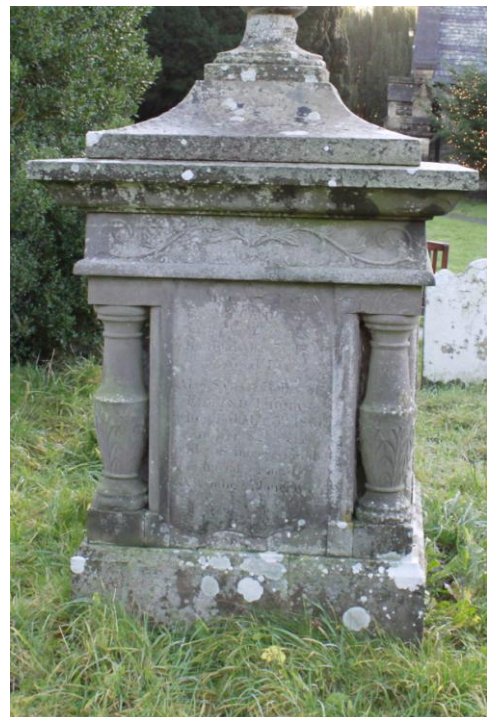
The west elevation of the Thomas memorial before and after all treatments. Delaminated stone along the bottom bed of this elevation was also rationalised back to sound substrate, with support fillings inserted along the length of the previously tacked edges. Carved detail to the frieze is a little easier to determine on this elevation.

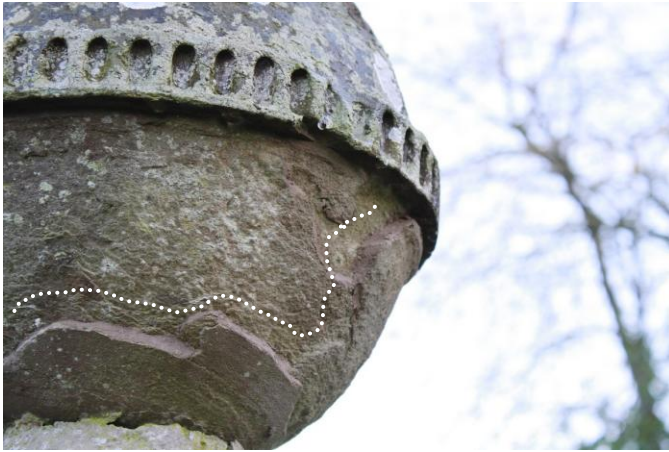
Extensive rationalisation was undertaken to the ball-final which had delaminated significantly, given the poor-quality sandstone and amount of carving and therefore shock imparted into the weak, laminar material. Perhaps surprising that the fluting within the horizontal band isn't more disrupted, given the work involved in its execution. Note the large support filling packed into the previously tacked laminations. Mortar colour is selected as the colour of the host stone/substrate and not the colonised surfaces.
