Final Conservation Report for Churchyard Memorials

St John the Baptist Church - Bishops Castle - Shropshire

The Diocese of Hereford

Elliott Ryder Conservation

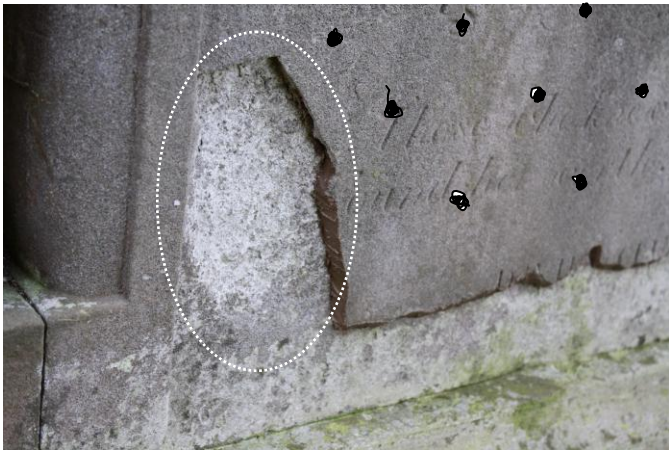
The lamination at the base of the inscription was tacked with resin previously and therefore was strong enough to pack repair mortar in, as far as possible. Grouting uphill is all but impossible so was discounted. Grouting could only be successfully achieved by filling the lamination and drilling into the carved surface at centres (indicated) to create a series of needle entry-points. This risks shattering the brittle, weakened layer and compromising the historic dedication, both of which are against conservation ethics.

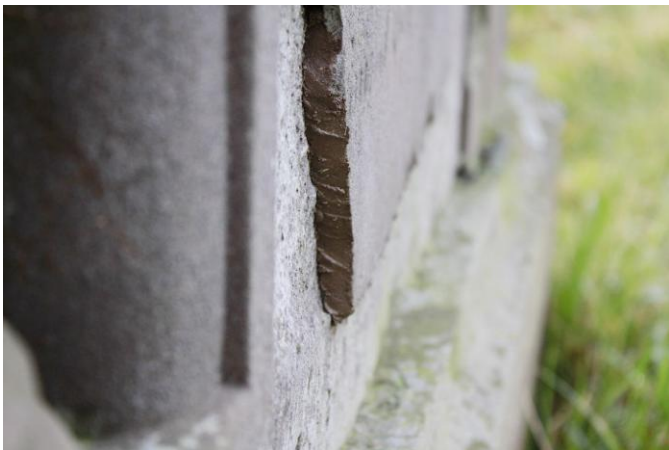
Support filling in progress, with mortar being packed into the previously open lamination. The upper carved, inscribed surface has deformed/curled outwards somewhat. Note the amount of material that has been lost, back to the revealed substrate. The white zone (indicated above) is efflorescence (soluble-salt crystals) of which exerts pressure on weak laminations when moving in and out of solution – re-crystallising, exploiting weak laminations or poor-quality stone.

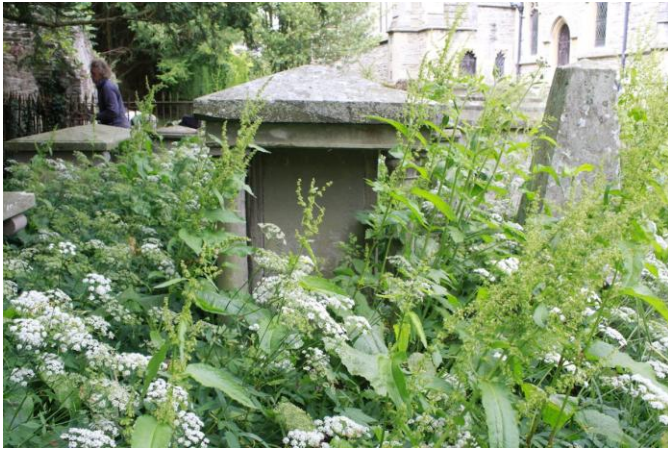
The east elevation of the Medlicott memorial before any treatments, highlighting the extent of perennial weeds and their proximity to the aged stonework. The memorial is also over-hung by a mature Yew tree. Both the weeds and tree keep ambient moisture levels high and provide a ready source of nutrients for the biological growths witnessed.

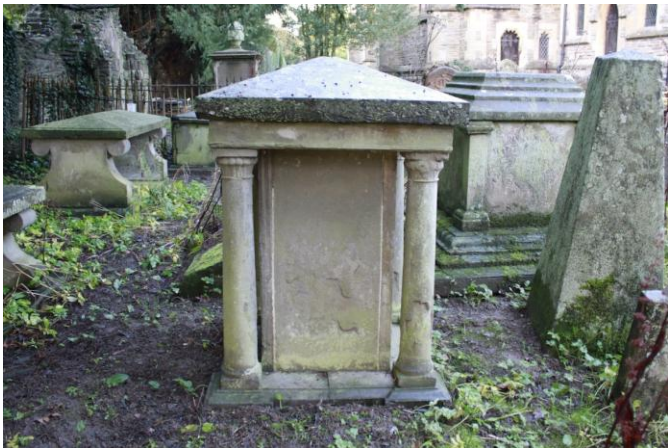
The memorial after weeds had been removed, to give unfettered access to all four sides. Note how the memorial appears to be out of proportion with the moulded-base now partially obscured, due to ground-level having risen significantly over the decades - from soil created by decomposing broad-leaf weeds and Yew needles. The 'short' box-panel on this elevation has been re-pointed the same colour as the remains of very-fine, failed joints.

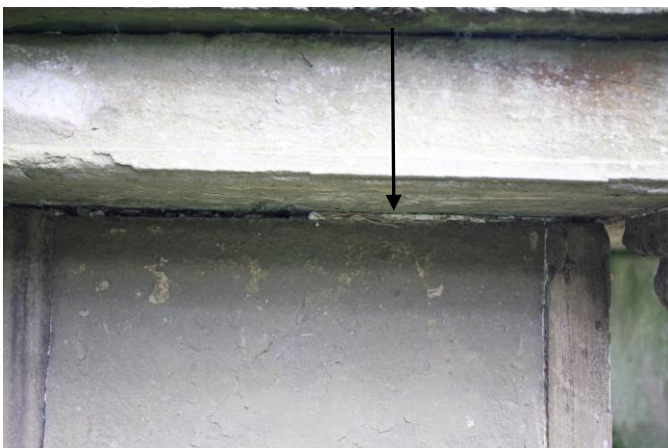
The fat-lime-rich mortar visible in the horizontal joint between the 'short' side-panel and capstone above. The joints are so fine on this memorial, indicating good-quality workmanship during its manufacture/erection and latterly, lack of movement in the structure, which has a relatively small footprint and obviously has well-established tree roots beneath it, as well as the likely interment below ground-level.

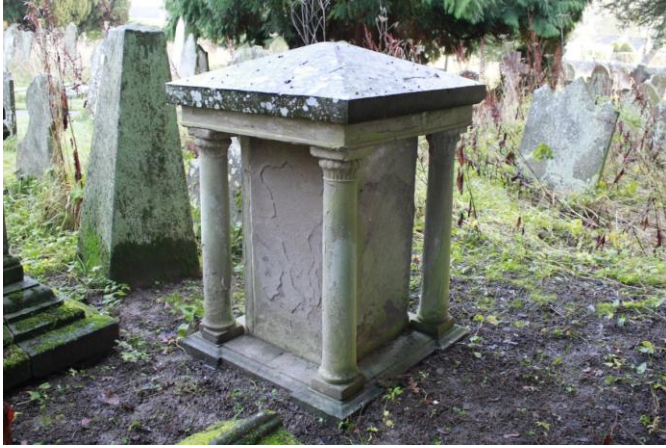
The south-west corner in the foreground. Note how the capstone (steeply angled on four elevations) is doing a good job of shedding nutrient-rich rainwater away from the colonettes and box-tomb beneath, which all appear drier after removal of significant weeds adjacent to it. The skyfaces of the capstone all display significant lichen growths, most notably the very tenacious white/grey genus.

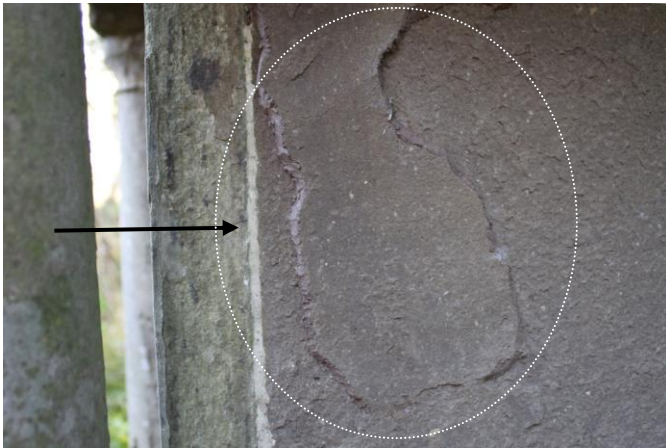
New vertical pointing between the long and short box-tomb panels (indicated). The island of original upper surface (indicated) has had coloured support fillings inserted into its perimeter, to minimise the risk of further loss of material. The adjacent substrate has been rationalised, that is loose, flaking stone beyond practicable repair removed. Flaking stone (not delaminating) harbours water more readily with all the attendant erosion problems, leading to accelerated deterioration.

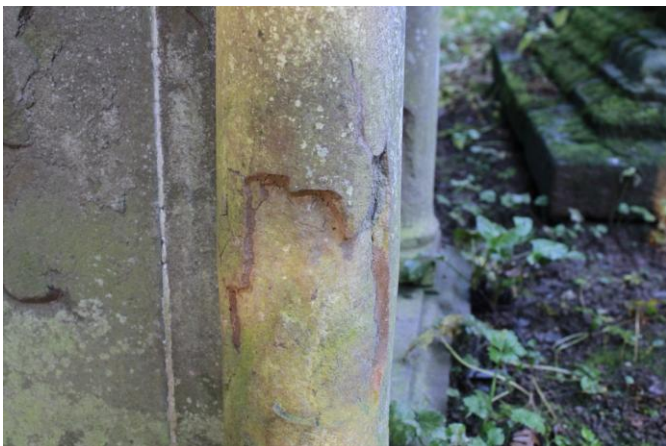
The colonettes displayed random areas of deep material loss, due to delamination. Loose stone was rationalised and support fillings packed into vulnerable edges that had been tacked with resin previously. It was not clear if the colonettes were turned on an early lathe or cut with chisels and finished by hand.

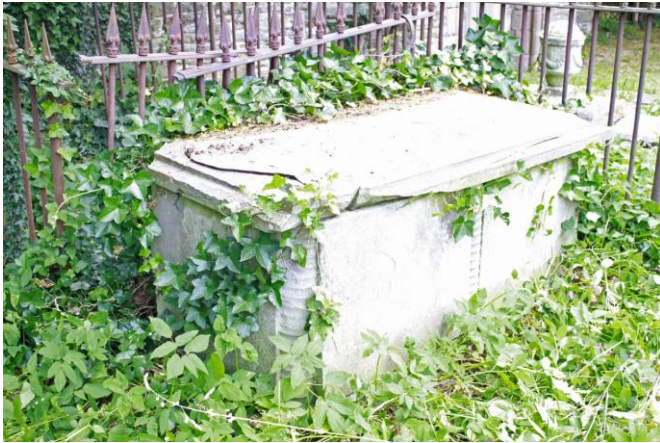
The Drew memorial before any treatments, note the broken and corroding wrought-iron railings resting against the stonework. Ivy was attached to the rear of the tomb chest and the railing had to be cut free to gain free access to the ivy. The ivy and bramble growths were removed in the Autumn of 2019 as well as emergency consolidation to vulnerable areas of delaminating stone.

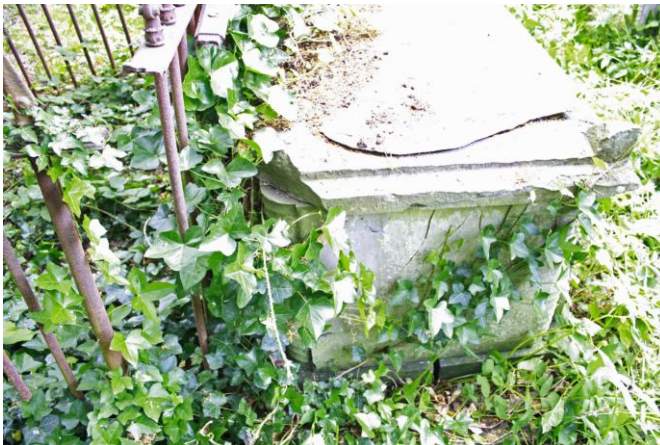
The east elevation, note the lamination in the lid, which was not caused by corroding fixings, which were in a sound condition. The lamination was caused by inherent weakness in the stone lid being exploited by weathering over a prolonged period.

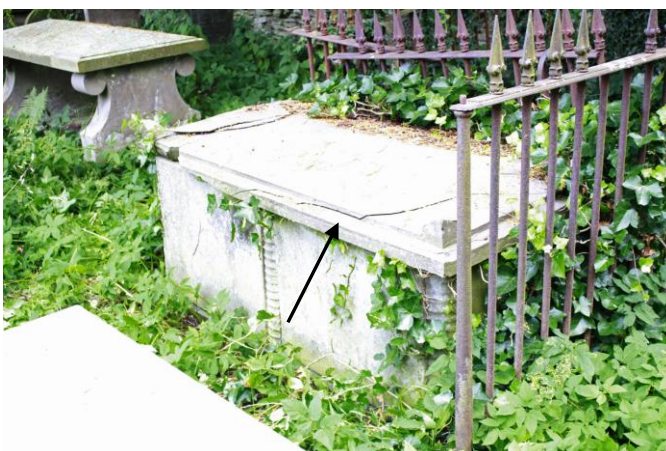
The lamination in the foreground (indicated) is where the stone has 'sprung' or deformed and is not attributable to ivy stems (of which there were none) or expanding iron fixings.

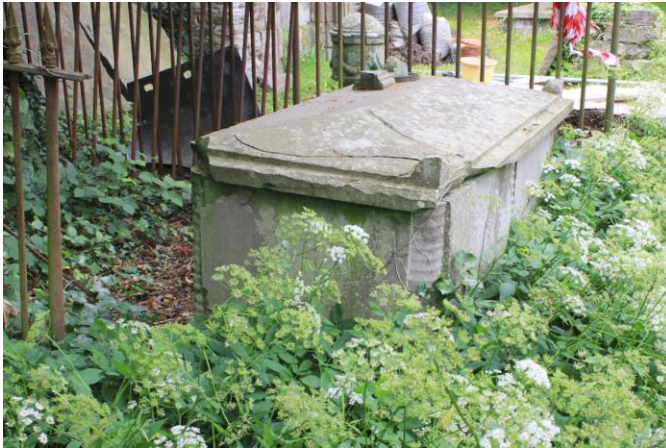
The amount of perennial plant growth that greeted us after cutting ivy and bramble growth back hard, to ground level not six months previously. Many of the plants are touching the stonework. Out of the shot above, is an over-hanging mature Yew tree, both plants and tree are a ready source of nutrients for biological growths visible over the whole memorial.

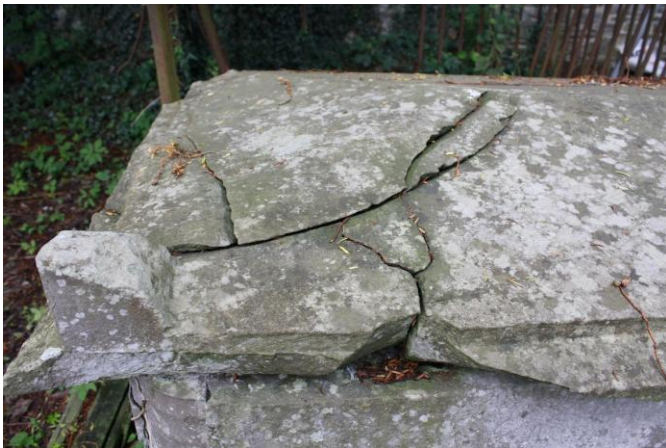
Vertical and horizontal fractures to the lid, the most significant of which follow bedding planes within the stone block. There is a shallow double-pitch to the lid meaning a lot of stone has been removed by chisel – punch, claw and flat chisels. The carving process of ‘wasting’ or removing stone will have imparted a significant amount of shock into the weak, poor-quality local material. Note how much of the outer moulding/nosing is now lost, despite searching in nearby undergrowth.

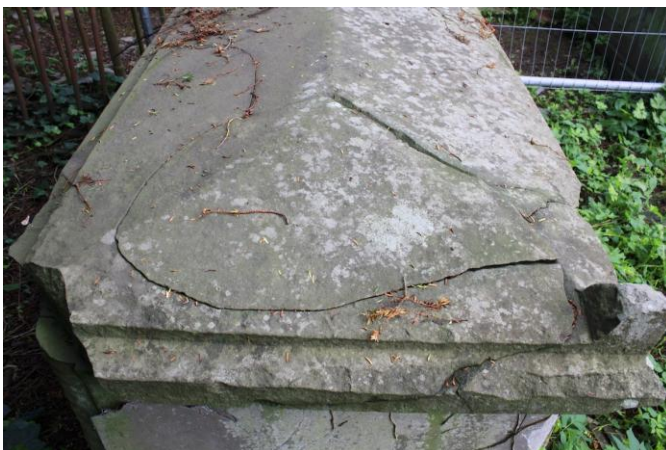
From the east elevation, the apex of the lid is more obvious. It is no coincidence that the east-end has been worked (chiselled) in two planes where the large section of stone is now detached.

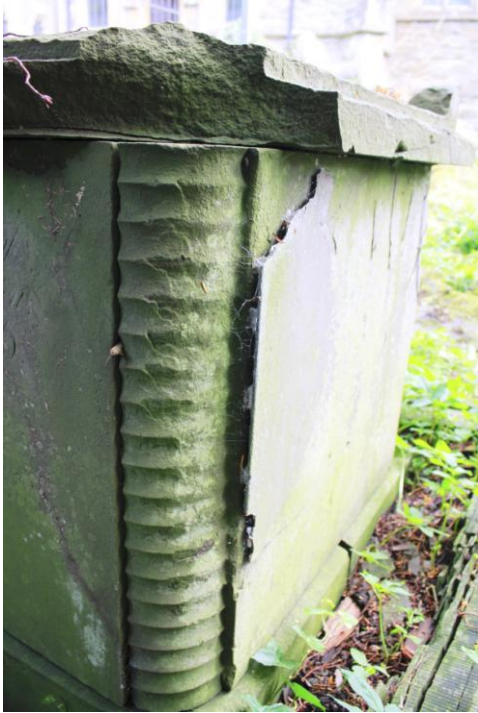
Emergency consolidation was carried-out by us in 2019 to the section of carved surface which was springing. Spots of resin were inserted along its length, to bond it back to the substrate and prevent un-wanted movement. Small sections had repair mortar packed in as far as possible, and then liquid grout was introduced to fill the void horizontally. This process was repeated until the void was filled vertically from the bottom to top of the lamination.

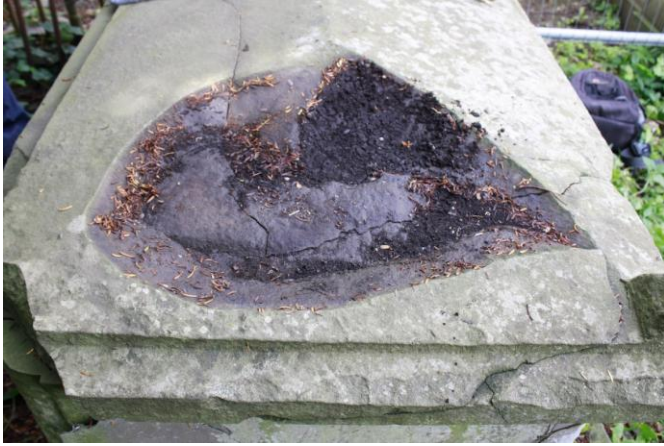
This section was loose, largely due to easy access for moisture, which exploits such laminations by repeated wetting/drying – freeze/thaw cycles. Soil debris has penetrated deep into the lamination indicating a long-standing problem for the weak building stone.

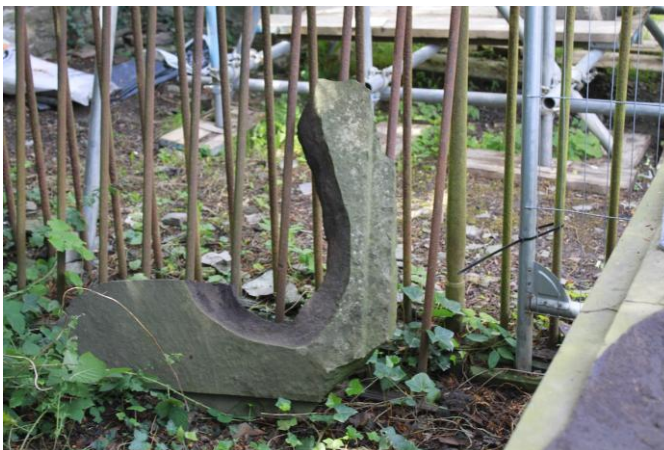
The removed fragment shows how random the delamination is in this weak material, following the bedding plane and not the worked surfaces.

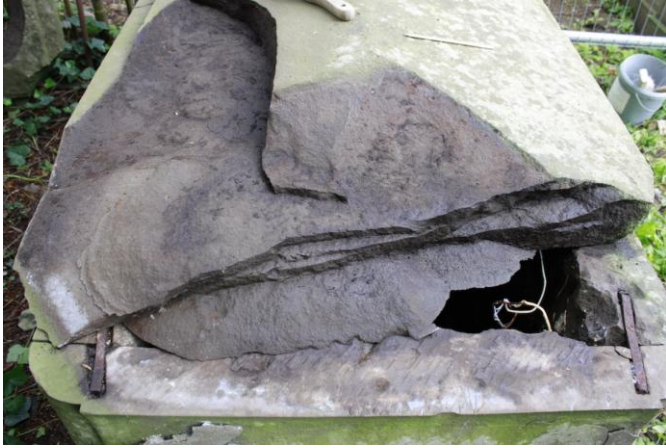
Luckily the laminations were overlapping, which makes for a much stronger long-term bond, as overlying fragments lock into place, with the aid of an external-grade resin. The hole in the bottom bed of the lid allowed sight into the core, which was largely free from plant growth and objects of any archaeological interest.

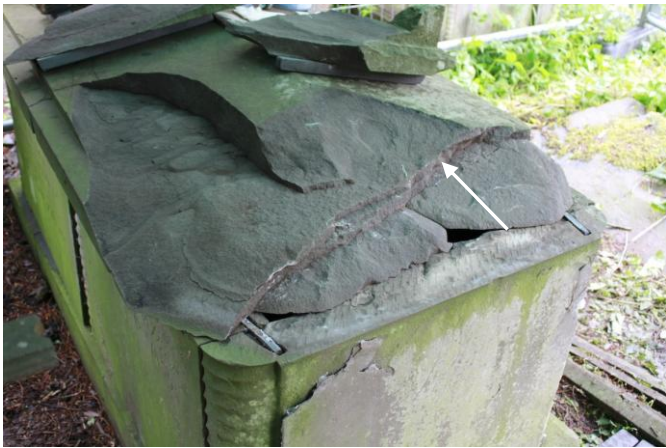
The different fragments were marked up dry and re-instated in reverse sequence to their removal. The two dog-cramps in the tomb chest beneath are just about to be secured with epoxy-resin. Note the true colour of the stone (indicated) in the parallel break edges, being a pinky-grey, not green, which is from almost complete algae colonisation.

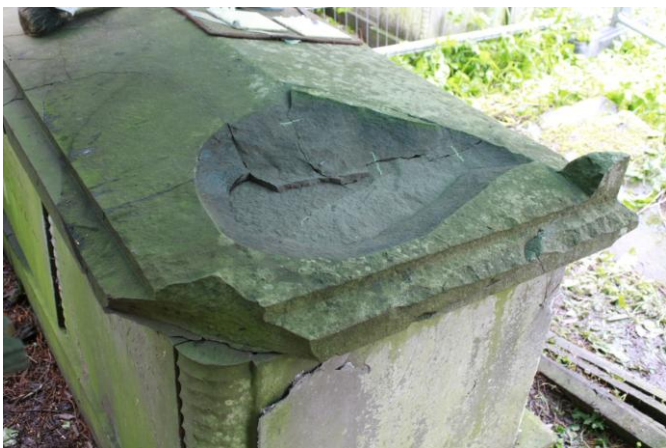
The last section of the lid about to be applied. Note the missing lower left-hand corner does not allow the lid to perform its architectural function in this area, and has been directing rainwater into the fluted corner and the adjacent section of previously loose upper surface.

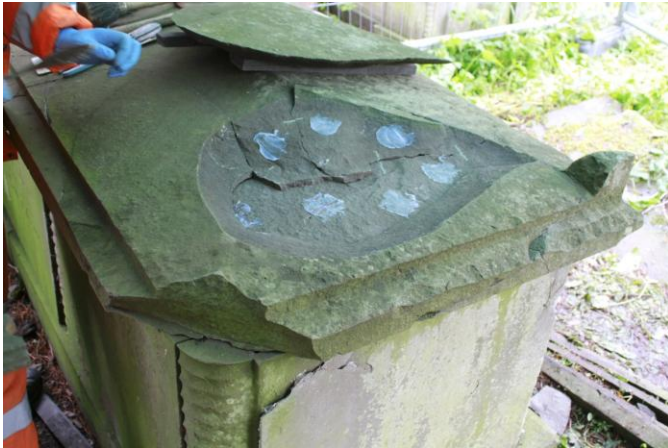
The final section about to be adhered. Again spots of resin allow the movement of moisture, which is inevitable. Despite the sections going back as well as possible there were still resultant gaps, as the breaks were old and the laminar stone had sprung.

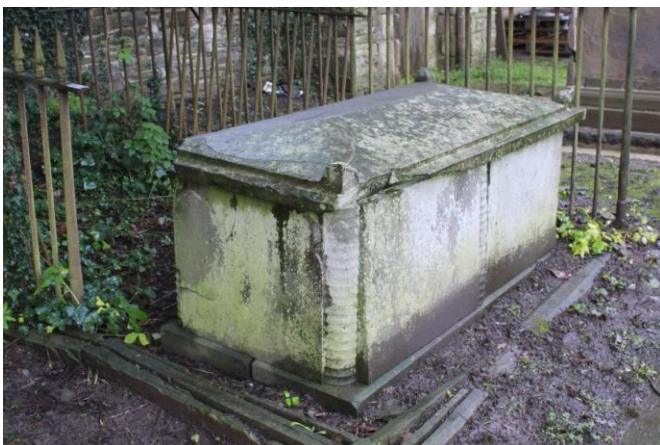
The tomb chest after all treatments. Note the kerb-set, which is the same material as the memorial and is much delaminated due to being poor-quality stone edge-bedded and expanding, corroding wrought-iron within it. Loose sections of railing had previously been removed and placed carefully within the remaining railings.

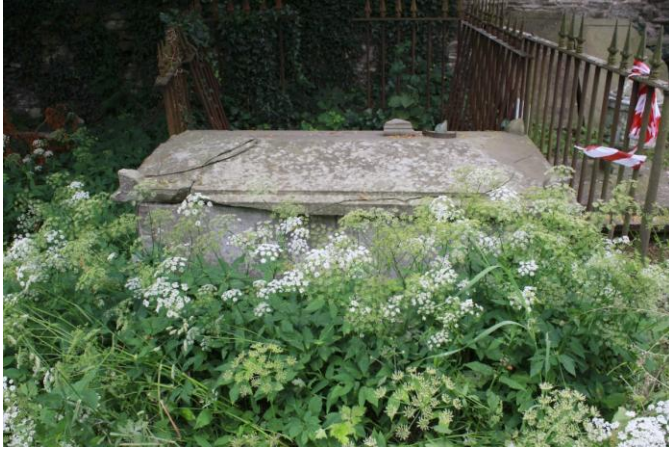
The amount of perennial growth that can occur in one growing season. This should be kept back and away from the conserved memorial. If this area has to be trimmed, it should not be against the stonework, which is vulnerable to physical damage.

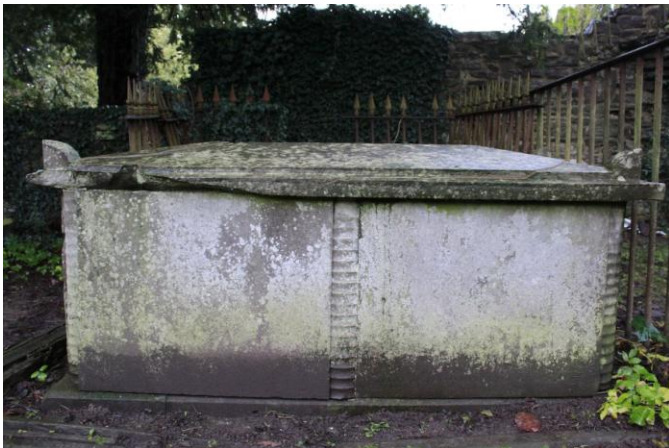
The undecorated north elevation of the tombchest covered with white/grey lichens which are particularly tenacious and difficult to remove, if you wanted to do so.

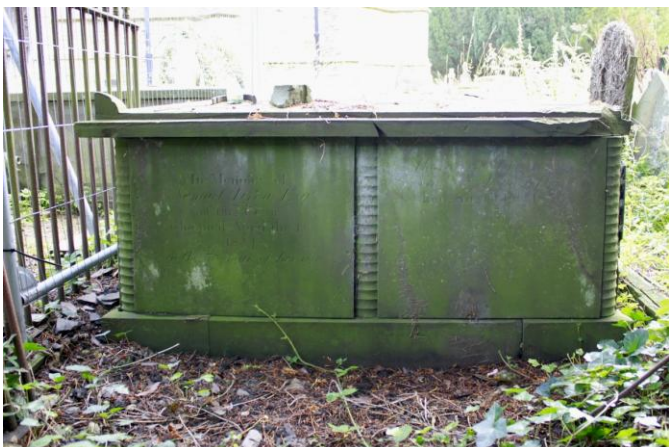
The more protected south elevation which displays the beautifully carved inscription on the viewer's left-hand panel, between the fluted colonettes. This side displays few lichens, as on the opposite elevation, but a well-established bright-green alga. This elevation was completely covered with thick ivy and bramble within the railings, keeping the little daylight available from the surface.

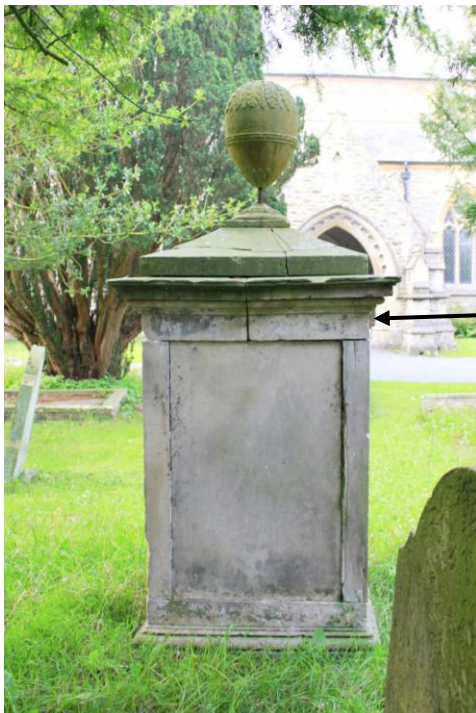
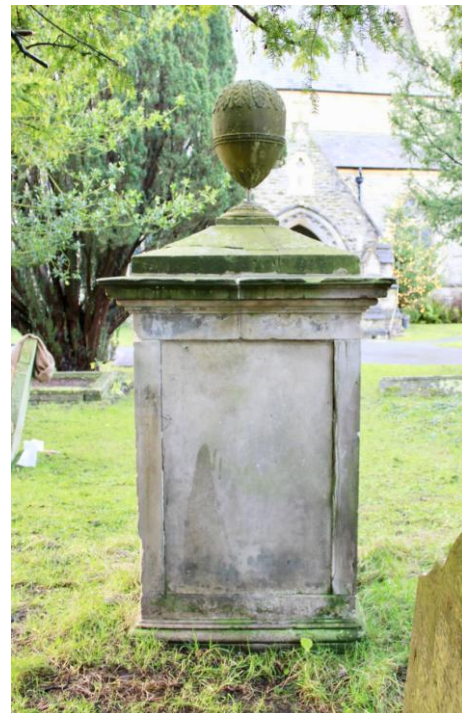
The rear, north elevation before (left) and after all treatments. Note how the moulded entablature (indicated) shows a dovetailed, vertical, central-joint, due to failed fixings - causing point-loading on the 'short' box panels beneath, at the front and back. That situation was significant on this elevation, contributing to the inside of the panel delaminating in half and being substantially weaker as a result. The resultant joints lines have all been pointed from back to front, with a fluid, gunnable mortar.

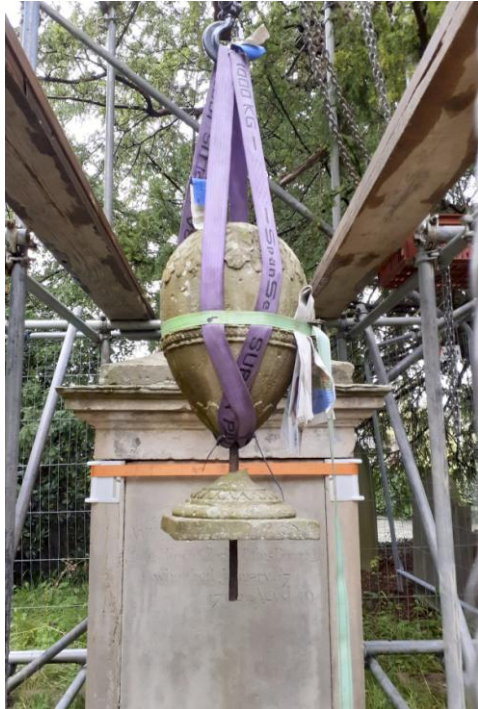
It was easier to separate the compromised sections at ground-level as well as making lifting easier. Note the section of missing neck, which was forced off at an earlier date. On the right, the underside of the expanded dowel which split the capstone. Expanding iron can exert huge forces on a strong albeit natural material.

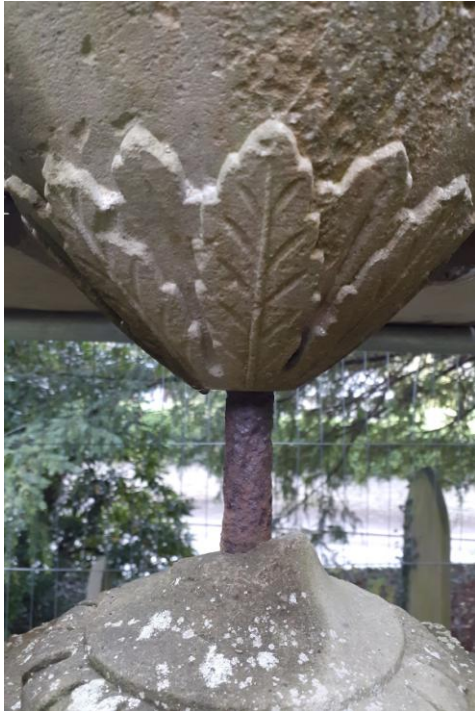
The missing section of the stone neck before dismantling. On the right, the new threaded stainless-steel dowel, secured plumb into a now deeper hole in the ball-finial with epoxy-resin. Drilling-out the corroded dowel from the ball was difficult as it had been set in with lead and there very little room between the edge of the lead and the small diameter of the carved stiff-leaf detail.

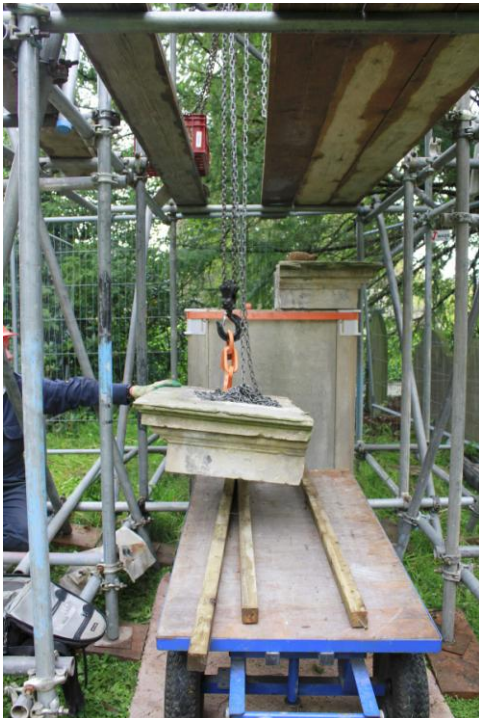
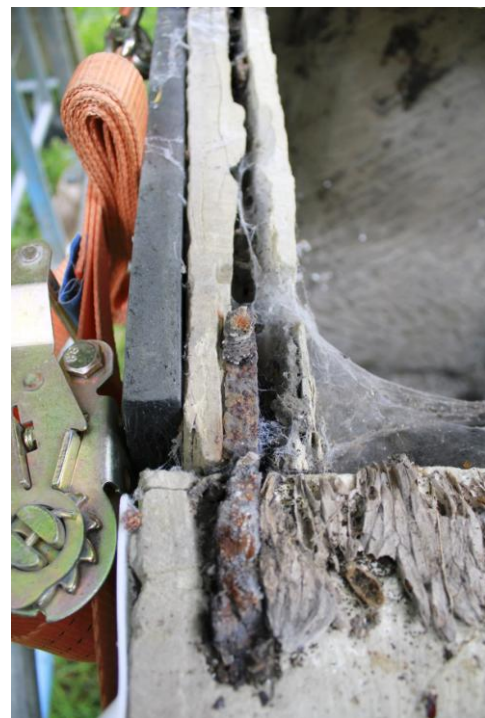
One of the heavy entablature sections being lowered down with the aid of the Lewis-pins. This made things much easier when re-building, as the heavy units could be lowered exactly into position without having to remove thick slings. On the right, one of the seriously expanded corner cramps, which had caused delamination of the already thin 'short' side-panel. The remains of several wasp nests were discovered in the by now wide joints, not in the box-tomb itself.

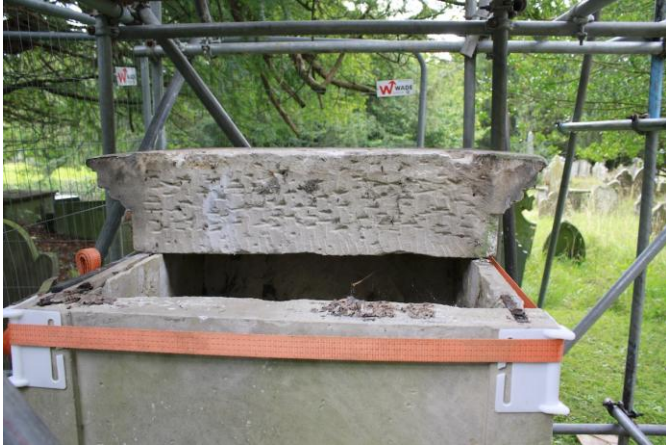
A 'punched' surface on the central joint between the two blocks. The tooling is to provide a better key for mortar, when the two blocks are butted against each other. The orange ratchet strap was necessary to prevent the 4 side panels moving once they were un-weighted as all the fixings had failed.

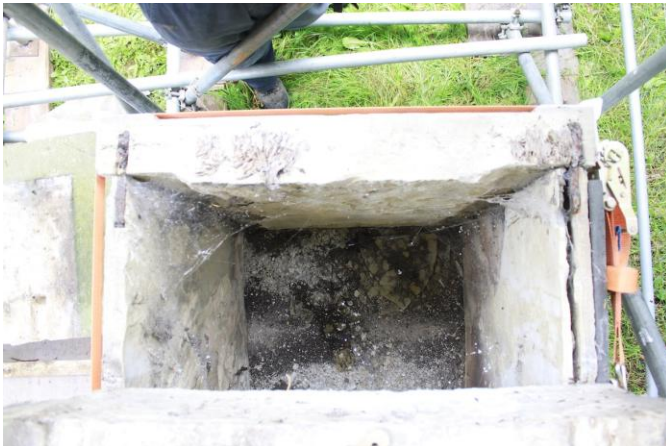
A birds-eye view inside the box-tomb. Note the north and south 'short' panels are much thinner than the thicker 'long-sides'. The lamination is in the north panel, caused by face-bedding, expanding cramp in a laminar stone and point-loading from the overlying entablature blocks.

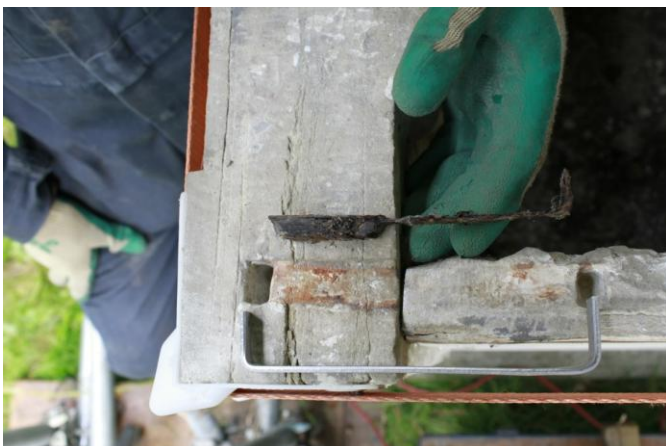
One of the corner cramps which initially had expanded, significantly - causing upward movement in the heavy entablature (jacking) and is now a thin delaminated fixing with only one, fairly useless turn-down, the other having disintegrated. The new stainless-steel cramp in the foreground. Note the laminations in the thicker stone panel follow the carved surface, with the slab being face-bedded.

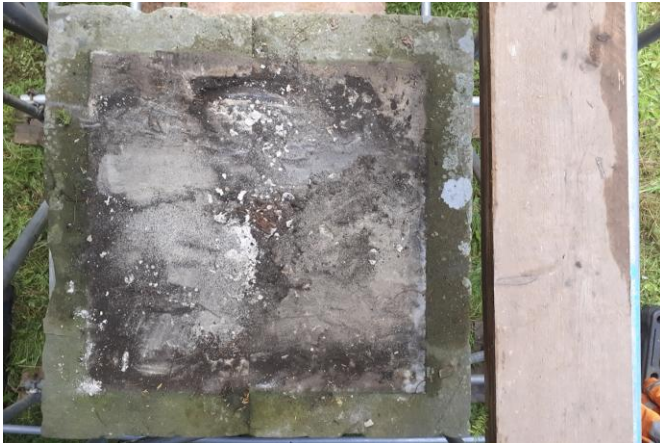
The top-bed of the entablature after removal of the capstone. Note the amount of debris in there, which is introduced by water, from defective/empty joints due to lack of maintenance.

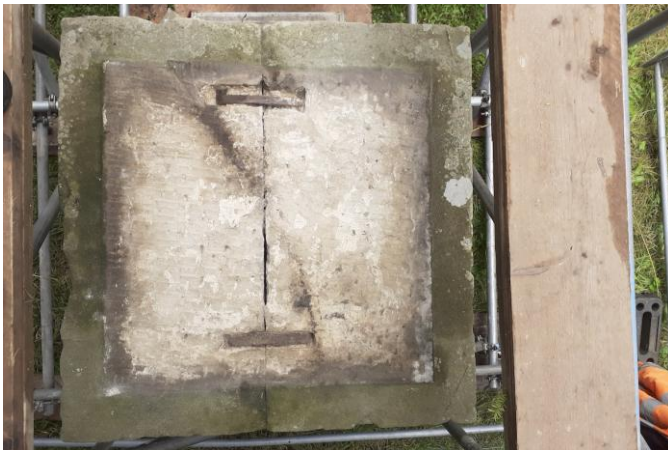
After brushing to removed defective bedding mortar and debris. The two fixings have failed, allowing the joint to collapse in on itself. It would have been better to include slate in the joint so they couldn't rotate, causing the point-loading they did, in the 'short' box-panels.

The turn-downs were filled with lime mortar, which is a soft material anyway but didn't stand a chance once excess water had got in and was allowed to sit there, due to defective pointing. The fixings were simply lifted out with a chisel. The central joint was stoned to stone and it shouldn't be. We used new stainless-steel cramps secured with epoxy-resin and lead shims in the central joint, so the blocks can't move again.

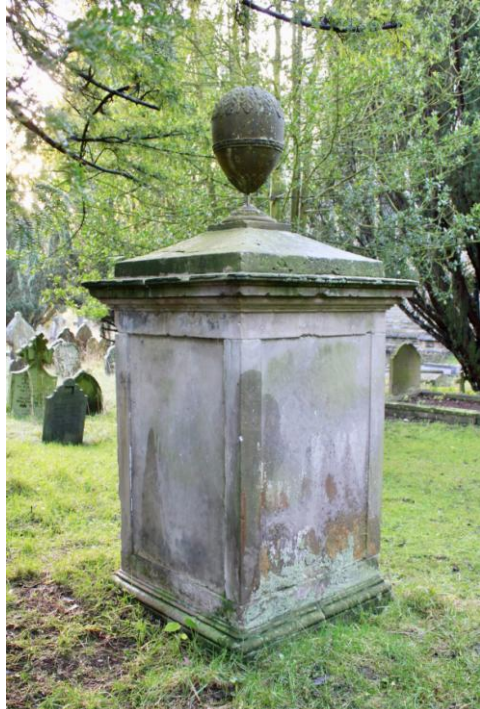
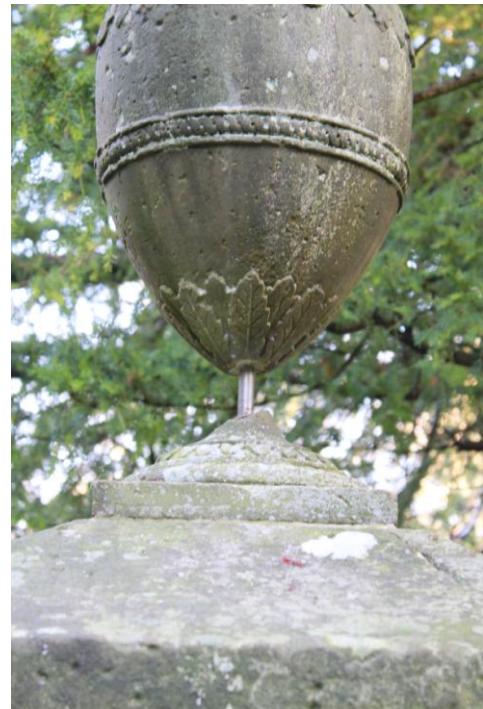
The re-built memorial after all remedial treatments. The new stainless-steel dowel was cut to give the same gap between the broken sections, as was the case before dismantling.

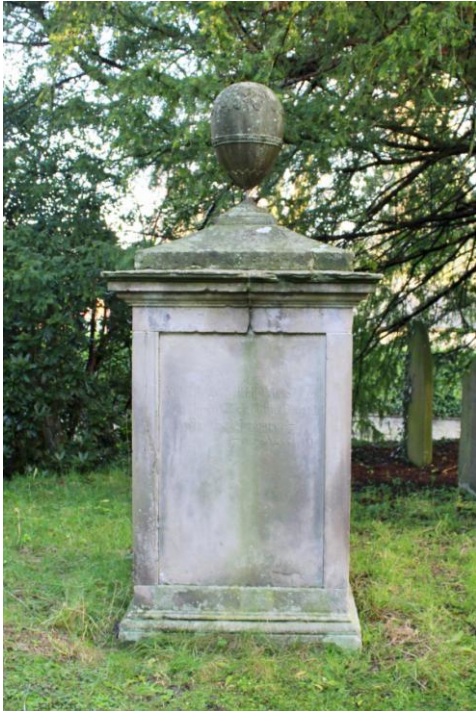
The south elevation of the memorial after all treatments and re-building has taken place. The fracture in the capstone was a natural fit and went back together tightly. Note the green colonisation already in a matter of months, on the new vertical joint in the entablature.

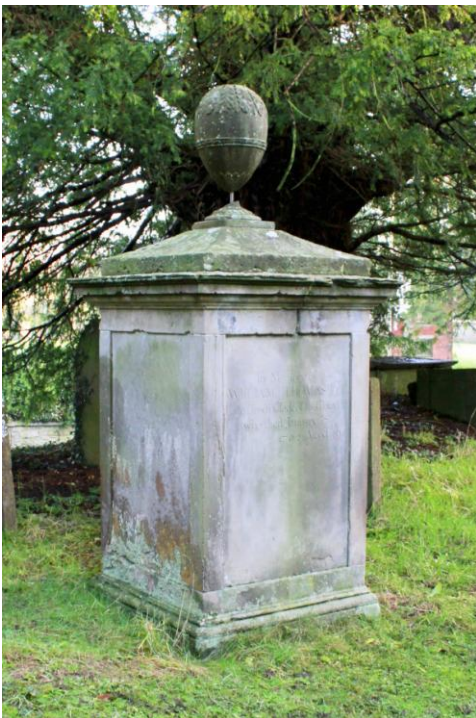
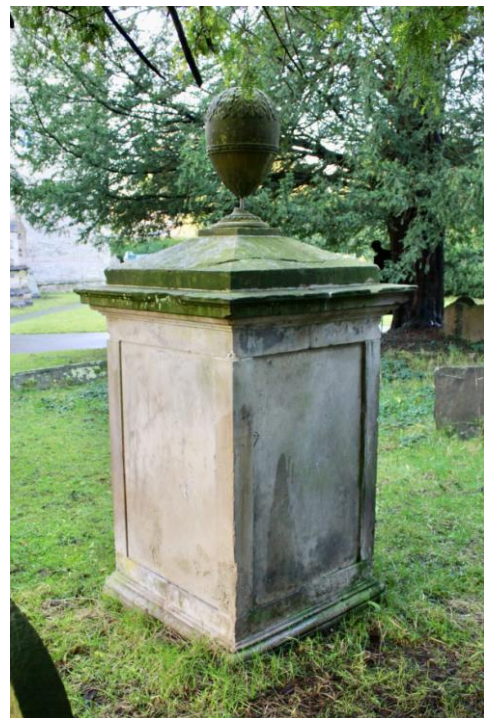
On the left, a three-quarter view of the south-west corner, looking like nothing has happened, except all the horizontal joints are now parallel and you couldn't push it over. On the right, the north-east corner shows the nearly white, new mortar (the same colour as the original mortar) is already colonised and doesn't stand out, due to the location of the memorial beneath trees and that it wasn't cleaned.

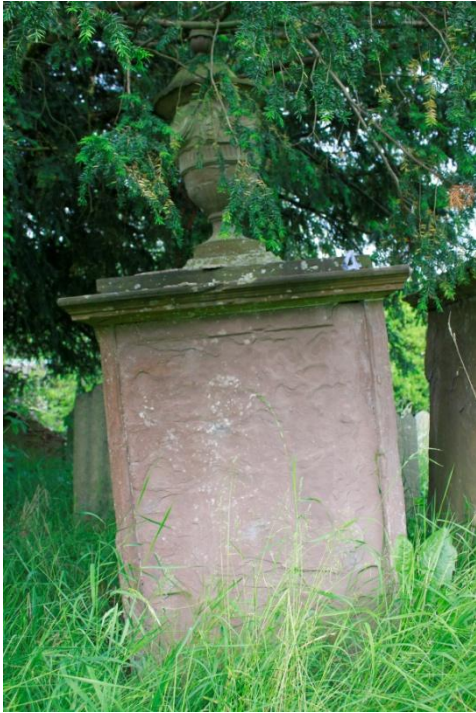
- 1.7 The composite urn on this memorial had suffered differently to that of its neighbours, with branches physically touching the upper elements of the urn-lid, which were found to be off-set and actively loose on top of the draped-urn section as a result.

The memorial before any treatments, note on the left the branches are actually touching the upper sections of the urn. This shouldn't have been happening to a listed memorial. The left image highlights the angle of subsidence, whilst the right shows the amount of the moulded plinth that is now below ground level.

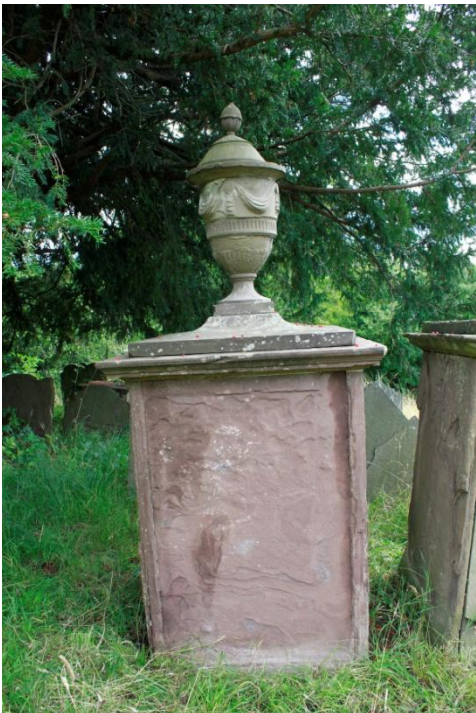
After our initial removal of over-hanging branches, showing the now off-set positioning of the upper urn sections, which were loose and could have been dislodged/damaged during high winds, with the tree moving enough. Despite the perhaps alarming stance of the memorial, the joints are parallel and tight with no signs of separation. The bed joint beneath the capstone was in a relatively sound condition.

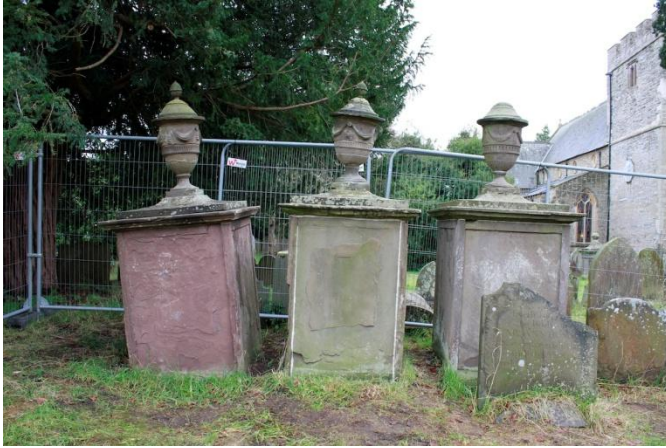
The three strikingly similar box-tombs next to one another. Note how vividly red the sandstone panels are to the Home memorial. All three memorials have been completed in this image.

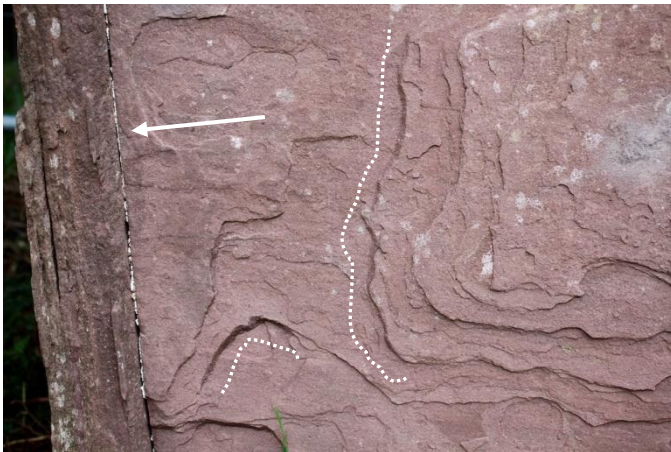
Classic contour scaling/delamination on one of the elevations to the memorial. The panels were all rationalised to remove loose, de-laminating areas of substrate (not upper carved surface) beyond practicable repair. Getting back to sound stone, but delamination is progressive. Note coloured support fillings applied into vulnerable edges (some indicated). And the fine, vertical, white, fat-lime joint between the adjacent 'long' panel.

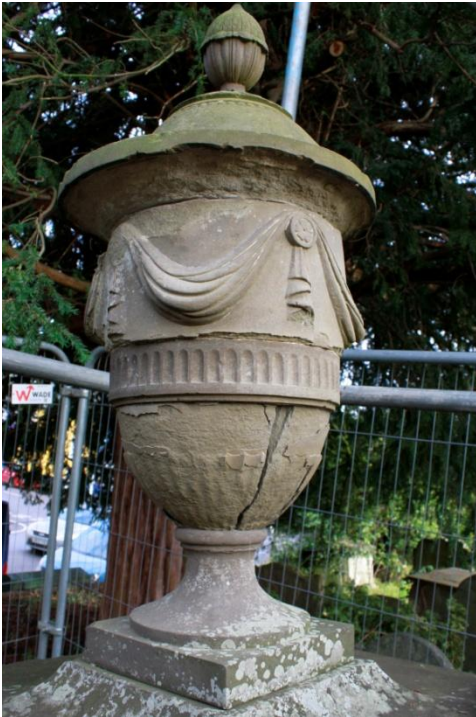
- 1.8 The diminishing fluted urn-base beneath the draped section had fractured in two, due to the expanding internal, iron-dowel. Luckily the delicately proportioned diminishing neck was intact (which could act as template in the future for the crudely repaired neighbour) despite a heavily expanded dowel passing through it and on downwards, beyond the bottom-bed of the capstone such was the length of the dowel.

On the left, the urn prior to dismantling, note the lid above the swag or draped layer is loose and could have been dislodged in high winds, causing damage to these carved elements. On the right, the top-bed of the diminishing lower-urn during removal of the expanded iron-dowel. The existing fracture, both sides were full of organic debris and insects.

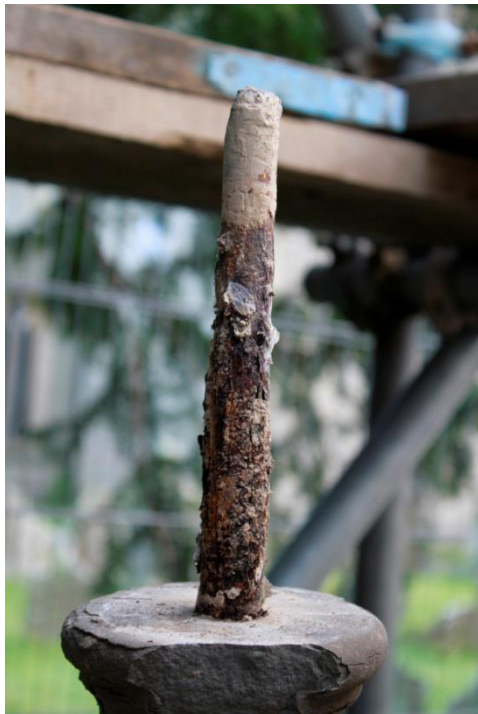
On the left, after removal of the fractured lower section, see how the delaminating iron-dowel had expanded into the available space before forcing the stone apart, exerting huge pressure to split the block. On the right, the repaired lower urn section with new, threaded stainless-steel dowel issuing from the top. The drill-hole between the steel (which cannot corrode) was filled with a pourable anchor grout used in civil engineering.

- 4.1 The drill hole through to the capstone was packed with tin-foil at depth and a two-part, epoxy anchor-grout poured in. A pre-cut length of threaded stainless-steel dowel was secured into the correct depth and the material allowed to cure overnight. Its position was fixed using a bolt and washer to ensure it was at 90 degrees to the top-bed of the neck and the urn would be in the correct (albeit angled) alignment, with no point-loading.

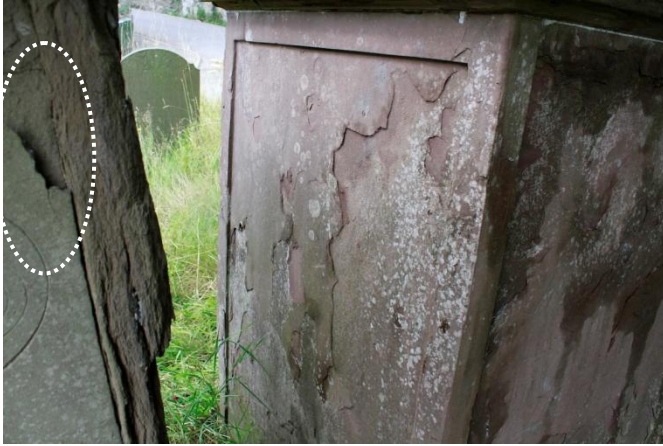
Support fillings being inserted/packed into laminating areas. The stone was so delaminated it was difficult to know where to stop. The area indicated was grouted because it can cause more damage trying to pack in repair mortar to deep voids. The corner on this memorial has suffered particularly badly as corners are points of greatest evaporation, taking harmful minerals and soluble-salts in and out of solution.

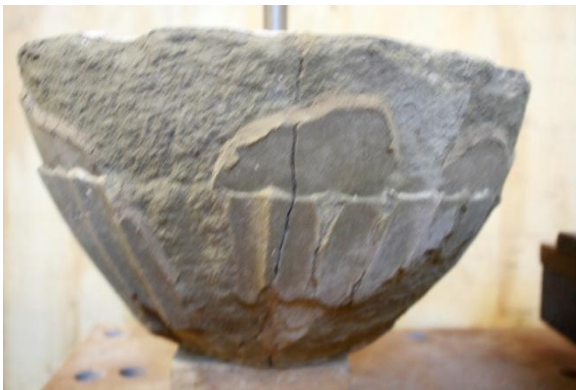
The diminishing base to the urn after being re-joined and before the new cramps are secured into position, to strengthen the bond further.

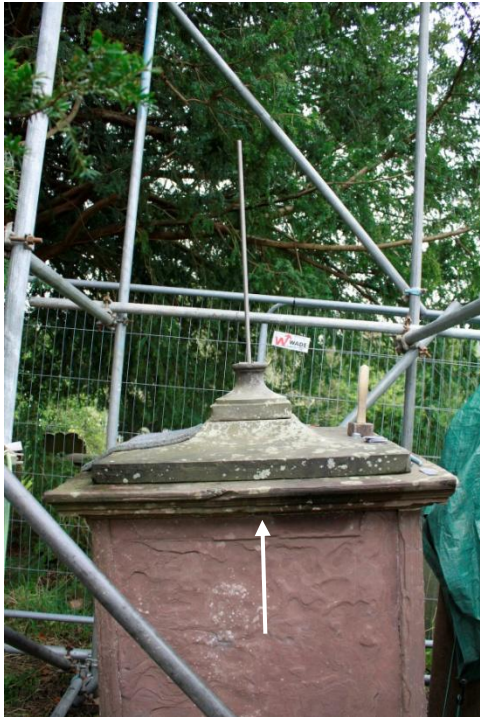
The threaded stainless-steel dowel secured into position with an epoxy anchor-grout, that penetrates deeper holes even further than gunnable resin. This material was used because of the length of the dowel hole, which was only secured with mortar previously. The urn is heavy, on a leaning capstone and therefore needs to be solid. Three smaller strips of Code 4 lead were used to create a stable, parallel bed (plus the pointing mortar after) and facilitate cutting the dowel if needs be, in the future. All resins employed are water-proof in the long-term.

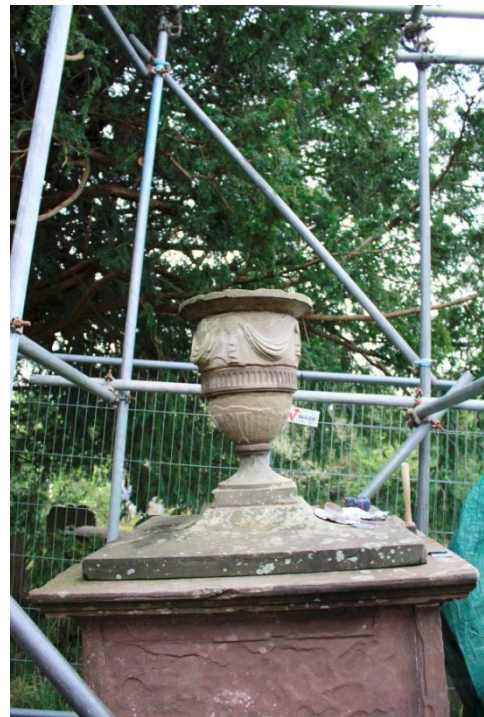
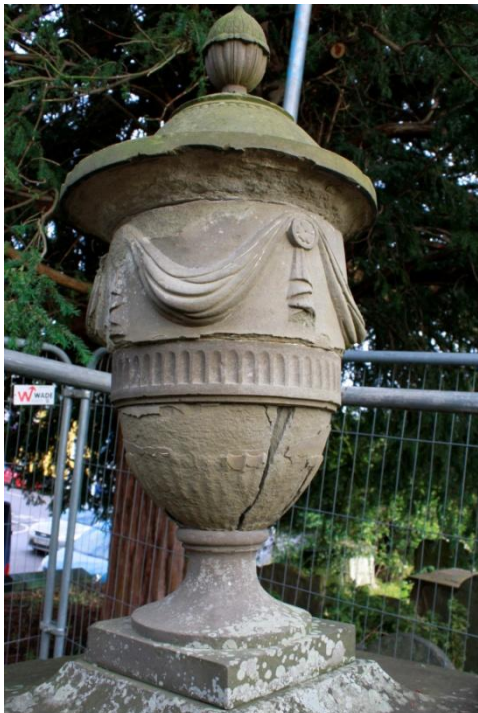
On the left, the urn-base bedded into position and a length of dowelling used to determine the exact length required. It extends down to where indicated. On the right, the diminishing lower-urn and draped/swag level, secured into position with the anchor grout. There were no fixings above the lid, historically, just bedded into position.

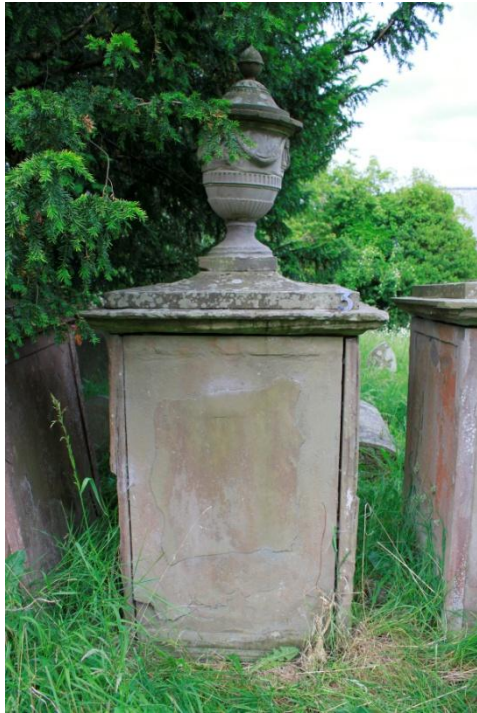
The memorial to Mary Hughes before and after all treatments. On the left, the Yew tree branches brushing the urn, prior to being pruned back. The box panel on this elevation was actively loose when the capstone and urn were lifted off. The new pointing mortar is the same colour as the original fat-lime mix.

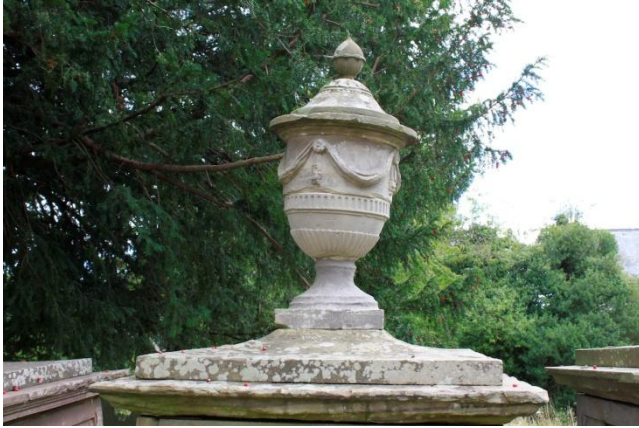
The square base and diminishing neck look nice from far but are far from nice. The base sits over the underlying stouling, where there should be a rebate in the other direction. From the lid upwards was dismantled, so these elements weren't damaged during the lifting process.
