Final Conservation Report for Churchyard Memorials

St John the Baptist Church - Bishops Castle - Shropshire

The Diocese of Hereford

Elliott Ryder Conservation

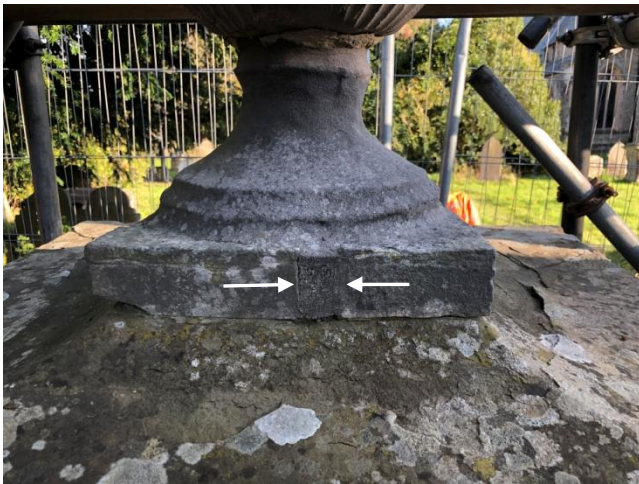
- 1.5 The composite urn on top of the capstone has suffered more than its neighbours, judging by the crude historic repair to the urn-base and neck. The base has obviously been fractured into four pieces and displays wide joints on all four elevations, leaving the urn-base sitting beyond the stooling beneath, when it should be stepped-in to form a neat rebate. The round moulding and neck have been crudely repaired with a cementitious mortar. Despite it looking unattractive and been in a material now deemed inappropriate (due to it being too hard) there were no signs of material or structural breakdown, or staining from the likely still ferrous dowelling within.

A detail of the crude cementitious repair, with a wide joint on each elevation of the base (indicated) where there should be no joint. Despite looking ugly, the repair shows no signs of iron-staining or any structural breakdown. A unanimous decision was taken in consultation with members of the DAC, not to dismantle this section and monitor its condition going forward. Note the extent of biological colonisation on the repair medium, indicating it has been there for a long time.

- 1.6 We deemed it would cause avoidable damage to the historically, repaired surfaces if we sought to remove and replace the likely iron fixing, especially in light of our experiences with the urn on the neighbouring box-tomb to William & Ann Hughes, where the dowel was nearly 400mm long. The decision to leave the urn alone was at odds with our initial assessment at time of tender, which was conveyed to the Project Manager (Mrs Harriet Carty). The PM convened a meeting with the DAC secretary and its Architectural and Archaeological Consultants - Mr Andrew Arrol and Mr Andrew Pike respectively. The issue and options raised were discussed on-site between all parties involved and the unanimous decision was taken to leave the urn un-molested and monitor its condition.

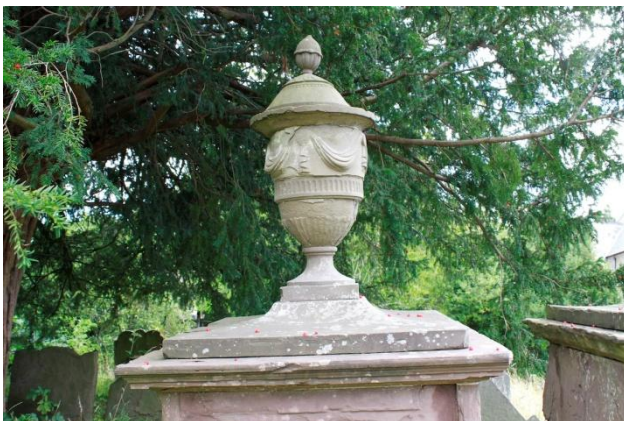
The same detail as above but stone, from the neighbouring Home memorial, which is intact despite of corroding iron. See how the square base sits within the stouling beneath.

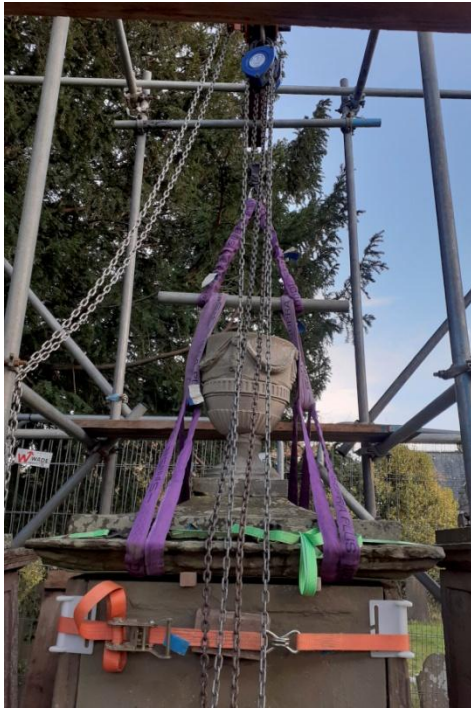
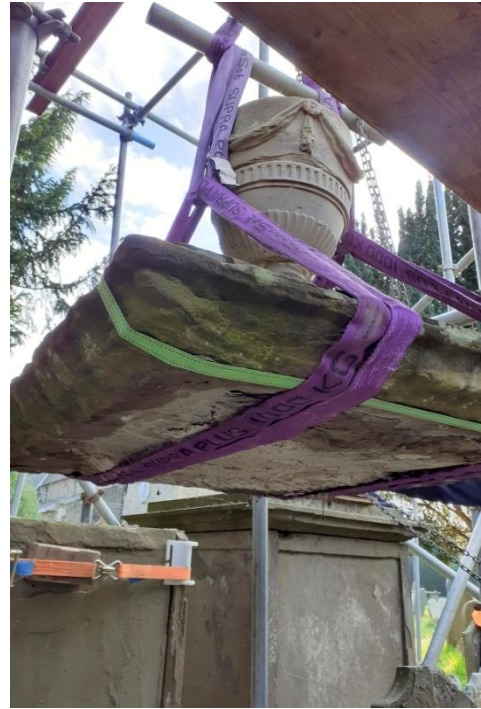
On the left, the urn-lid having been removed. A spreader bar was still required to prevent the slings pinching the weak, carved swag details. The lift was difficult as the weight of the whole urn was focused on a small footprint at the centre of the wider capstone, meaning the slings had to move inwards to overcome this. Note the rough-nature of the bottom-bed of the capstone when in mid-air.

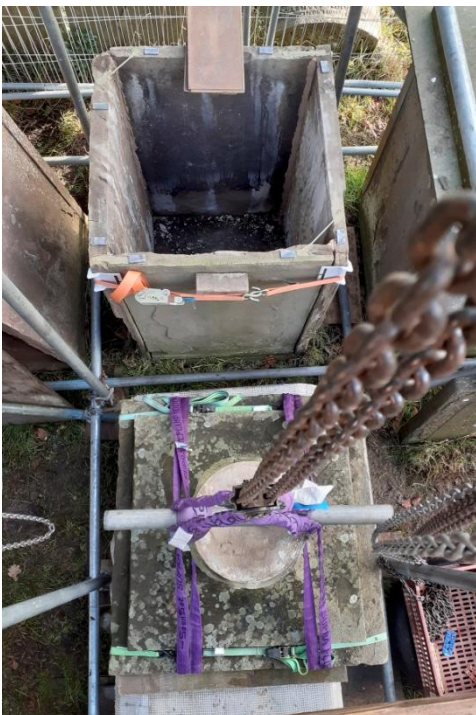
- 2.4 After removal of the capstone it became clear the four iron-cramps at the corners were providing no restraint, as they had either failed or were delaminated. Despite the restraining ratchet strap the west elevation panel was actively loose. The fixings were easily removed with chisels and the sockets removed of dead-metal whilst deepened to provide additional support. Fortunately there were no side studs in the centres of the panels, which we had been expecting after the previous memorial. The sockets and channels were enlarged to receive new stainless-steel fixings which were fabricated next to the memorial.

When the capstone was removed the stone panel in the foreground, closest to the chain, moved forward against the ratchet-strap. If the strap hadn't been there it would likely have fallen against the capstone being lowered. On the right, the inside of the box-tomb after the internal mitres have been removed of defective mortar and new mortar packed in, to increase rigidity and prevent moisture entering the structure. There was no plant-growth of any kind in either of the partially dismantled box-chests.

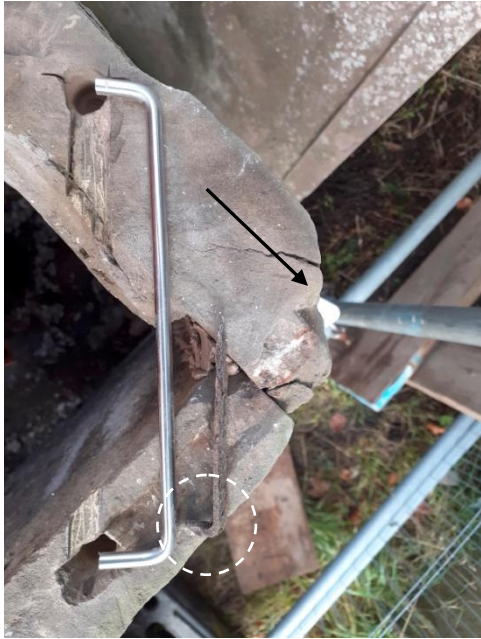
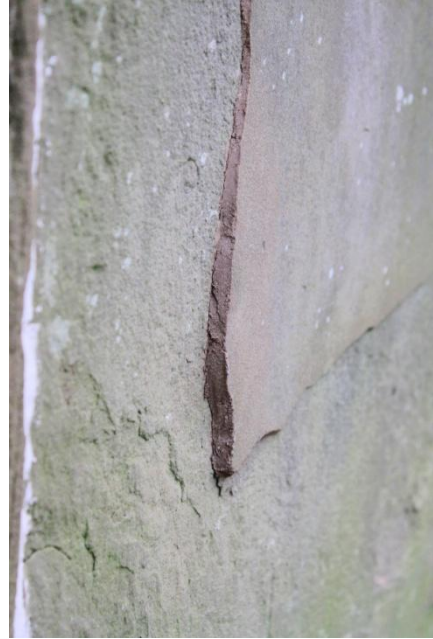
On the left, the remains of a laminated iron-cramp. One of the turn-downs is now missing but had forced off the outer corner due to its expansion. Note how small the remaining turn-down is (indicated) and the depth of the new stainless-steel turn-downs, with holes drilled deeper. As the corner was lost a new socket was created diagonally across the mitre, so that the cramp wouldn't be seen. On the right, one of the laminations filled partially with a coloured support filling then grouted before more filling, protecting the smooth, carved upper-surface to the right.

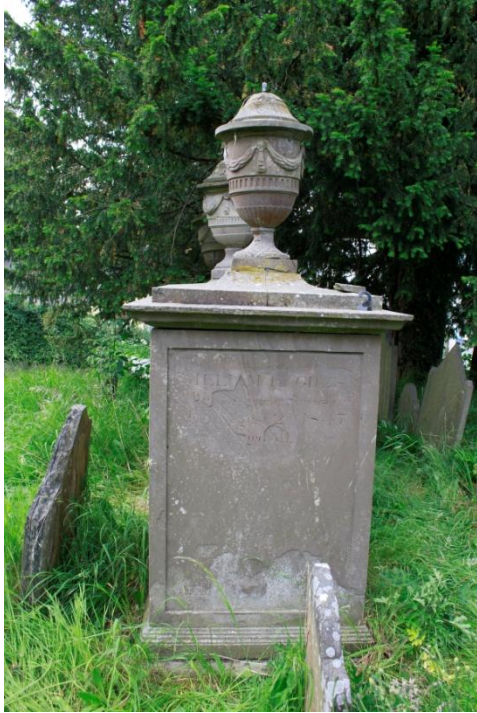
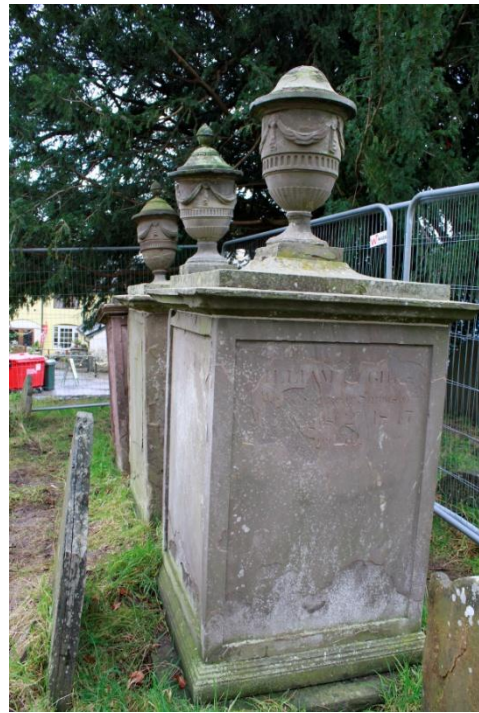
The south elevation of the memorial to William & Ann Hughes before and after all treatments. Note the parallel joint between the capstone and the box-panels, pointed on the right image. The shallow, moulded plinth and sub-base is just visible through the grass on this elevation.

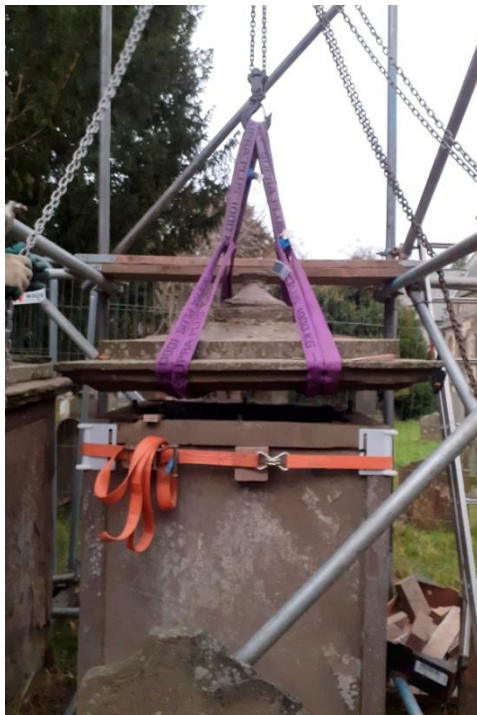
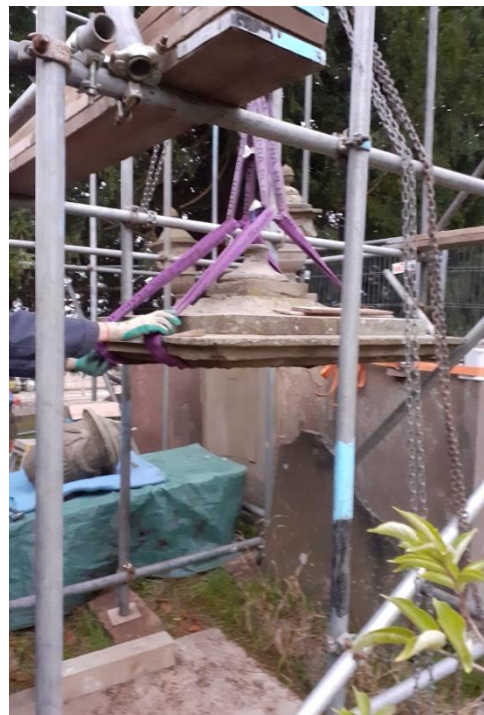
Once the urn was removed, which was also lifted using the block and tackle given its combined weight, the capstone and urn-base was raised slightly, moved horizontally on the girder-trolley before lowering onto the turn-table truck below and away from the area of work. Note the very uneven nature of the bottom-bed of the capstone, with the surface having a rough 'punched' finish from the workshop.

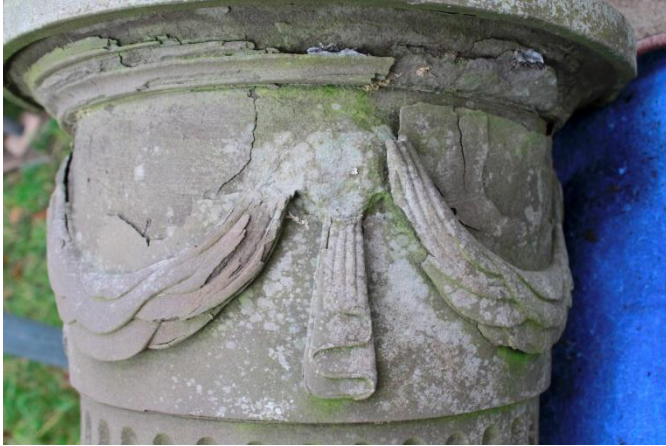
The poor condition of the urn showing laminations concentrated around the moulded and high-relief carved areas. The stone obviously takes carving well given the sharp detail, but weathers poorly, something the masons of that period were probably unaware of. Note the resin behind the laminations carried out as part of the emergency consolidation, in advance of surface filling.

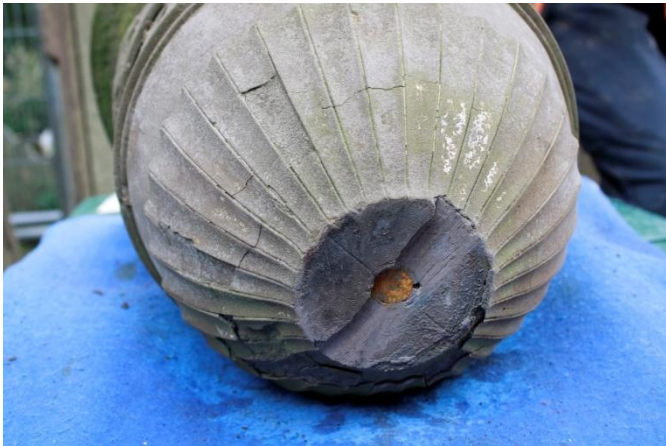
The dowel in the bottom bed of the urn, which had expanded to fill the hole and fortunately was not that deep. We lengthened the hole to give deeper embedment for the new stainless-steel fixing. Note the laminations (following sedimentary bedding planes) horizontally through the fluted decoration.

- 2.4 The dowel in the urn had been set-in with molten lead and luckily wasn't drilled that deep into the urn-base. This was eventually released by drilling around the perimeter of the fixing. As there was very little embedment, the hole was deepened to receive the new, threaded stainless-steel dowel and ensure a stronger long-term fixing.

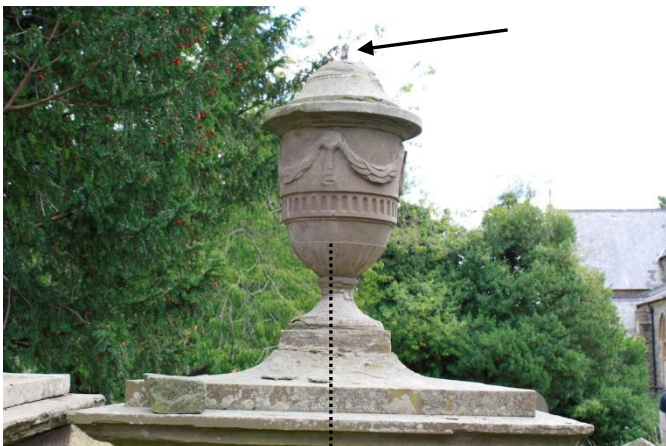
- 2.3 The dowel had to be removed from the stone urn-neck, by drilling around the perimeter of the expanded iron. The dowel extended vertically all the way through the neck, on past the bottom-bed of the capstone. This required our longest, small diameter drill-bit, to drill around half the perimeter of the dowel before it was released. The iron had expanded into the historic drill-hole, but luckily hadn't fractured the urn-neck or capstone as witnessed on other memorials.

The urn before its removal. Note the thin, stone neck remained intact despite having to drill a series of holes around the perimeter of the embedded iron dowel to release it, which was over 50cm long. The hole in the urn was extended to below the horizontal fluted decoration, to make it more solid. The iron dowel from the lid (indicated) was removed and resultant void filled with repair mortar.

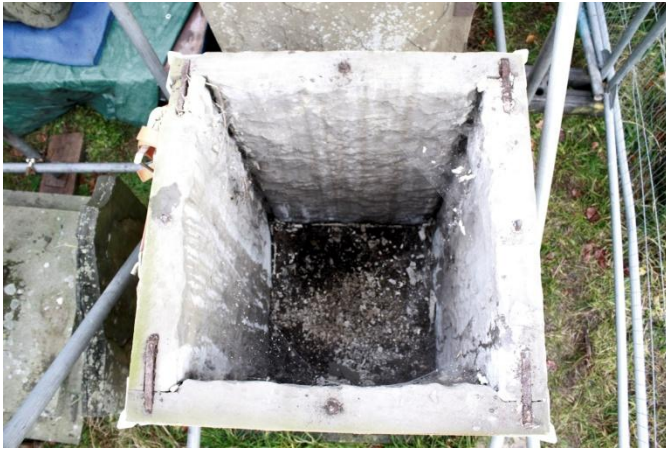
The top-bed of the box-tomb, showing the much more substantial fixings at the corners. Threaded locating studs lead into position were also incorporated in the top bed, making this memorial seem much more sturdy – that is until the iron starts delaminating and expanding, causing structural issues. There were no plant growths inside this box-tomb.

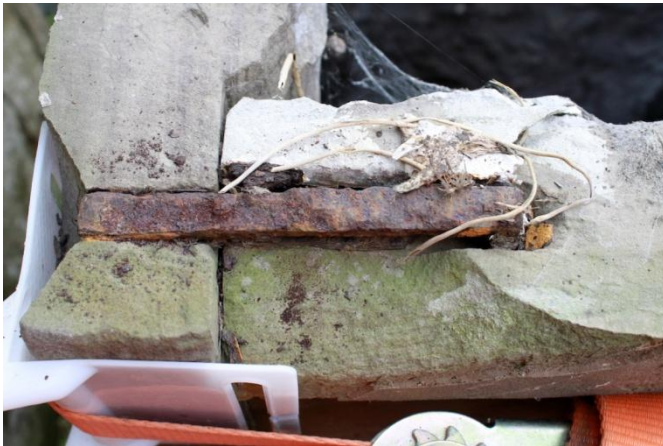
This cramp from above, has forced off stone on two elevations and raised upwards, forcing the capstone up. The broken stone has been long gone judging by the biological growths on the break edge, in the foreground.

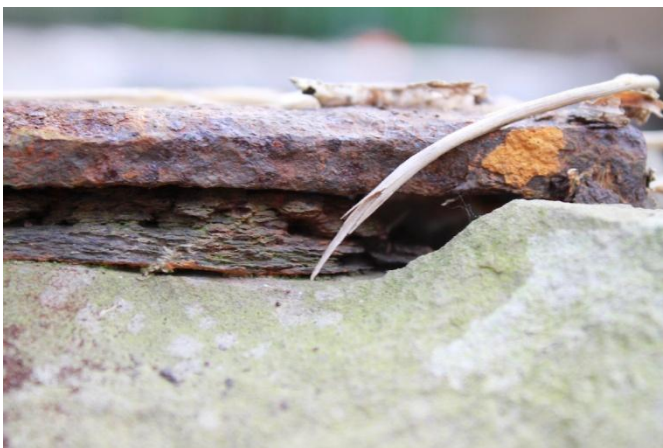
The same iron-cramp from the front. As the corrosion product slowly formed the large increase in volume has raised the fixing upwards. The smoother surfaces would have had the same flaky appearance but have detached once exposed to the elements, when the stone was forced off.

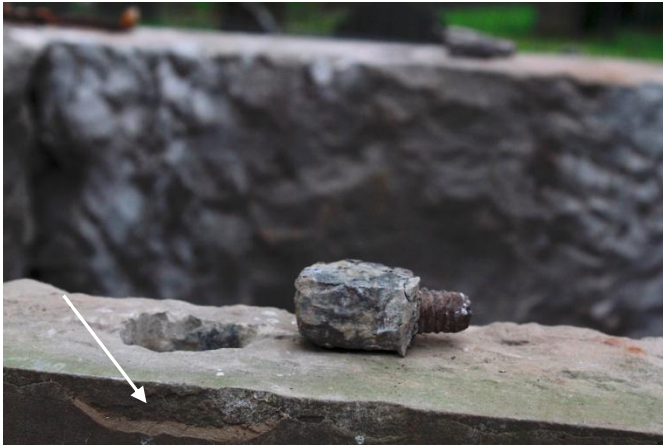
One of the threaded iron locating lugs, which we didn't see in any of the other memorials dismantled. There was one in the centre of each elevation and weren't replaced, as there was no need for them. A support filling can just be seen beneath the hole for the stud (indicated).

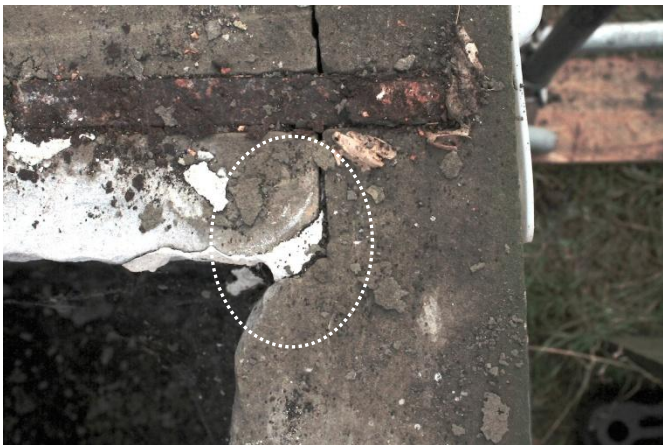
Another corroding fixing that has corroded to fill the sockets and joining channel, with corrosion product on its top surface. All the fixings were set in with mortar. Note the internal mitres have been filled (indicated) with the same fat-lime, pointing mortar. This was all removed and replaced with new mortar to provide additional support.

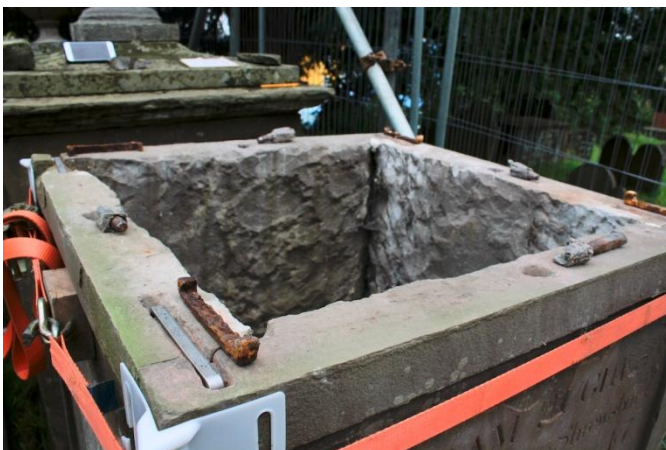
The top bed of the box-tomb showing all the iron fixings and locating bolts removed and new stainless-steel cramps about to be secured into position with epoxy-resin. This box was of much sturdier construction compared the memorial to Mary Hughes. The four slabs were much thicker and the fixings of a bigger scale to start with.

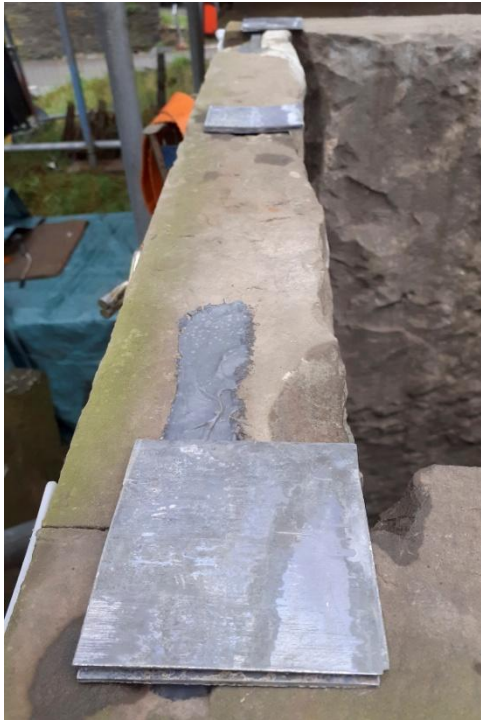
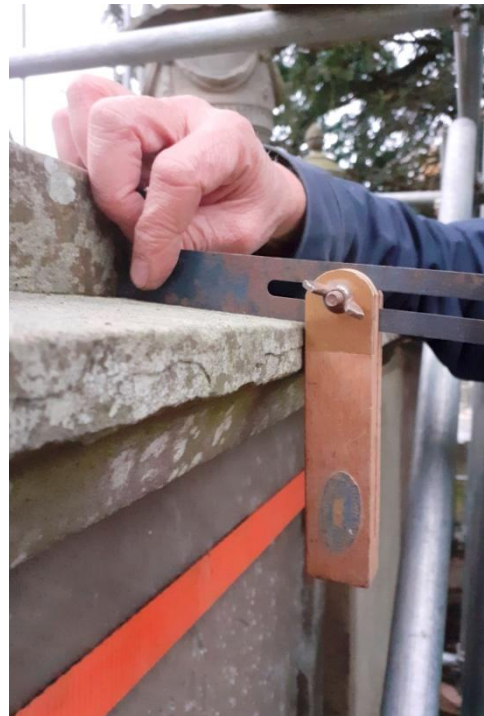
Lead shims in place over the epoxy-resin (to ensure a parallel joint) prior to dampening the stone and applying a thin mortar-bed at the rear of the panels, so there was something to point against, when introducing mortar through the front joint. On the right a sliding bevel to take into account the weathering of the capstone and ensure the capstone was located centrally side to side in both axis's, when coming down off the timber battens.

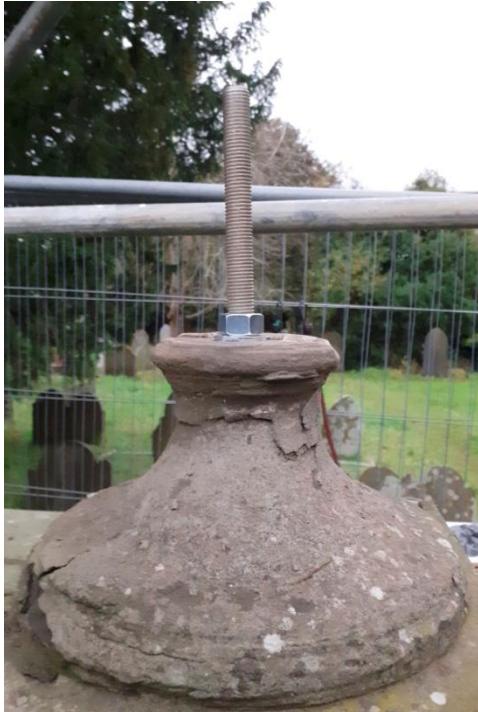
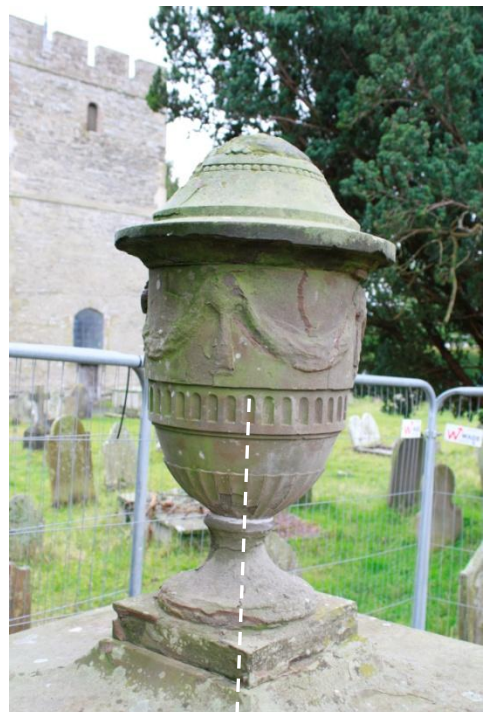
On the left, the 15mm diameter, threaded stainless-steel dowel secured temporarily at right angles, to the stooling on the urn-neck (whilst the resin within cures) as the capstone was not level. On the right, the completed urn in position. Note the depth of embedment of the new dowel (indicated).

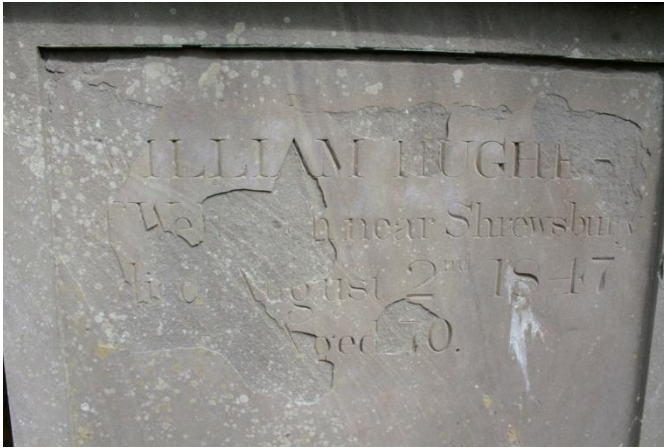
The dedication to William Hughes on the south elevation prior to any treatments. The stone is face-bedded and delaminating and risks losing even more carved detail. The sinking which is beneath the now raised border has undergone additional tooling to make it flat, then smooth and then the surface is lettered with the dedication. All these processes impart significant percussive-shock, creating micro-fissures in this poor quality stone.

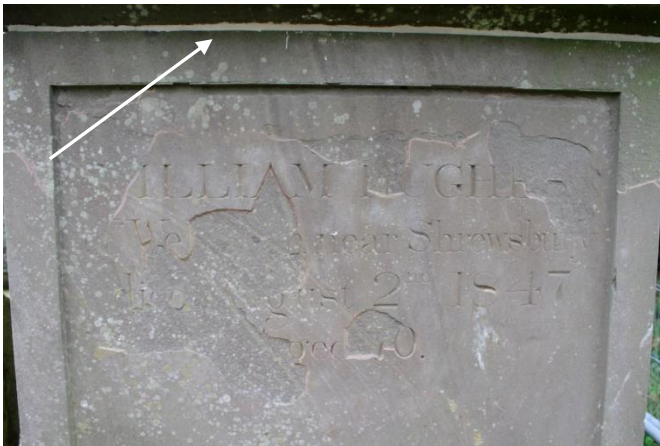
Discreet support fillings were inserted into and behind laminations to slow-down the ingress of moisture and all its attendant problems. Note the horizontal pointing (indicated) the same colour as the original fat-lime, but with a hydraulic lime NHL3.5 binder which is compatible with this stone type.

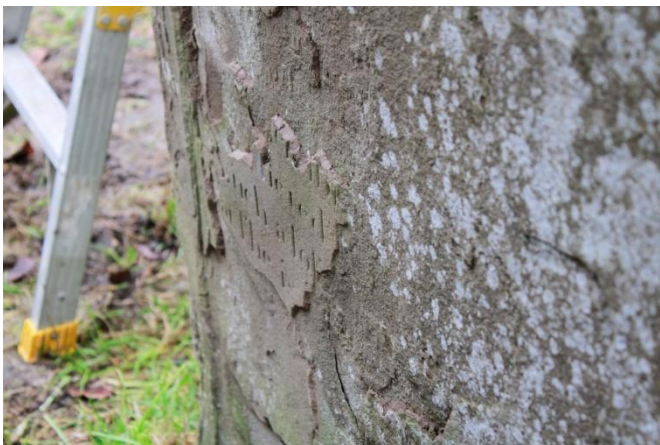
An island of surviving upper carved detail which was filled and grouted to prevent entry points for water and slow down the rate of deterioration. The stone on this elevation is so weak due to its lithology. You can see the depth of the substrate that has been lost, making the island of surviving stone all the more remarkable. Note the extent of white lichens to the right of the surviving inscription.

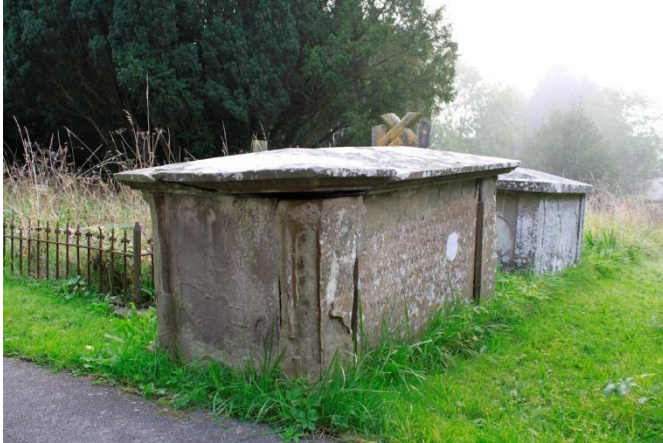
- 1.1 The tomb-chest was in an extremely unstable condition having sunk into the ground at an alarming angle at the west elevation closest to the path. The stone of this memorial, is the same poor-quality, laminar stone type to the majority in this project. Stone elements displayed significant delamination and loss of material, with individual blocks much thinner in scale and the lid being too thin for its length again.

The memorial to William Powell before any treatments. Note the plinths proximity to the path, the degree of subsidence in the foreground, disruption/misalignment of the lid corner and delamination in the pilaster beneath that corner.

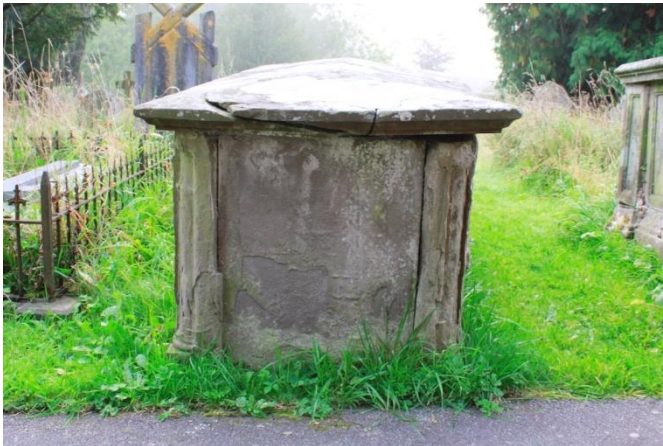
The west elevation of the memorial, highlighting subsidence in two planes east – west and north – south. The laminations in the lid can be seen more clearly in this image, largely attributable to the level of deformation witnessed in the underlying tomb chest.

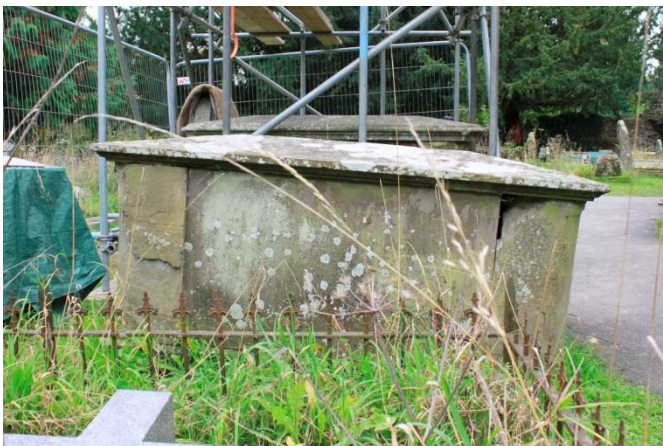
The north elevation of the memorial highlighting the extent of subsidence and the proximity of the path. The iron railings in the foreground are more or less level across their top.

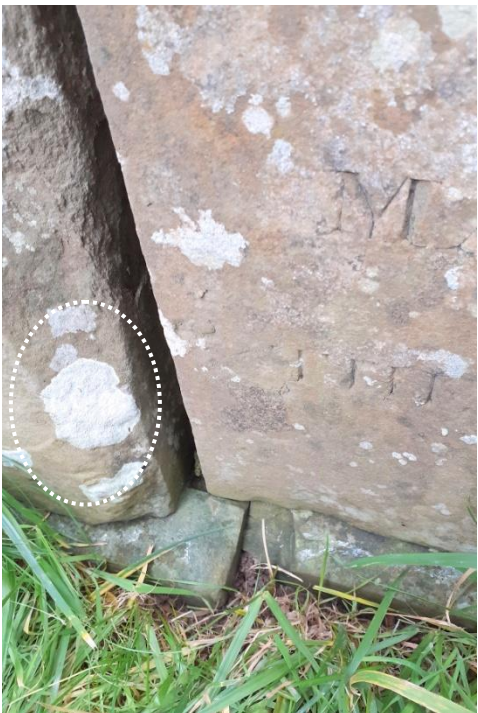
The south-west corner on the left isn't just a wide joint. The left-hand corner block should have a rebate which sits over the dedication panel, but is long-gone. The island of aged, white lichen where the carved detail has been lost and rounded stone indicates this has been missing for a long time. The right image highlights the extent of delamination and flaking to this poor-quality, laminar stone.

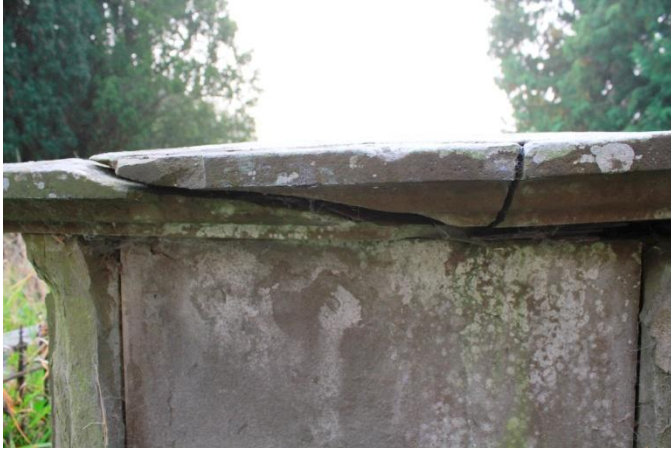
The transverse fracture is inherent within the laminar stone; the vertical fracture is a result of point-loading. Note the vertical joints in the tomb chest are still largely parallel, indicating the tomb chest is subsiding as a whole.

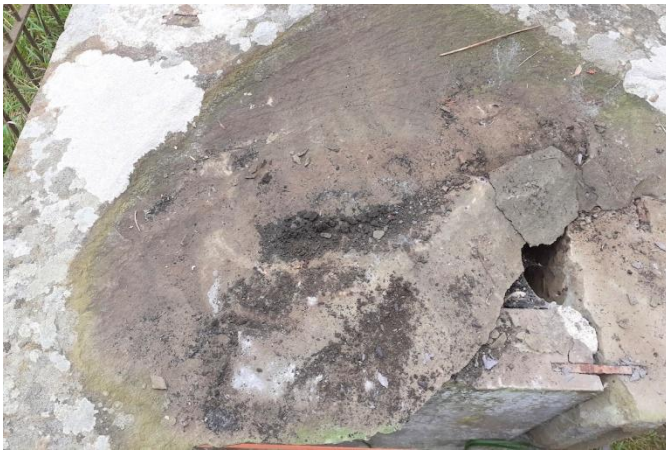
The remains of debris from within the lamination, indicating it has been allowing the ingress of moisture for a prolonged period. Fortunately the different layers are overlapping making for a stronger bond, when adhering the fragments in stages.

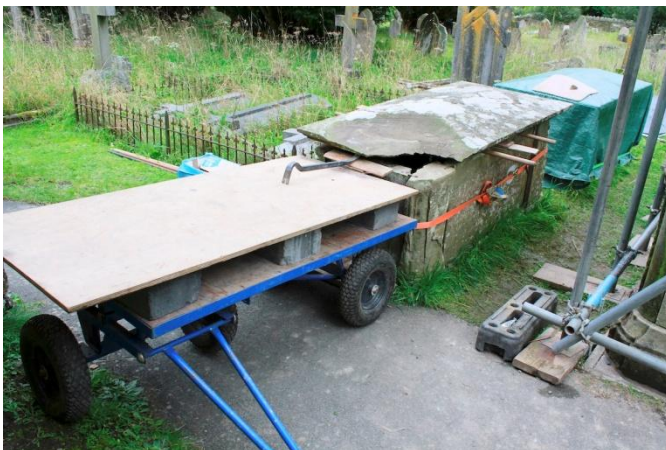
The remains of the lid being rolled off the tomb chest, after the fragments have been moved for storage. Because of other inherent weaknesses still in the slab it was not up to lifting, which risked pulling it apart. The slab was successfully moved off and back on without compromising the existing geological faults.

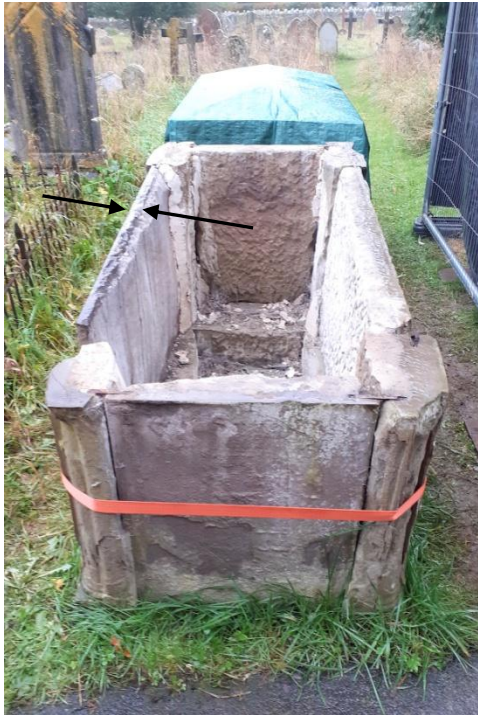
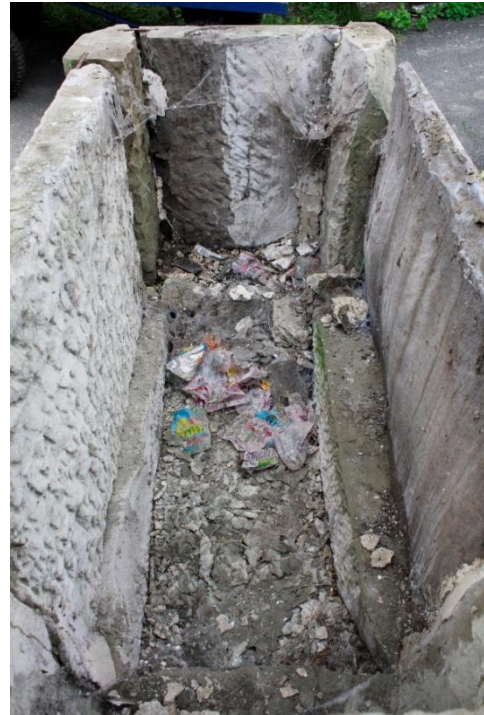
The tomb chest once the lid was removed. On the left, note the thin nature of the bedding surface (indicated) the rear of which slopes away, leaving only 10-15mm of bearing. On the right, detritus on the inside of the chest. The west elevation, 'short' side shows where (white) liquid plaster has been poured in historically, in a vain attempt at consolidation.

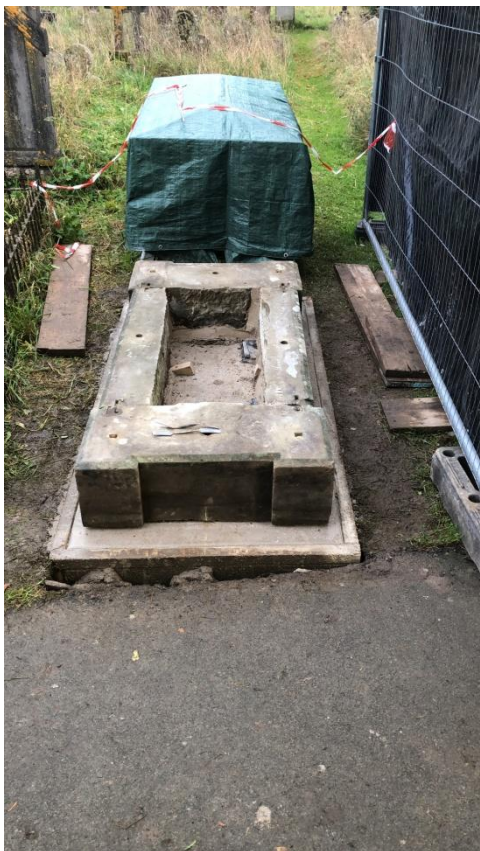
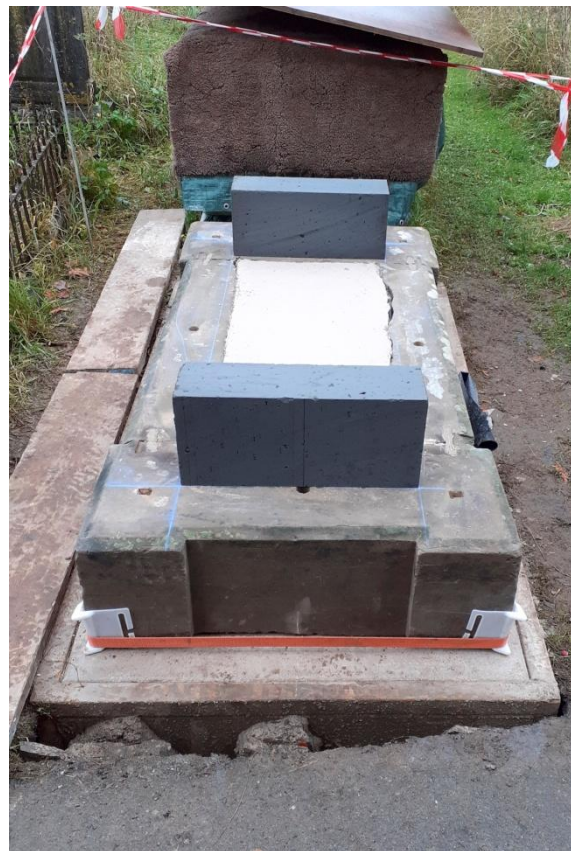
On the left the new re-enforced sub-base in position with the plinth blocks having been bedded into position. On the right, the void within the plinth has been filled with Limecrete, on top of a Visqueen DPM/separation layer. Celcon blocks being laid to create a supporting internal core.

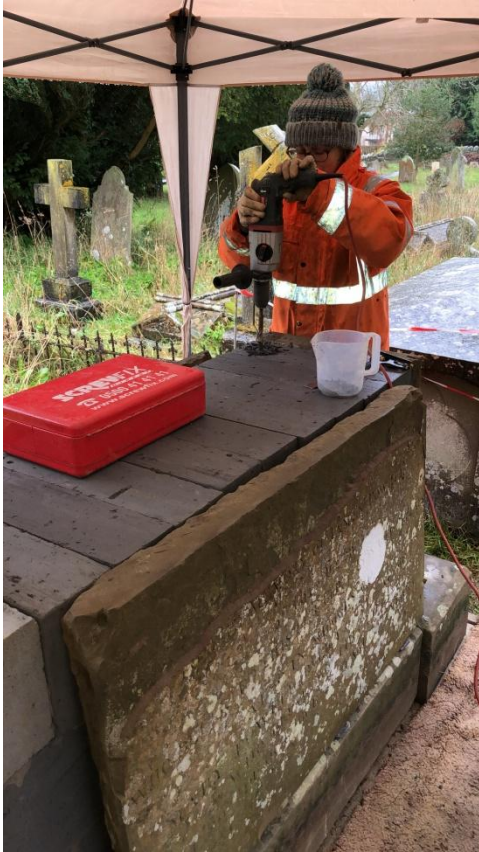
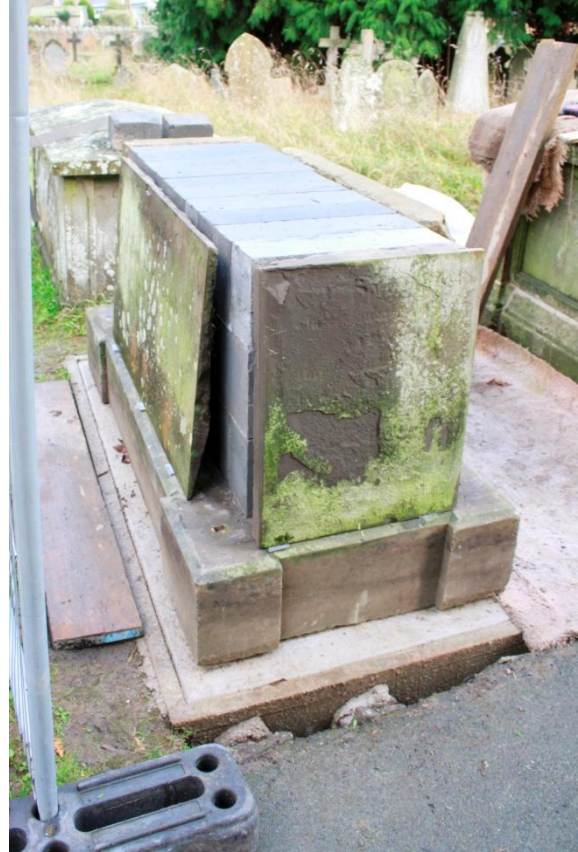
The top outer blocks at either end, had long dowels secured with gunnable epoxy-resin, deep into the course beneath, such that the two opposing blocks could not be pulled outwards by the slabs being restrained. The central fixings on the long panels were in the same block, so were pulling against one another. On the left, the top quarter of the panel has been lost through delamination, with an angled support filling inserted along the length of the vulnerable edge.

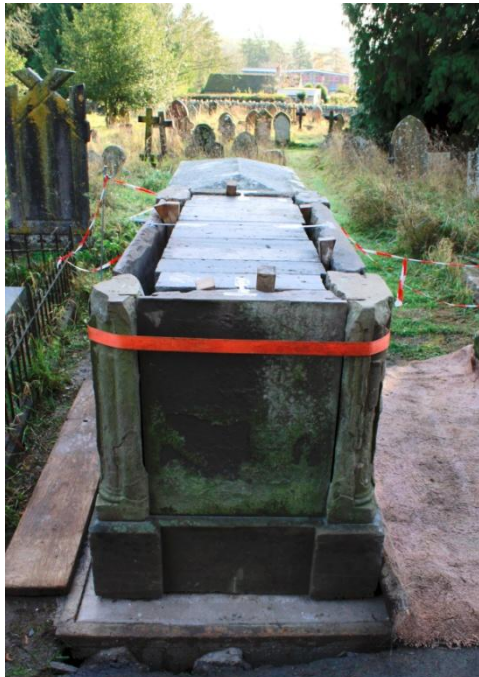
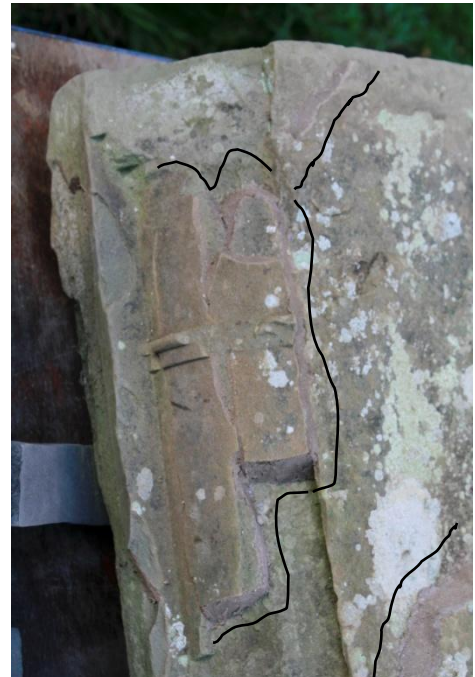
On the left, all restraint fixings are in place and stone elements are kept plumb with wedges and a ratchet-strap, whilst the epoxy-resin cures. On the right, one of the corner blocks displaying the extent of loss of carved detail and coloured support fillings to protect edges, previously tacked with epoxy-resin (by us) to prevent further loss.

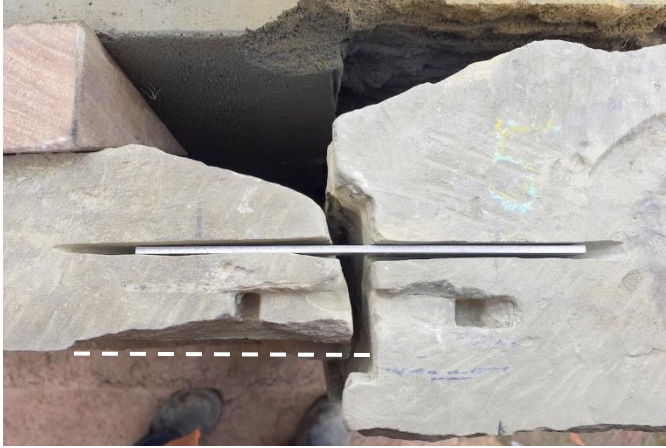
A new stainless-steel fixing to replace the thin-section clamp, which would have been visible due to the loss of material (indicated). These were all secured with an external-grade epoxy-resin.

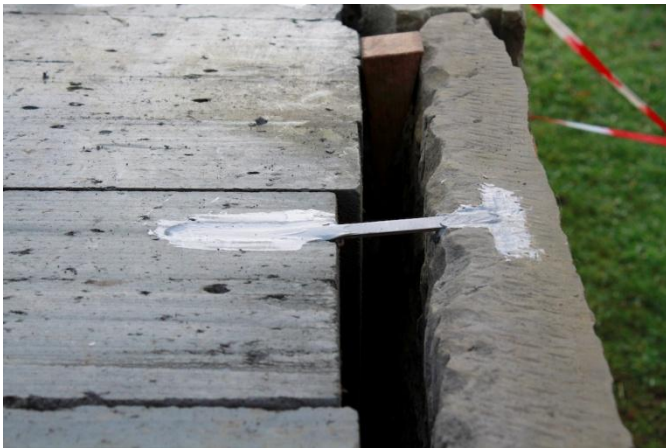
A restraint fixing in one of the 'long' panels. The core was built slightly higher than the tombchest panels, such that it bore the weight of the restored lid and not the fragile side panels. A thin layer of mortar was applied to the top-bed of the panels at their rear, so there was something to point against, with the gunnable pointing mortar.

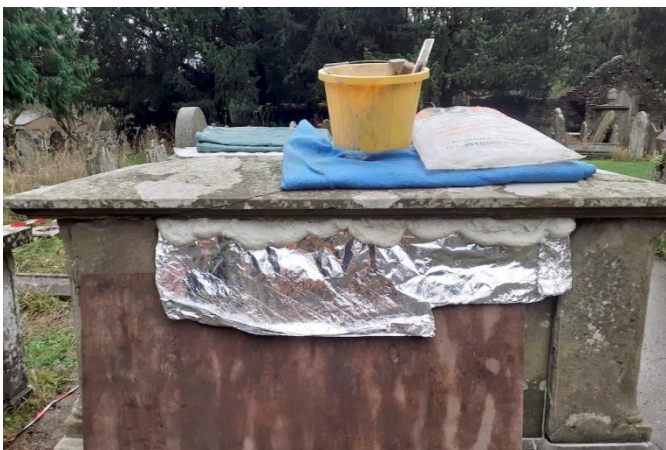
On the north elevation the 'long' panel was so thin on the top bed, with a void behind back to the core. Because of this there was nothing to point against and so a pocket was created using expanding epoxy foam. The tin-foil and timber is to stop any foam coming into contact with the stone. When it had cured it was cut back to create a solid backing against which to apply the initially fluid pointing mortar.

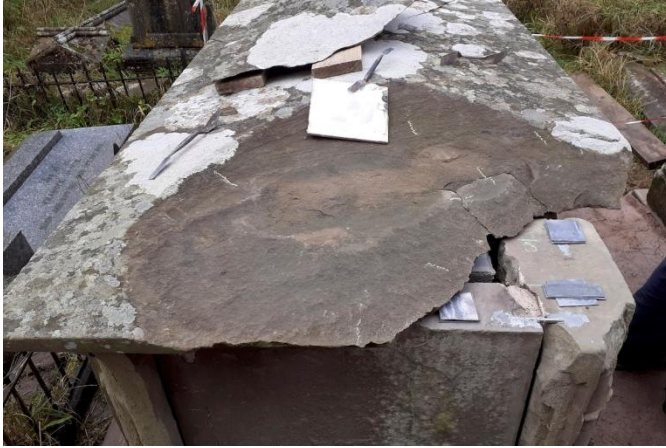
The cleaned lid, marked out dry where sections would sit and where to apply spots of epoxy to ensure the strongest bond. Note stacks of lead-shims on the tomb chest panels, which was easier than applying mortar and taking the sections on and off, which could have been messy and caused lime-staining.

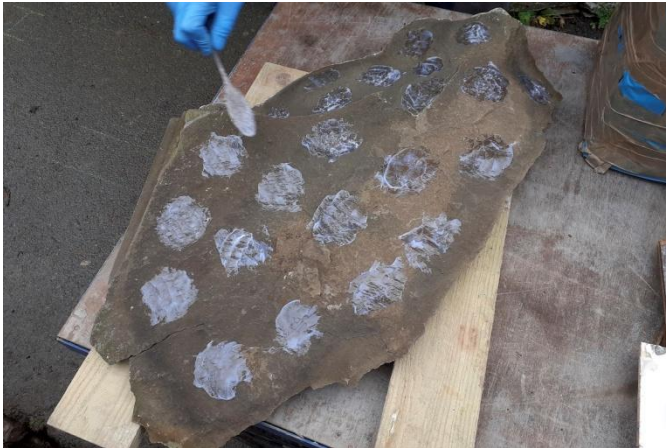
Resin is applied one side, the fragment applied to see where the corresponding spots will be on the lid, then the fragment is removed, with resin applied evenly to both faces. This gives a much stronger long-term bond than merely applying resin to one face only. Note resin is kept well back from break-edges.

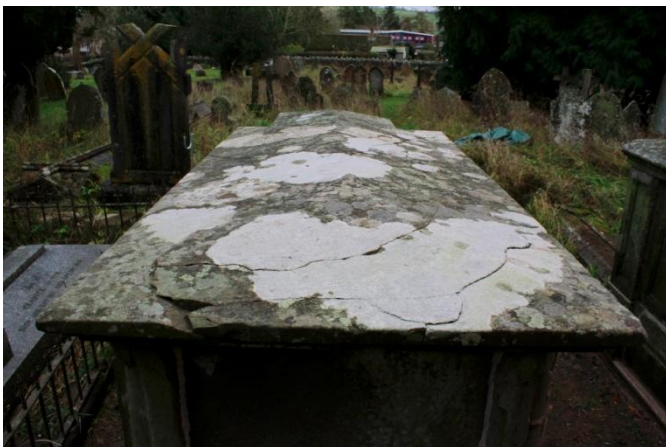
The fragments locked together in a natural, tight-fit after they had been removed of all organic material. It is hoped the extensive, aged white lichen will cover over the laminations eventually, sealing the moisture entry points. These lines were not filled as they are doomed to failure in such proximity to thick lichens, which secrete weak organic acid.

- 6.11 Spots of resin were used to secure the fragments and produce a strong long-term bond. The large island of thick white lichen precluded the use of a support filling which would have failed, as repair mortar does not bond to lichen material and the poly-saccharides from the lichen at such close quarters would weaken it almost immediately. Free-flowing liquid grout was introduced into the very fine joint lines which had minimal penetration, indicating the join is very tight and water percolation won't be such an issue. The joint lines that are there are diagonal, meaning any water that does penetrate will migrate through the lamination. Using spots of resin as opposed to a solid layer ensures moisture in gas, liquid, vapour phases can move freely through the porous stone. The hydrophobic lichen is likely to grow over the surface fissure and prevent the ingress of moisture in the short-medium term.

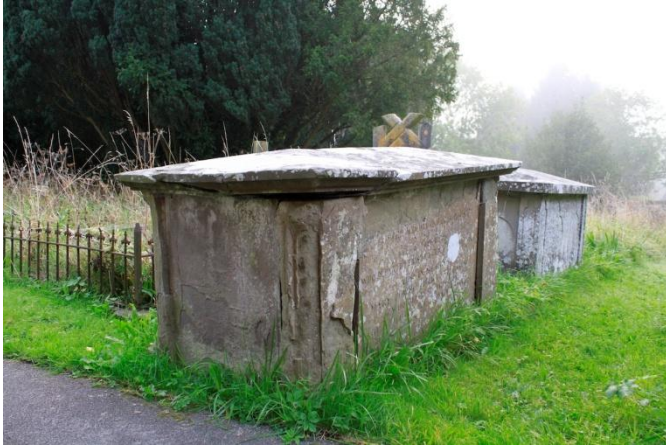
The Powell memorial before any treatments. Note the proximity of the grass around its perimeter, which obscures the plinth. In this image water would be running down the path and transferred into the plinth, which was saturated, being below ground-level.

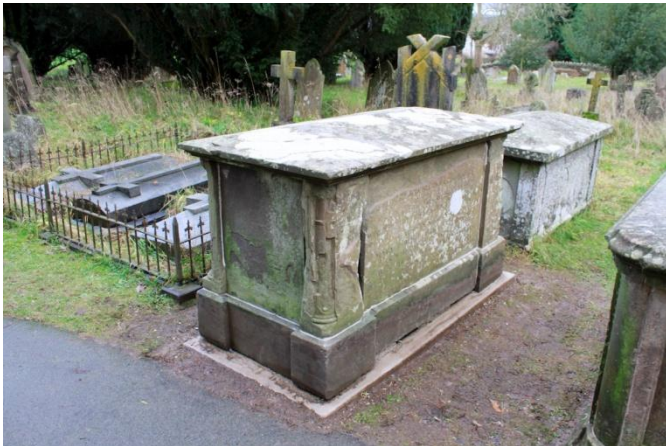
The memorial after nearly all treatments. The joint between the concrete sub-base and bottom bed of the plinth has yet to be pointed with a traditional mortar, such is the level of undulation, due to roughly shaped not worked blocks, which would have contributed initially to less than perfect transfer of weight. The plinth is well-bedded just not surface pointed.

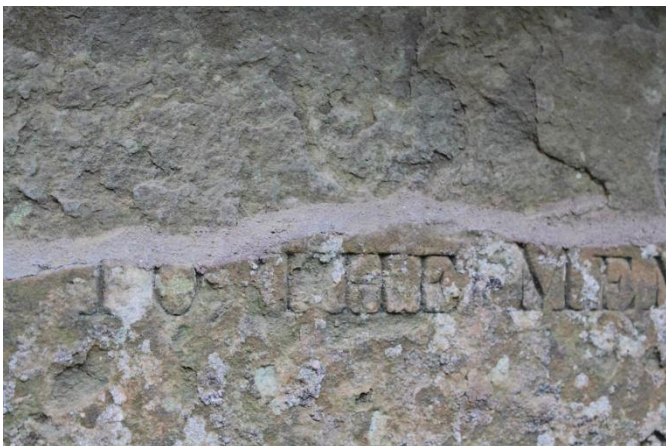
The coloured support filling (that is dry due to being covered) which ran nearly the entire length of the south long panel, to protect the carved upper-surface below, which contained the dedication. Note the poor condition of the flaking substrate above, the loosest stone and other areas beyond practicable repair were rationalised to prevent loss and retention of excess water.

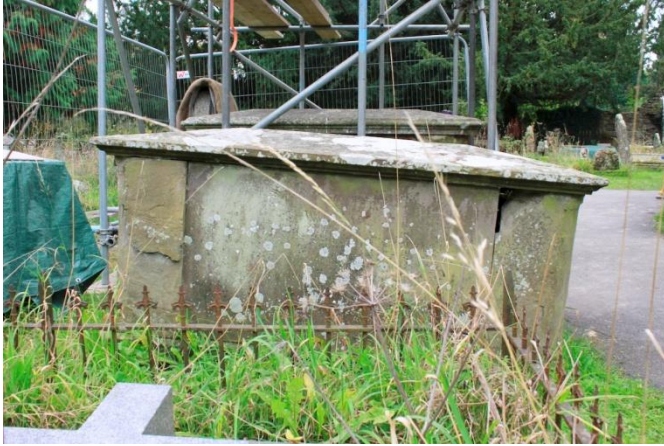
The extent of subsidence prior to dismantling. Note again the proximity of the nearby path and adjacent railings.

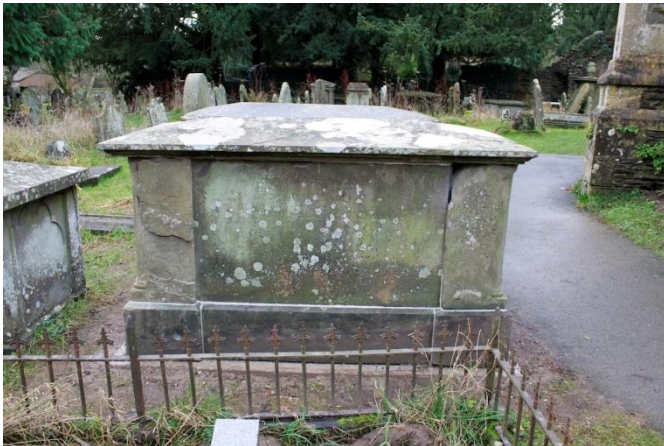
The memorial after nearly all treatments. Note the concrete sub-base is just below ground level and the path but the void between both is filled with free-draining aggregate, which will prevent water pooling in this location. The plinth will dry slowly in time, having been below ground-level for so long.

- 9.2 The tarmac path will continue to direct rainwater toward the west elevation of the plinth. The aggregate spanning between the path and the plinth should be monitored to see if it gets silted-up in the medium-term. If it does it should be replaced with something similarly free-draining such that saturated soil does not sit against the stone of the plinth and cause damage from frost. That situation is likely to be a long way off.
- 9.3 Elliott Ryder Conservation will monitor the condition of the memorial (free of charge) and the appearance of any ivy near the plinth after twelve months, as part of our on-going maintenance commitment, and report back to the PCC with any findings.
