Final Conservation Report for Churchyard Memorials

St John the Baptist Church - Bishops Castle - Shropshire

The Diocese of Hereford

Elliott Ryder Conservation

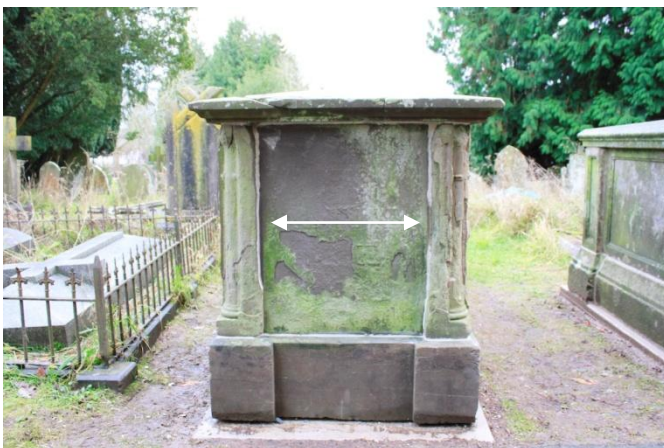
The west elevation of the memorial showing the relation between the neighbouring kerb set/railings and Griffiths memorial to the right. The gap between the two memorials is a mown path and we didn't want to create a trip-hazard on the corners of either sub-base. Note the inner mouldings or rebates on the two, rounded corner-blocks (indicated) is largely missing and why the joints look so wide.

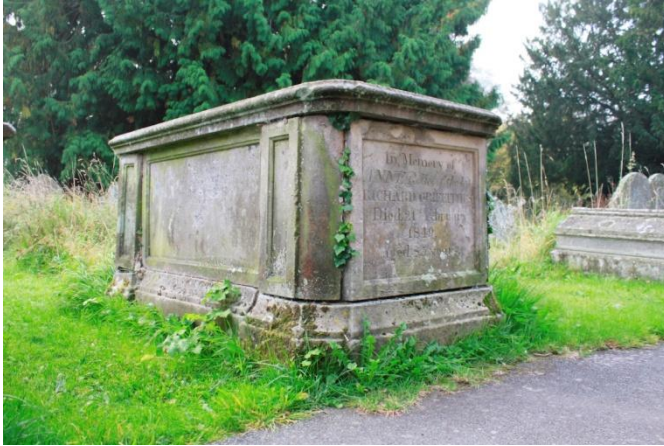
The memorial prior to any treatments, note the proximity of the tarmac path in the foreground, which gives no sense of the camber of the path, directing water into the plinth block. Work was done by us to remove as much of the ivy growth as possible in the winter of 2019. New growth can be seen issuing from the joints of the memorial.

- 8.3 Elliott Ryder Conservation will monitor the condition of the memorial (free of charge) and the appearance of any ivy near the plinth after twelve months, as part of our on-going maintenance commitment, and report back to the PCC with any findings.

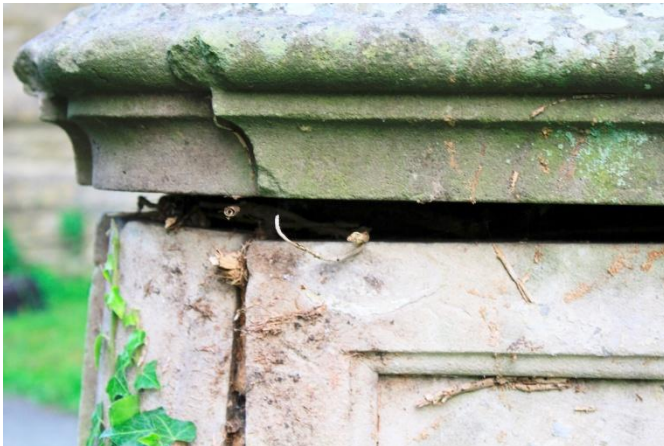
- 1.4 The double-pitched tomb chest lid has very little overhang and was observed to direct water onto the plinth beneath during heavy rain, surely an architectural oversight. Despite this anomaly, the lower elements are in a relatively good state of preservation, which is fortunate given the soaking this plinth must endure at times.

The compromised bed-joint between the tombchest and heavy lid, raised-up due to active, internal ivy growth. Note the poor architectural detailing of the lid with only a small bull-nose drip, effectively directing rainwater round onto underlying elements, instead of shedding water from the pitched lid, away from the memorial. Note also the tomb chest panel to the left is well out of alignment.

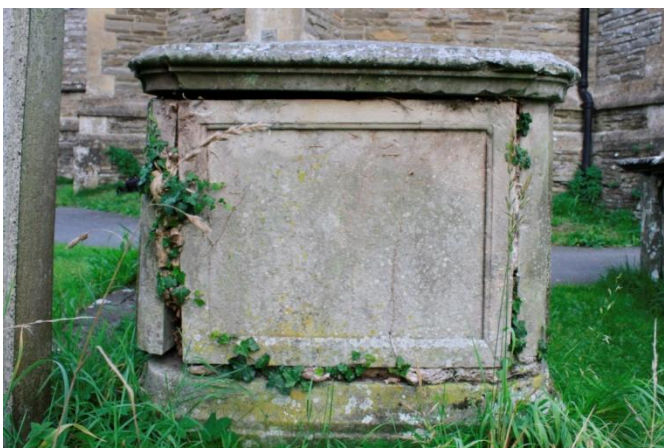
- 1.5 Ivy was seen to have grown through vertical joints in the tombchest, forcing some of the corners out of alignment by nearly 125mm. Because the lid was so thick, luckily this point-loading did not cause any further issues as witnessed on the Woolacott Memorial where differential loading led to delamination of the much thinner slab.

The extent of internal growth issuing from vertical and horizontal joints at the east elevation. Note the left-hand corner block has been forced-out beyond the plinth and the angle of the lid, raised at the left-hand (south) elevation, causing point-loading on the north 'long' panel and flanking corner blocks.

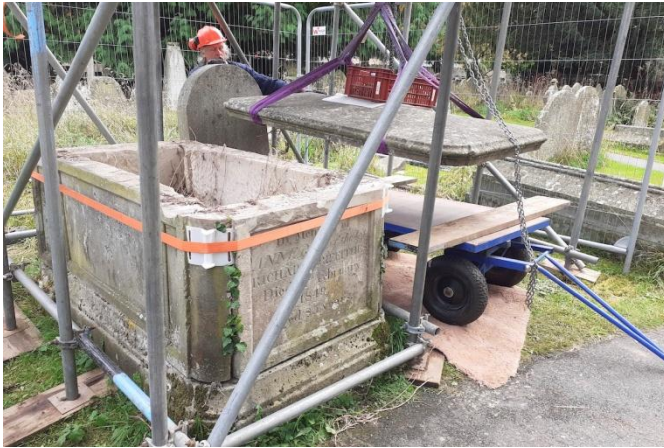
Lifting the heavy lid away from the tomb chest. We were able to lift the lid as the stone was assessed visually and 'rung' (assessed audibly) to determine any fractures or geological faults. The stone of this memorial is different to the majority of the other memorials and is stronger for it. There was no delamination despite the extent of deformation witnessed, just some isolated 'scaloping' (scallop shaped areas of loss) due to point-loading.

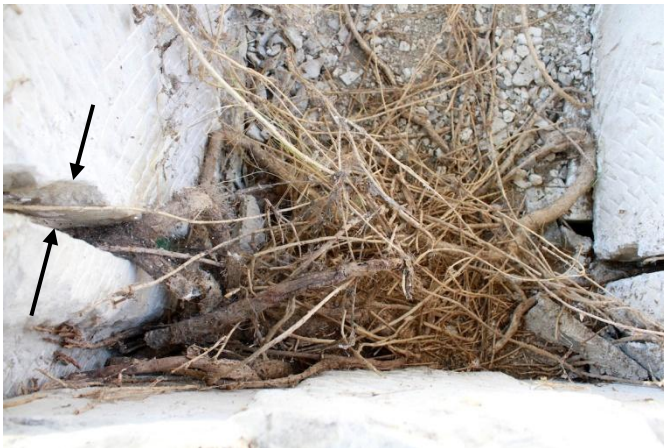
The mass of ivy stems visible in the south-east corner. Note the internal mitres (indicated) are empty of mortar, which would have prevented ivy from penetrating the joints and moving outwards, seeking daylight.

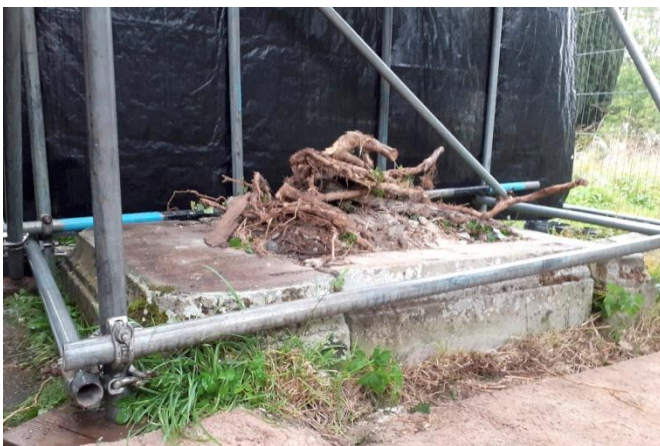
The thick woody stems visible after removal of all tomb chest elements and which carried on down below ground-level. The scaffold was tight to the plinth due to the weight involved in lifting and lowering the lid which was calculated as weighing nearly $\frac{3}{4}$ ton, plus the requirement to keep both paths open, for movement around the churchyard by visitors.

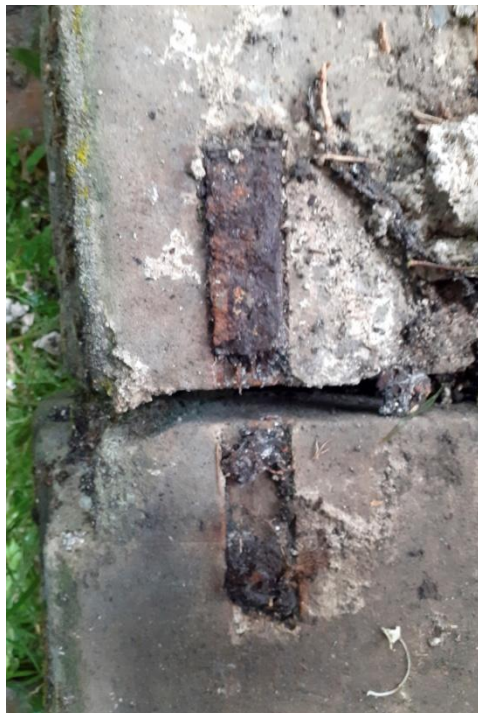
Corroded iron fixings which have delaminated to now flaky metal, serving no useful purpose. Luckily there was no iron-staining to speak of, despite there being easy access for excess moisture, with which to initiate the process. On the right, ivy stems grow easily beneath the fixing, ready to force this one apart.

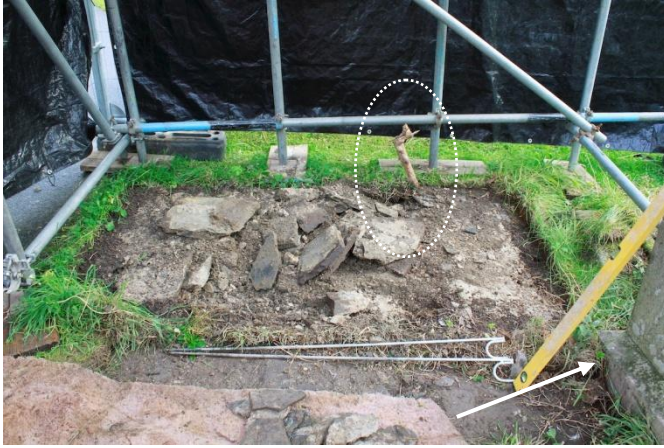
After removal of all plinth elements. The loose slabs are what the sub-base was made from, loosely arranged on top of one another with very little mortar. Note the ivy stem protruding from the ground (indicated) that was pulled outwards beyond the footprint and cut off. Note the proximity of the headstone plinth in the foreground which hampered the width of the new concrete pad.

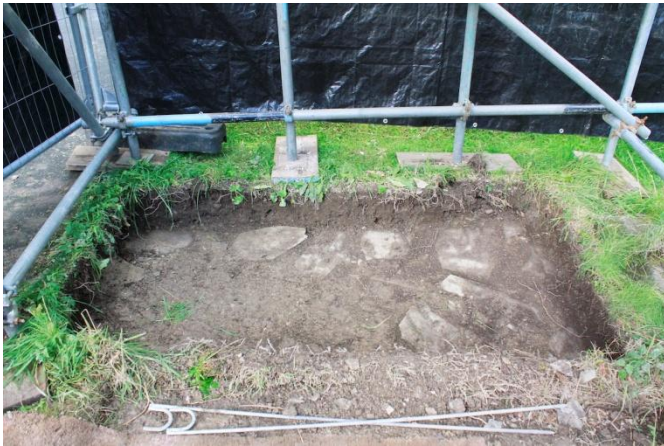
During removal of the stone sub-base to get sufficient level and depth for the new concrete pad.

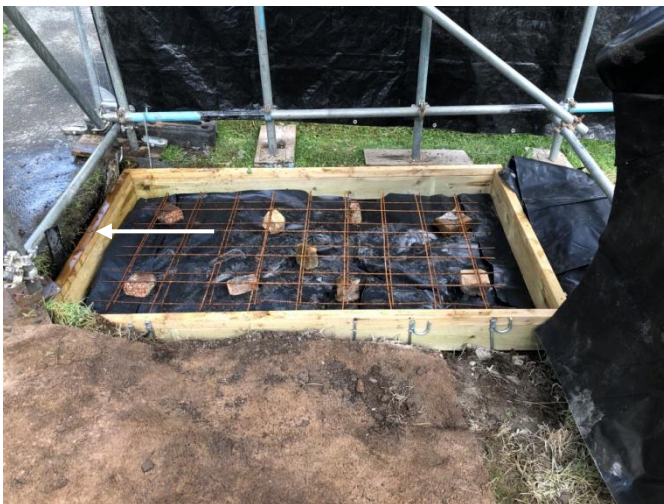
The shuttering and re-enforcing mesh in place, prior to application of the concrete. Note the top-bed of the shuttering and ultimately the concrete pad is lower than the height of the tarmac (indicated). The gap between the two was packed with free-draining washed, clean aggregate. If the pad had been higher than the path, there would have been a huge expanse of concrete at the east (right) elevation, which would have looked unsightly.

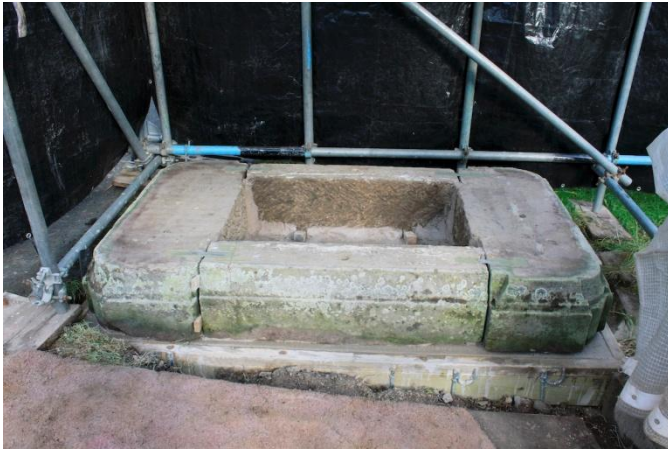
The cured concrete within the shuttering and the four plinth blocks now in place. The rear of the joints was packed with coarse bedding mortar to provide additional support/rigidity. The bottom beds of the different blocks had been worked to varying degrees, with some relatively flat and others requiring more bedding mortar to make them level in both planes on the top-bed.

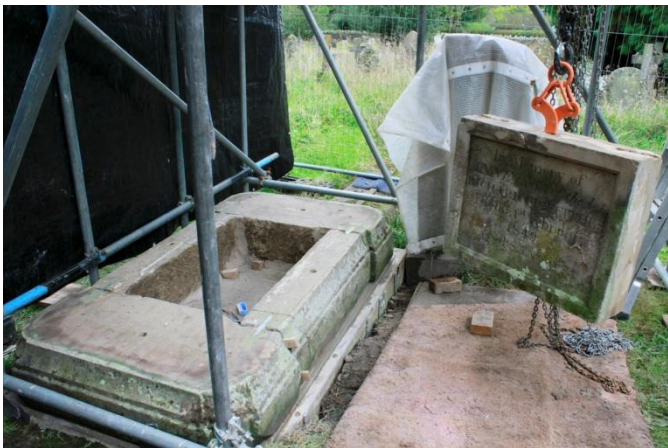
The west elevation 'short' panel being hoisted into position. The Lewis-pins enable blocks to be lowered into position precisely, without the need for removing straps. As none of the blocks were the same height or level on the top-beds, all eight had to be placed on the plinth dry, to see which was the highest and fix them around that block. This process was made much easier with Lewis-pins.

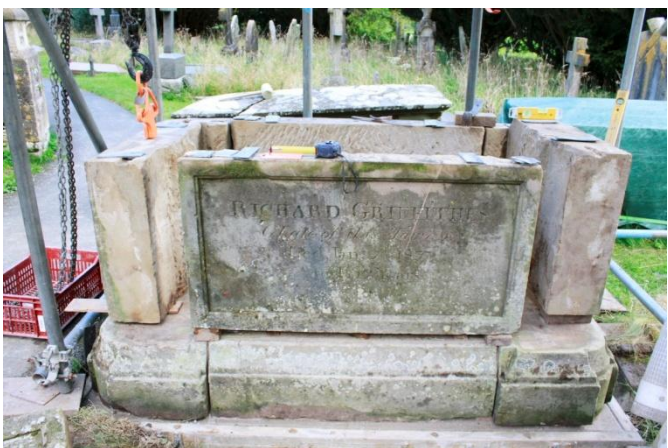
The last of the four main panels being lowered into position. The four corner blocks (which were just manageable by-hand) all fitted differently, with different masons interpretation of the 'bed-moulds' when carving the blocks obvious, during our fixing. Note the joints appear cleaner, having been jet-washed. No cleaning was carried-out on the outer faces.

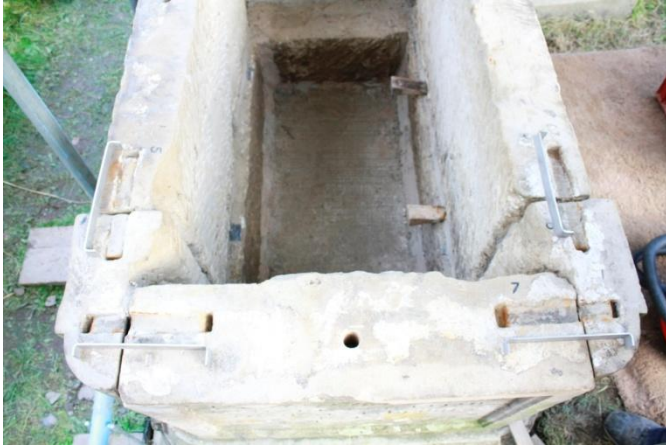
The tomb chest panels were so wide and in sound condition, there was no need for an internal supporting core. Note the new stainless-steel dog-cramps before being secured into holes/slots originally cut by hand, which we deepened by us in the same manner, them being rectangular. Not one of the cramps was the same length.

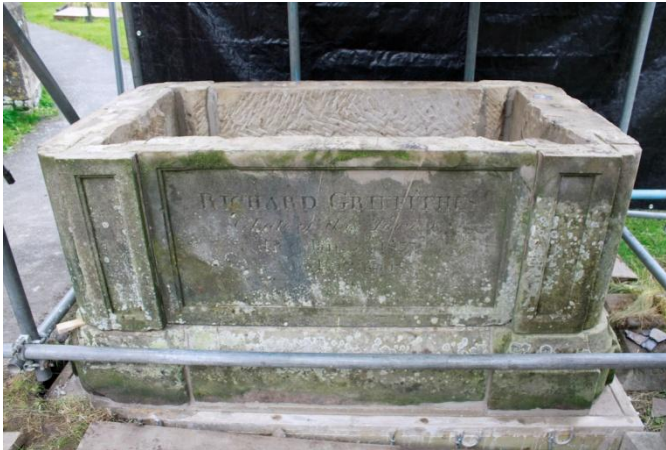
The tomb chest constructed with all bespoke cramps secured into position with epoxy-resin. There was a good deal of compromise when fixing the corner blocks, to ensure there were consistent parallel joints from top to bottom. If using the original slots and dimensions there would have been numerous ugly, dovetailed joints.

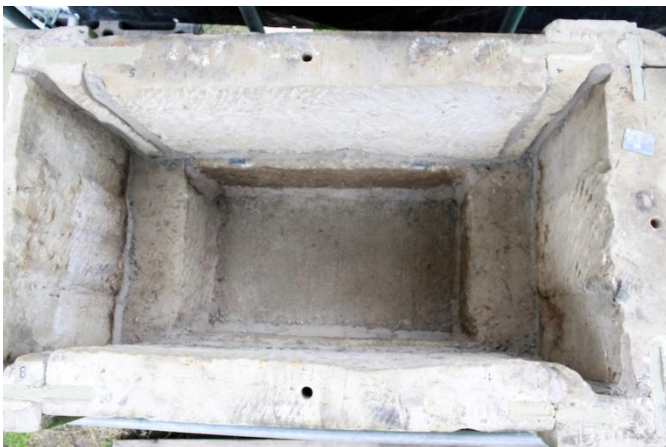
The inside of the memorial showing the massive footprint of the plinth and the thick tomb chest panels. All internal mitres were packed with mortar and the gunnable mortar used initially where joints were tight at the rear. This adds extra rigidity and strength to the already sturdy new fixings as well as ensuring moisture cannot penetrate.

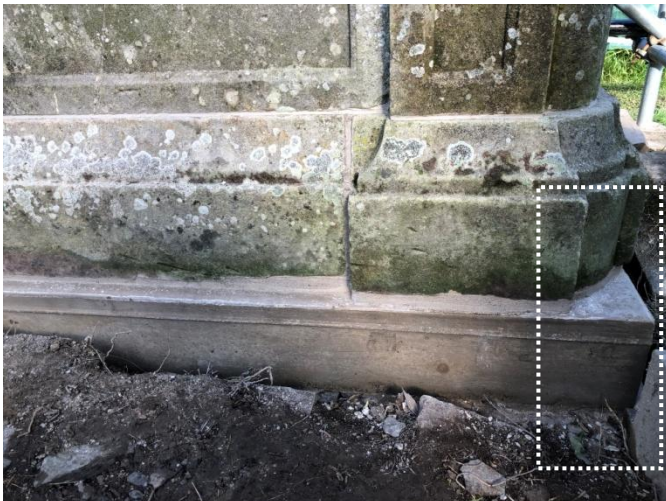
Detail of the concrete pad after the shuttering is removed. A coffin-shaped grave-slab is pushed tight against the plinth on this elevation. Note the tight, uniform joint between the plinth and the overlying tomb chest blocks. The joint between the concrete pad and bottom bed of the plinth blocks undulates significantly to ensure the top-bed of the plinth is flat for the next course and ultimately the lid. Note the proximity of the two plinths to adjacent headstones (indicated) which hampered the size of the new concrete pad.

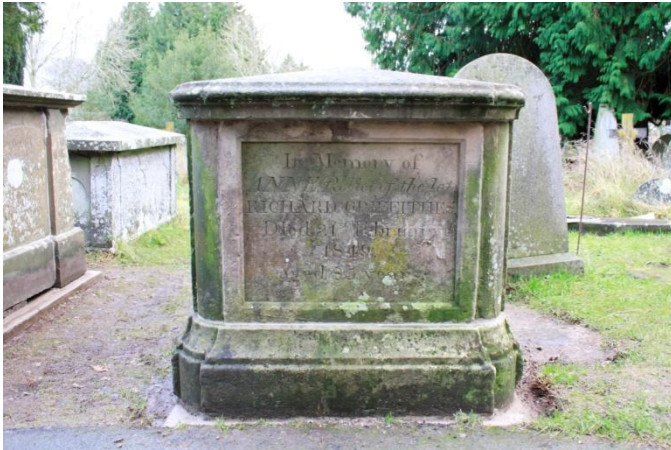
The west elevation of the memorial after all treatments. Note the uniformity of the joints and the small amount of overhang from the lid, which is rounded and therefore largely ineffective. The step down between the tarmac path in the foreground and the new cast slab is packed with free-draining aggregate. The biological growths on the upstand of the plinth should diminish in time, given it will no longer be saturated.

- 8.2 The tarmac path will continue to direct rainwater toward the west elevation of the plinth. The aggregate spanning between the path and the plinth should be monitored to see if it gets silted-up in the medium-term. It is does it should be replaced with something similarly free-draining such that saturated soil does not sit against the stone of the plinth and cause damage from frost. That situation is likely to be a long way off.

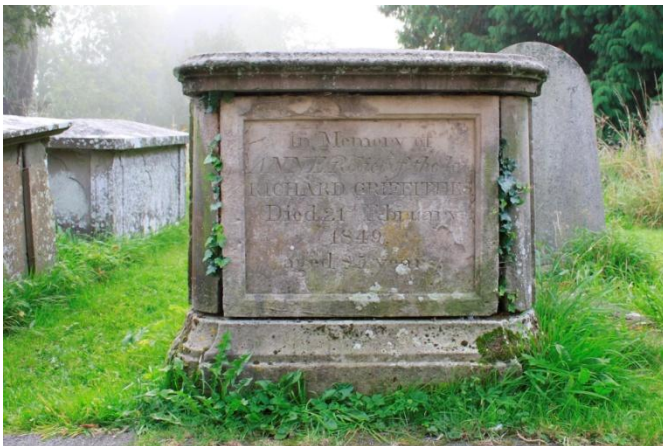
The memorial before dismantling showing an array of uneven, dovetailed joints caused by poor construction and the effects of ivy, forcing the memorial apart from the inside.

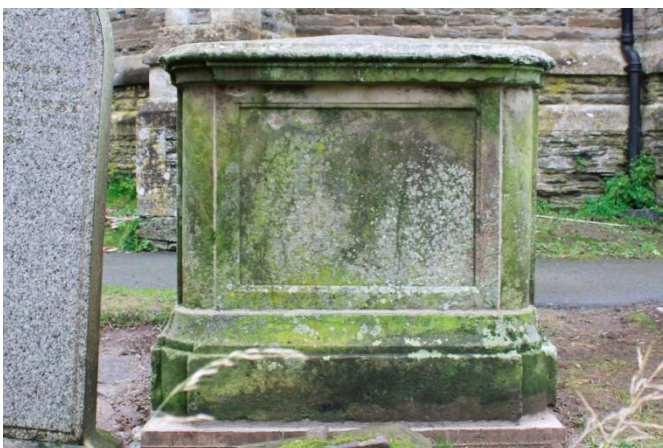
The east elevation after all treatments, note the dark-green biological growths on the plinth should also diminish in this location, however tall grasses were seen to grow against the memorial, before conservation. Note the concrete would have been even thicker at this elevation, had the pad been at the same height or above the tarmac at the opposite elevation.

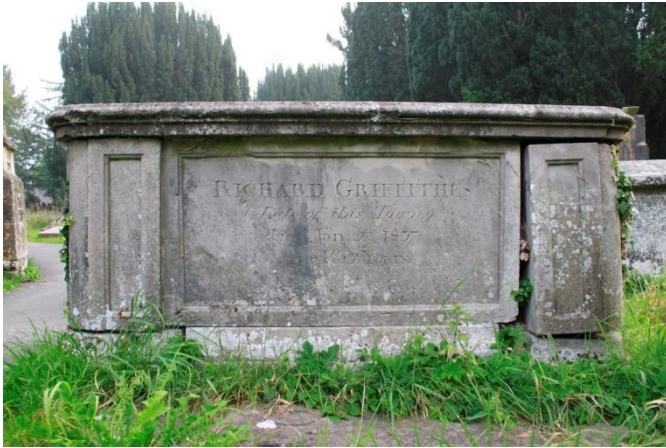
The south elevation of the memorial before any treatments. Note the amount of deformation to the south-east corner in particular. Note the coffin-shaped grave-slab in the grass in the foreground.

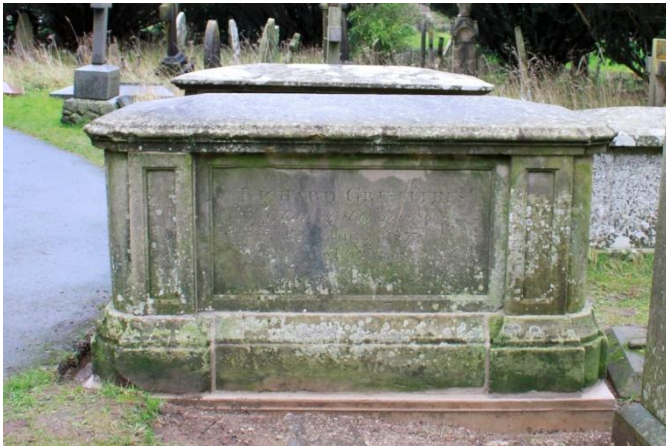
The south elevation after completion of re-building, with soil due to be packed down into where the timber shuttering was for the concrete pad. The coffin-shaped slab will also cover the concrete on this elevation where the ground drops away to a far-greater extent. The downward sweep of the tarmac path can be seen to the left.

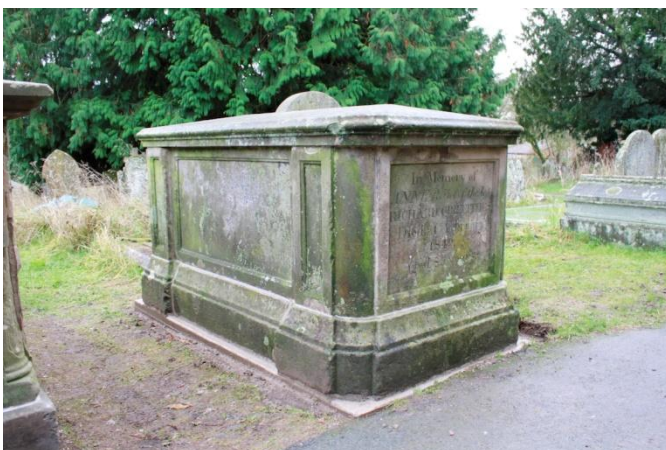
A three-quarter view of the completed tomb chest. Note the concrete pad could not be moved over any closer to the William Powell monument, which itself couldn't move any further to the north because of a granite kerb set to an adjacent family plot. The gap between the Griffiths and Powell memorials is a footpath, so it was important to maintain the existing dimension between both.
